NUMBER: 23-013-21 REV. A

Front Outboard Seat Belts May Not Retract Properly - X90 Warranty Extension

2014 - 2015	(WD)	Dodge Durango
2014 - 2015	(WK)	Jeep Grand Cherokee

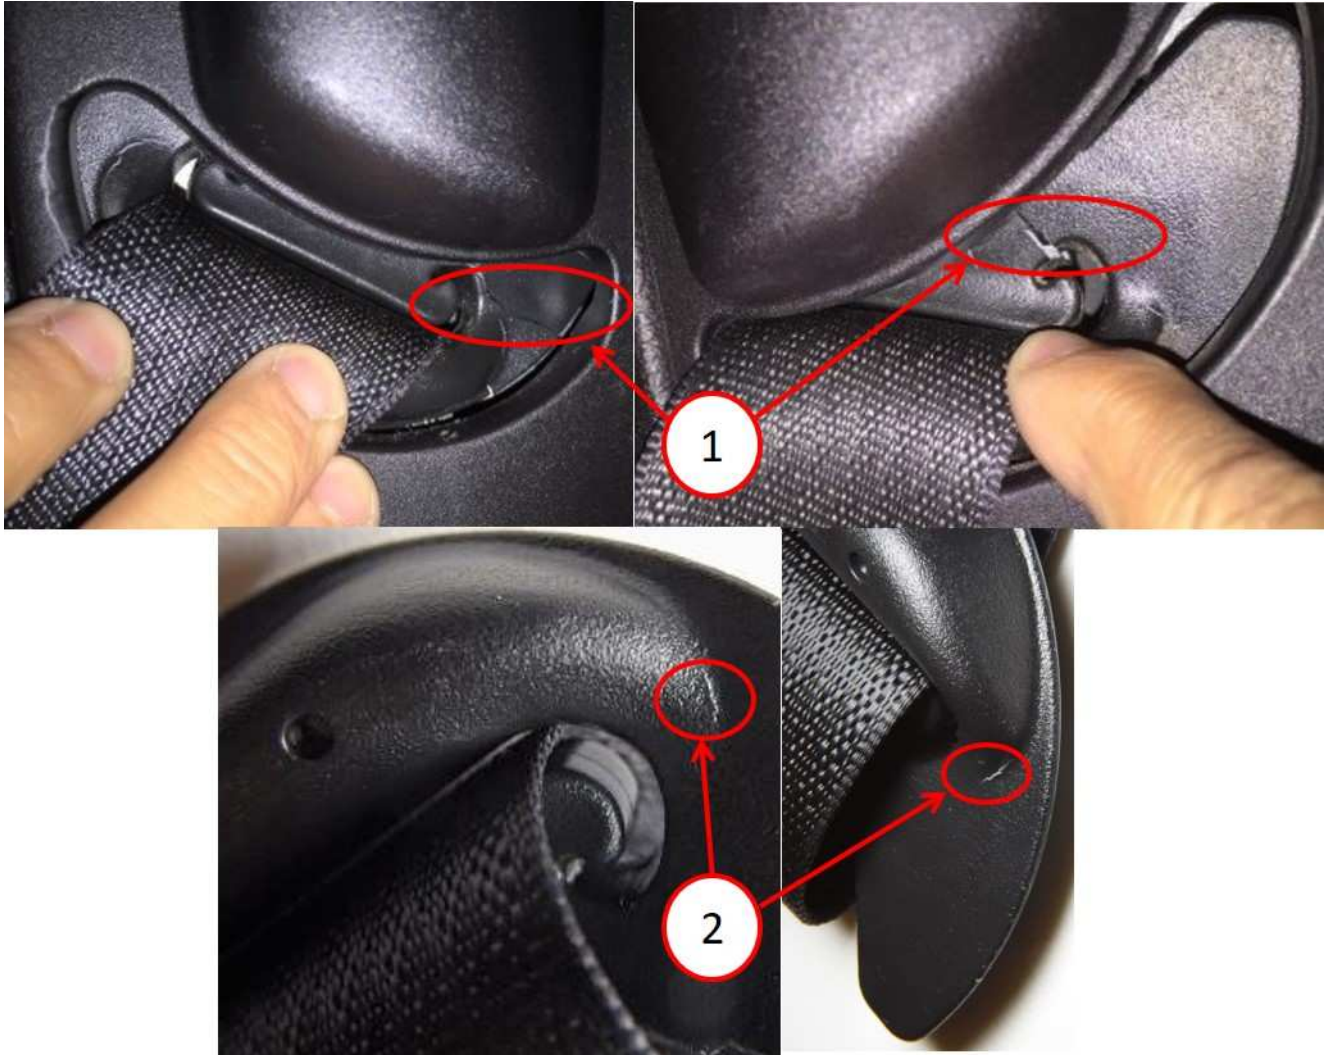
Fig. 1

1. Open the front door.
2. Using a flashlight or equivalent light, inspect both front door seat belt retractor D-rings for cracking, stress whitening, or witness marks on the D-ring plastic overmold (Fig. 1) .

Cracks And Whitening In The D-Ring Plastic

1 - Examples Of Cracks On D-Rings

2 - Examples Of White D-Ring Stress Marks

CAUTION! Whitening or stress marks may occur prior to a crack in the seat belt retractor D-ring(s) (Fig. 1) . If found, these seat belt retractor D-ring(s) must be replaced. Failure to replace a seat belt retractor D-ring with whitening or stress marks, may result in future D-ring failures.

NOTE: Only replace the front seat belt retractor assemblies with D-rings that are cracked, showing stress whitening, or witness marks (Fig. 1) .

1. Replace the front seat belt retractor assembly. Refer to the detailed procedures available in DealerCONNECT > Service Library> under: 10 - Restraints / Retractor, Seat Belt / Removal and Installation (Front).
