**NUMBER:** 23-024-21

Driver Side Freedom Panel Squeaks

This bulletin includes removing the left Freedom Panel, drilling out the receiver bracket hole and applying grease in the bracket hole for a squeak condition.

2021	(JL)	Jeep Wrangler
2021	(JT)	Jeep Gladiator

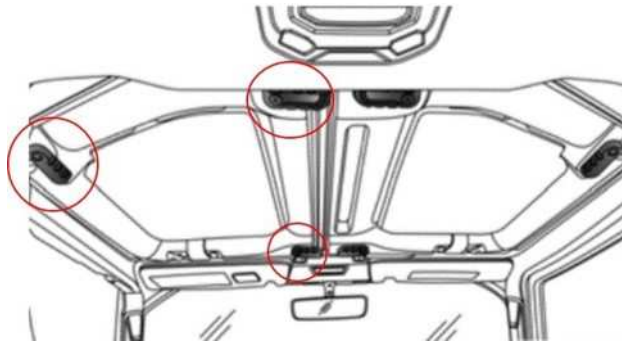
Fig. 1  
L-Shaped Locks

1. Remove the driver side Freedom Panel. Turn the three L-shaped locks on the left side panel (one at the front, the rear and outside) (Fig. 1) , unlocking the panel from the body.

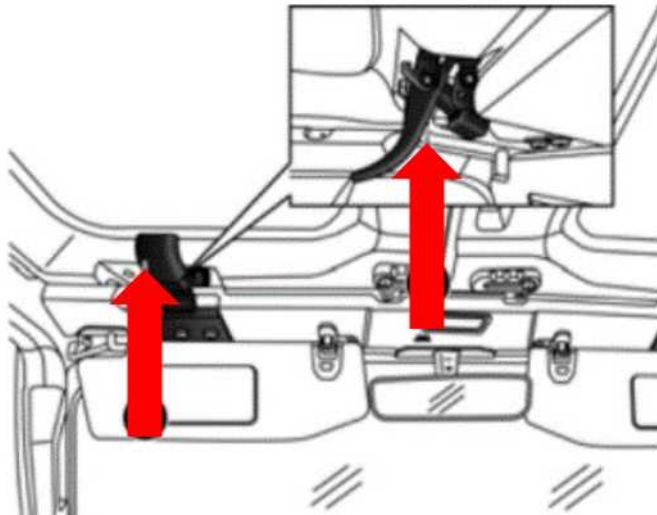
Fig. 2  
Header Panel Latch

2. Fold down the sun visor and unlatch the left side header panel latch, located at the top of windshield (Fig. 2) .

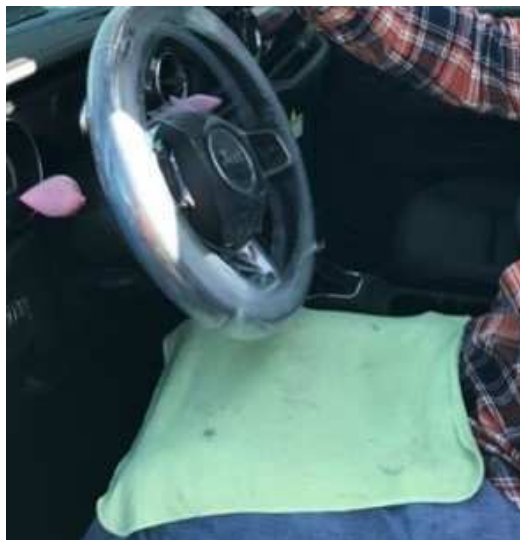
**Fig. 3**  
**Cloth Or Shop Towel**

4. While sitting in the driver seat, place a cloth or shop towel on your lap to catch any falling drill debris (Fig. 3) .

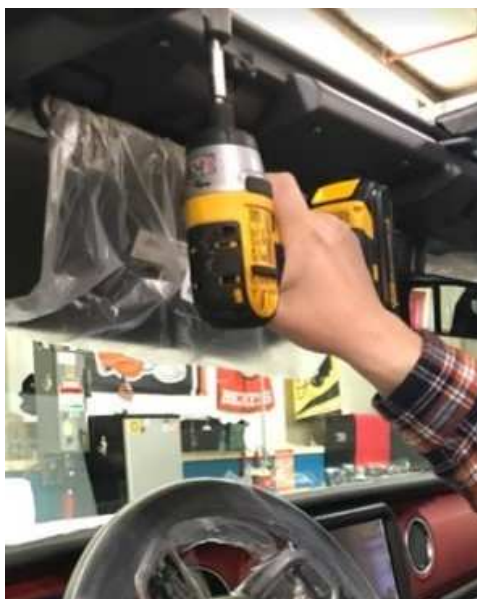
**Fig. 4**  
**Drilling Hole From The Bottom**

5. Using a drill and a **10 mm (25/64 in.)** diameter drill bit, insert the drill bit into the receiver bracket hole **from the bottom** and drill the hole for five seconds as perpendicular as possible (Fig. 4) .

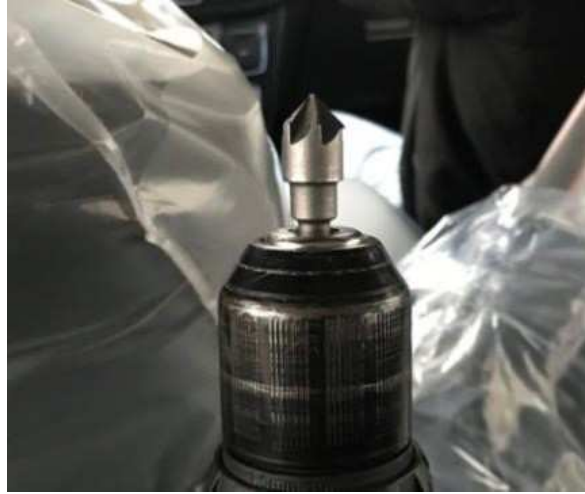
**Fig. 5**  
**Countersink Drill Bit**

6. Using a drill and a **12 mm (1/2 in.)** diameter countersink drill bit, drill **the top and bottom** of the receiver bracket hole to remove any sharp corners and burrs from the receiver bracket hole (Fig. 5) and (Fig. 6) .

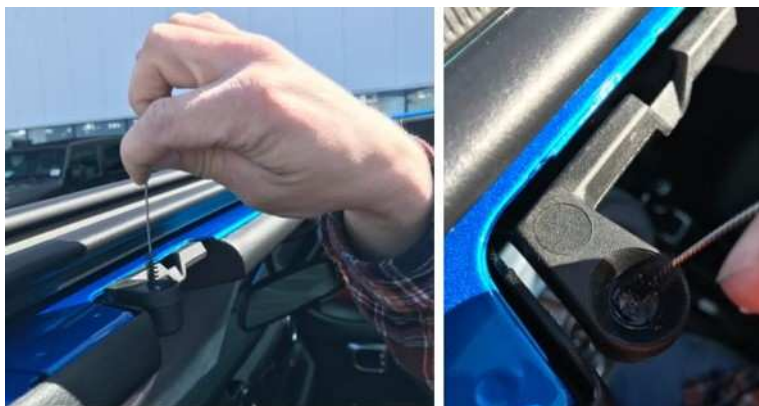
**Fig. 7**  
**Applying NLGI Grade 2 White Silicone Grease**

- Using an brush applicator and NLGI Grade 2 white silicone grease, apply grease through the top of the receiver bracket hole and on the sides of the bracket hole (Fig. 7) .
