STAR ONLINE PUBLICATION

Case Number: S2108000185

Symptom/Vehicle Issue: Passenger Rear Door Ajar Warning Lamp Display Illuminated On Cluster

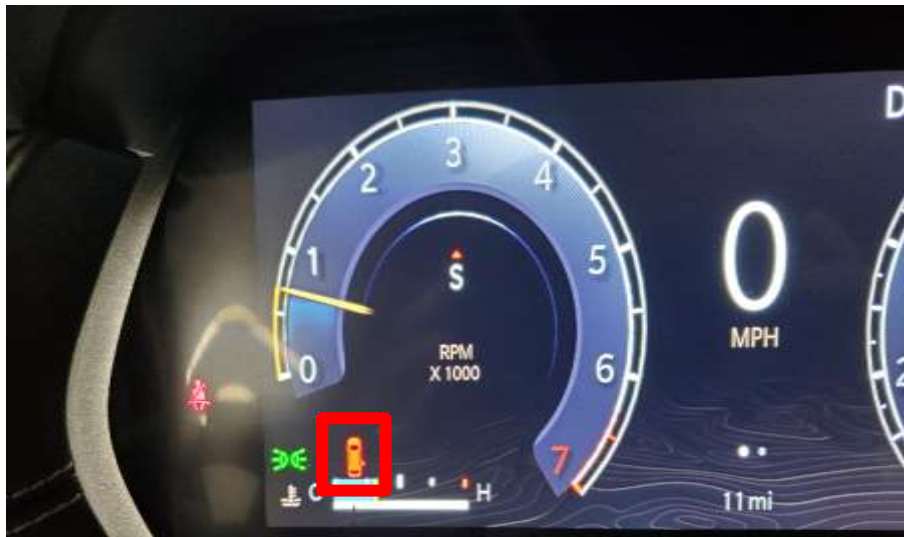
Fig 1, Rear Passenger Door Ajar Warning

Customer Complaint/Technician Observation: Owner complains of a cluster warning lamp on showing the passenger rear door is ajar; door is closed. Technician can see the warning lamp is illuminated, door is closed and there are no DTC's

Repair Procedure: Inspect the harness routing below the front passenger seat as shown below. Review the harness for any potential chaffing of the passenger rear door ajar circuit G74. Repair the circuit and isolate the harness as needed to complete Fig 1, 2.

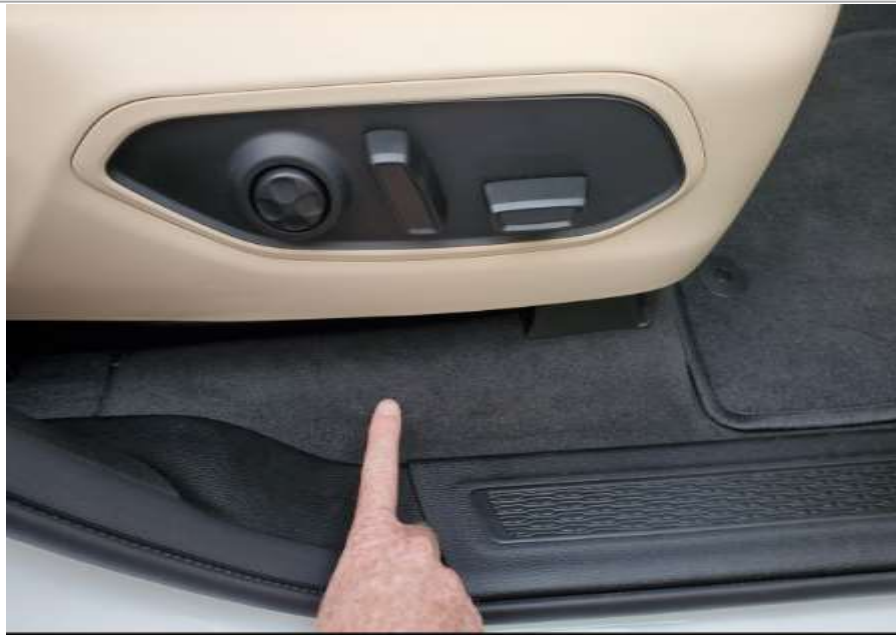
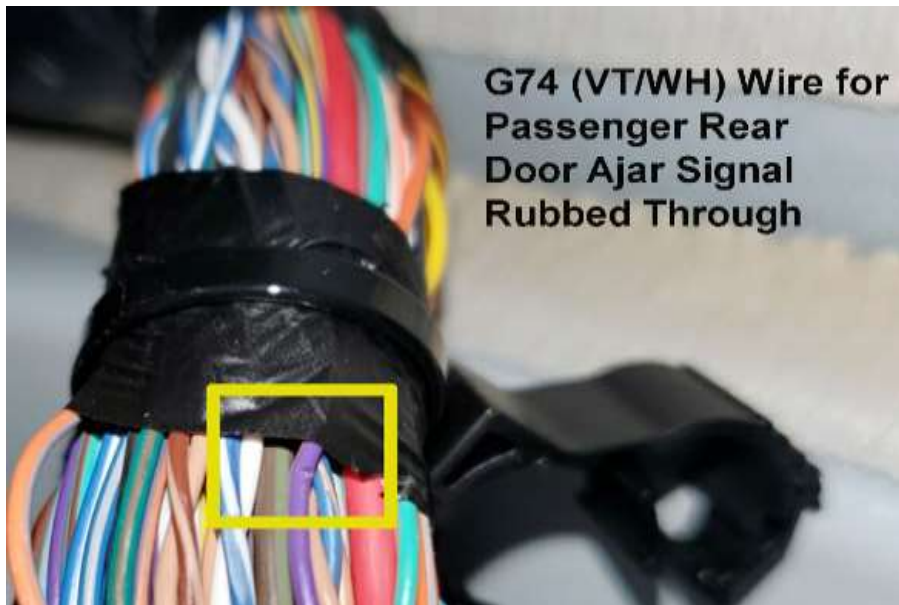
Fig 2

Location just in front of B-pillar near front door sill at area where the B-Pillar HVAC Duct Clips Over
