## TECHNICAL SERVICE BULLETIN

### VSB-04: Correction of Grey Tank Drain

**Models Involved:** 2021 Beacon 390LK and Vilano 41LKB Fifth Wheels built between October 15, 2020 and December 10, 2020.

TITLE: GATE VALVE REPAIR

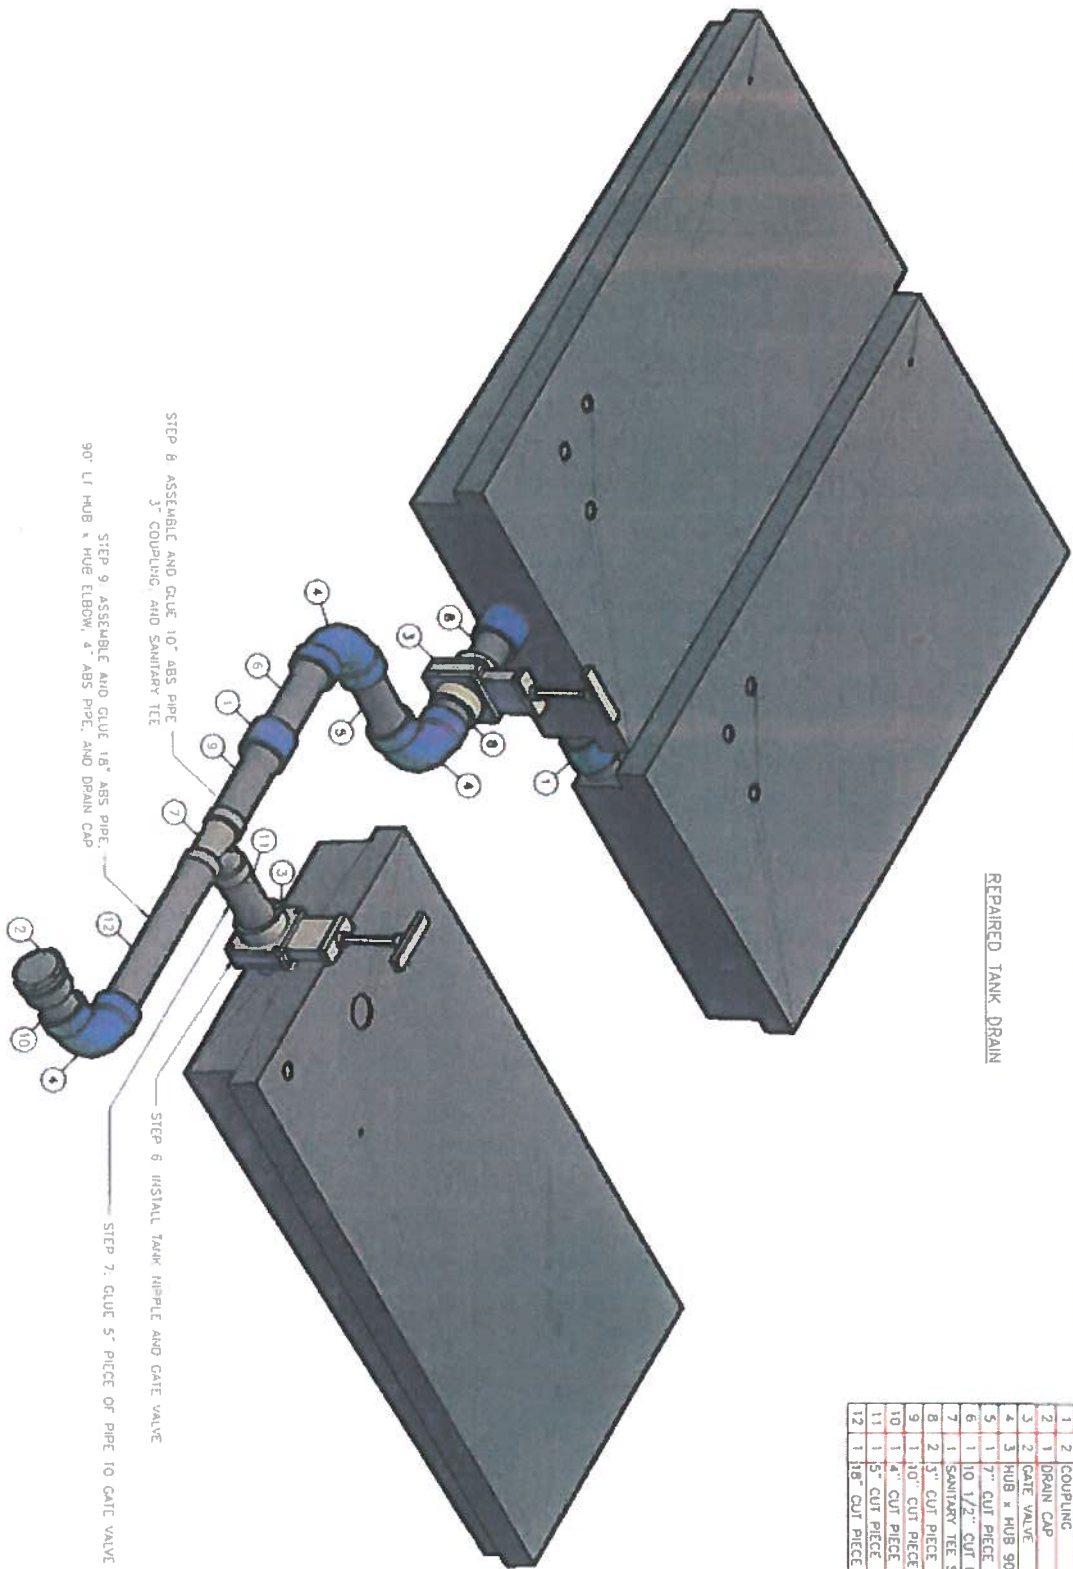
REPAIRED TANK DRAIN

REV	BY	DATE	DESCRIPTION
A	MBB	9/21/2021	REVISED TO ALLOW TANKS TO DRAIN INDEPENDENTLY

3. Cut the drain pipe coming from the gray tanks 10 ½" away from the 90° elbow.
4. Cut the pipe connecting the sanitary tee to the black tank. This will allow the technician to unscrew the gate valve from the black tank.

5. Remove the cut section from the black tank and disconnect the wires from the valve.
6. Screw in new ABS 3" pipe nipple on the black tank. Install the new gate valve at the front of the tank and connect the existing wires.

7. Add and glue a 5" piece of ABS black pipe to valve.
8. Add and glue a sanitary tee with a 10" piece on the gray tank side of the drain system. Glue the pipe coupling to the 10" piece of ABS pipe. Make sure the sanitary tee bend flows the correct direction, towards the drain.

9. Assemble the 18" piece of ABS pipe with the 90° elbow, the 4" piece of ABS pipe, and the drain cap.
10. Connect the assembly from step 7 to the sanitary tee.
