GENESIS

Technical Service Bulletin

GROUP Campaign	NUMBER 21-01-077G
DATE DECEMBER 2021	MODEL(S) G90 (HI) G70 (IK)

SUBJECT: FUEL CAP INSPECTION AND REPLACEMENT
(SERVICE CAMPAIGN T21G)

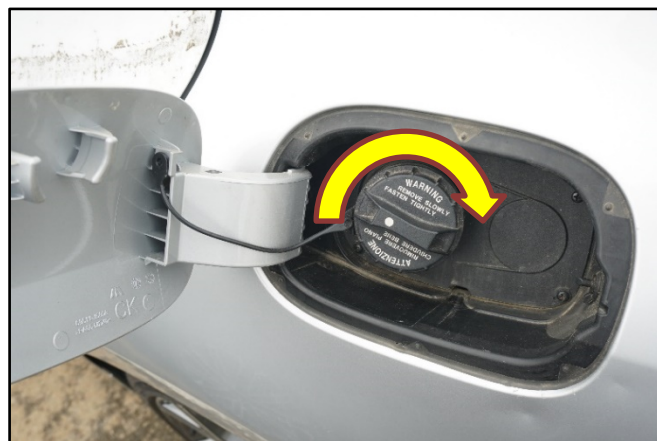
- Open the fuel door and completely rotate the cap clockwise to verify the fuel cap clicks into place.
 - If there is no click, replace the fuel cap.

If there is a click, no further action is necessary.
