Technical Service Bulletin

| GROUP Body | NUMBER 21-BD-004G |
| DATE February, 2021 | MODEL(S) GV80 (JX1) |

SUBJECT: 3RD ROW SEAT BACK STEP HEIGHT ADJUSTMENT

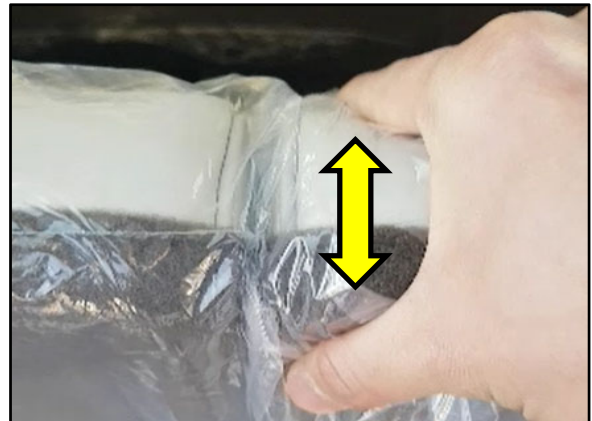
1. Push or pull one of the 3rd row seat backs to inspect for the step height.

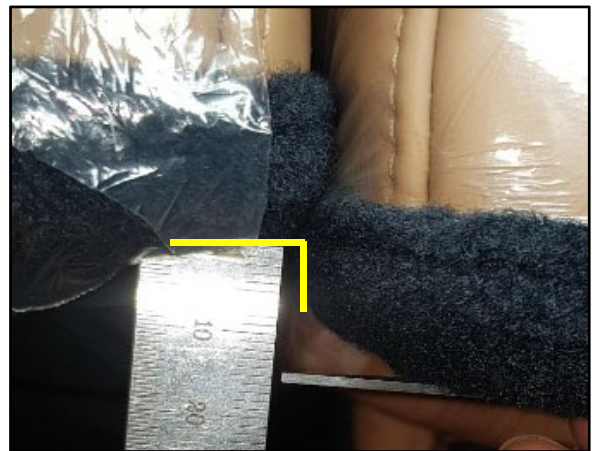
2. Measure the step height between the seat backs.

If the step height is less than 5 mm, no adjustment is required.

If the step height is more than 5 mm, proceed to the next section.

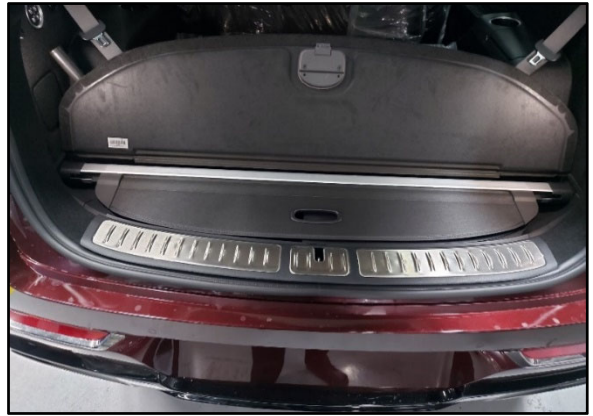
1. Open the luggage board.

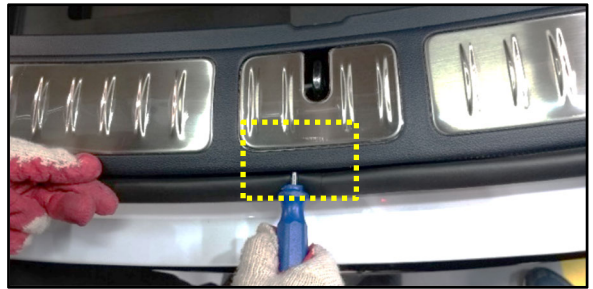
2. Remove the transverse trim clip.

⚠ CAUTION
 Do not damage the clip during removal. Replace the clip if it is damaged.

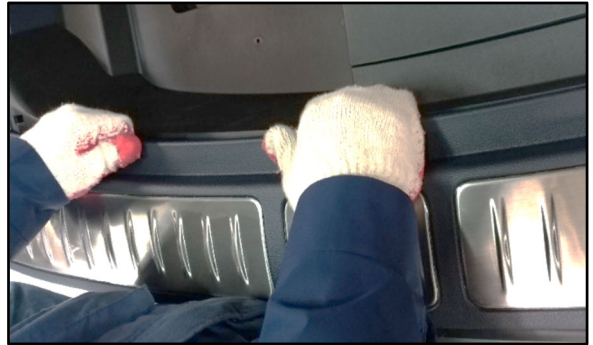
3. Remove the transverse trim assembly.

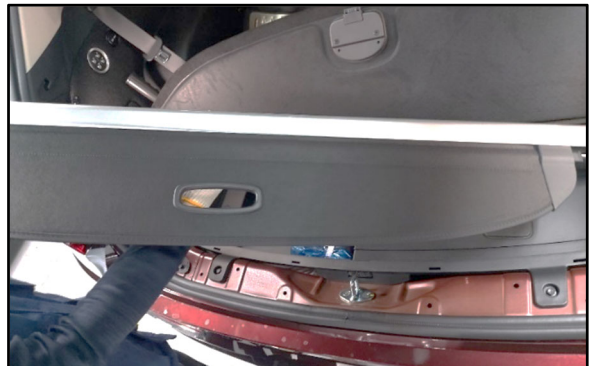
4. Remove the cargo screen assembly.

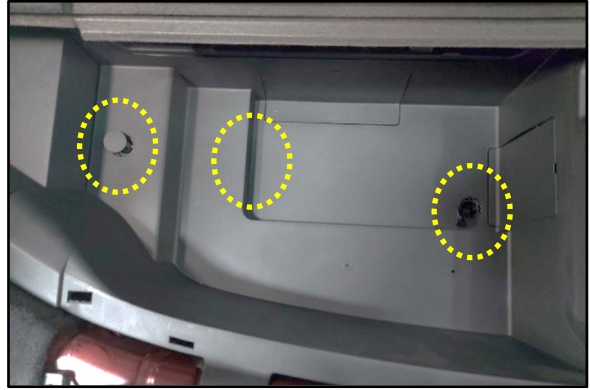
5. Remove the three rear luggage floor box trim caps and mounting bolts.

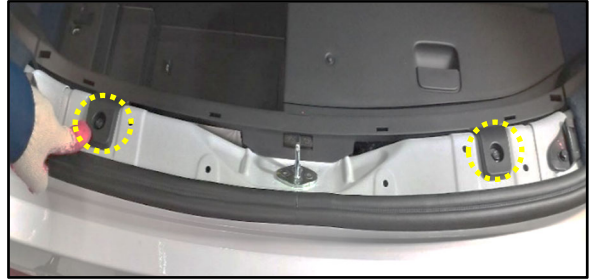
6. Remove the luggage floor box trim bracket mounting bolts.

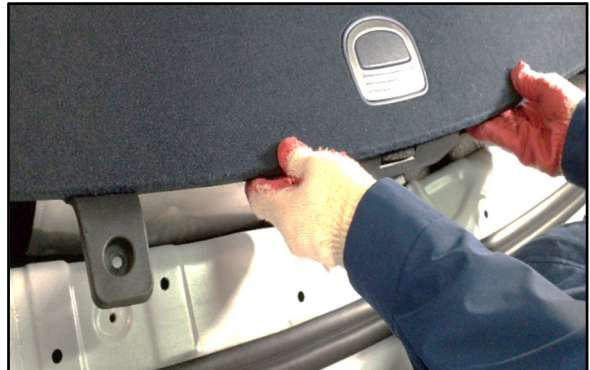
7. Remove the luggage floor tray assembly.

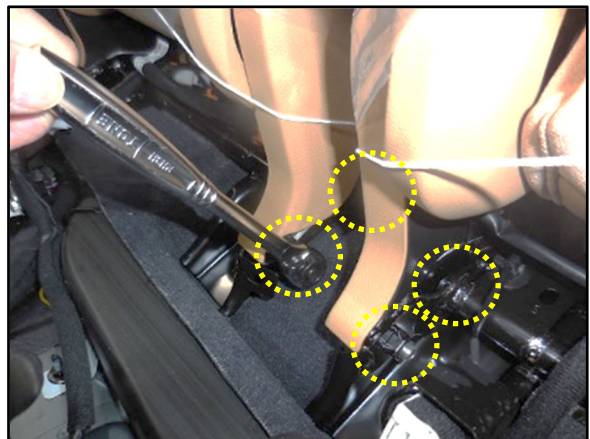
8. Slightly loosen the left and right seat back mounting bolts.

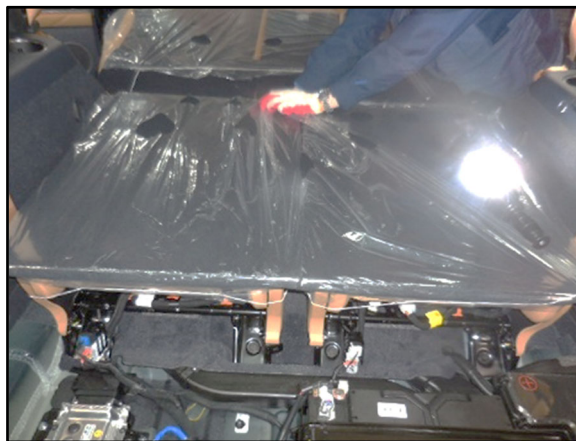
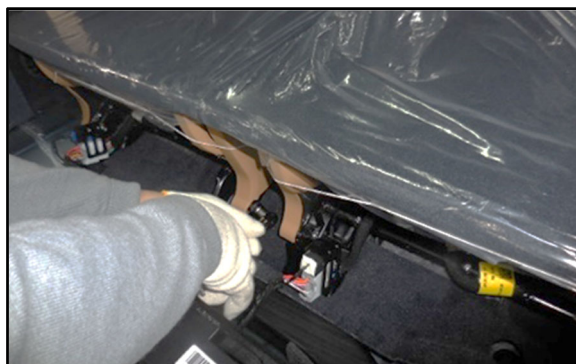
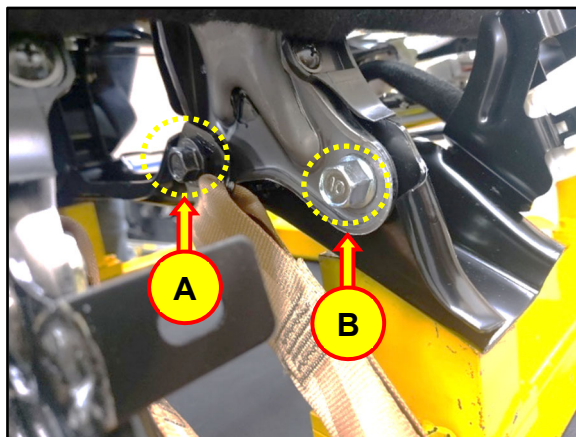
9. Fold the seat backs down and adjust the step height until the seat backs are even, while an assistant tightens the rear-side bolts (A).

Tightening torque:

- 44.1 – 53.9 N.m
- 4.5 – 5.5 kgf.m
- 32.5 – 39.8 lb-ft

The rear-side bolts (A) are black.
The front-side bolts (B) are silver.

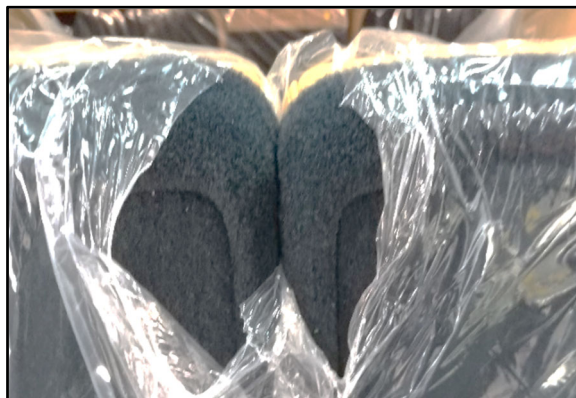
10. Return the seat backs to the normal sitting position and inspect the step height.

If necessary, adjust the step height until the seat backs are even.

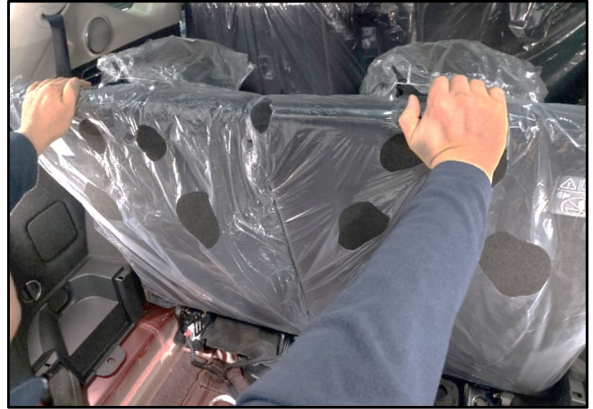
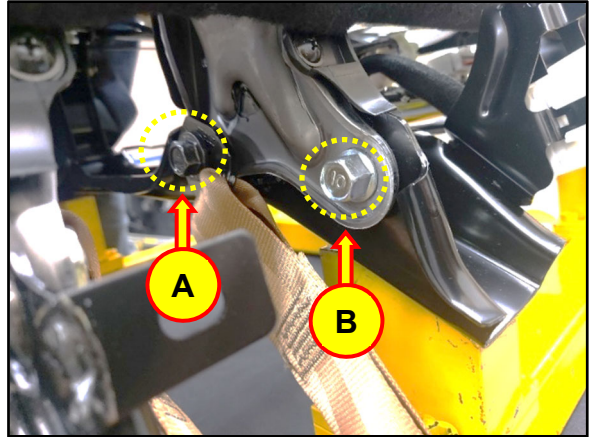
11. Hold the seat backs in place while an assistant tightens the front-side bolts (B).

Tightening torque:

- 44.1 – 53.9 N.m
- 4.5 – 5.5 kgf.m
- 32.5 – 39.8 lb-ft

The rear-side bolts (A) are black.
The front-side bolts (B) are silver.
