GROUP	MODEL
TRA	2020-2021MY Telluride (ON) w/AWD
NUMBER	DATE
099	January 2022

## TECHNICAL SERVICE BULLETIN

### SUBJECT: TELLURIDE (AWD) VIBRATION AT HIGHWAY SPEED INSPECTION AND REPAIR

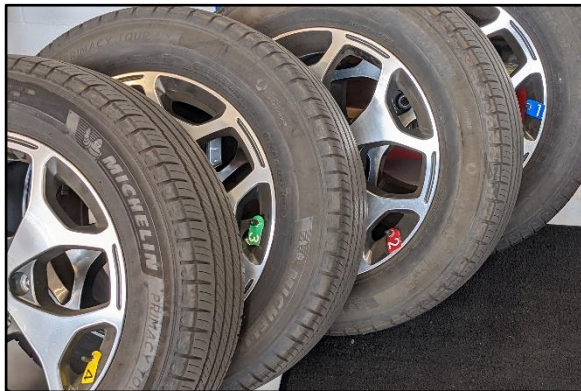
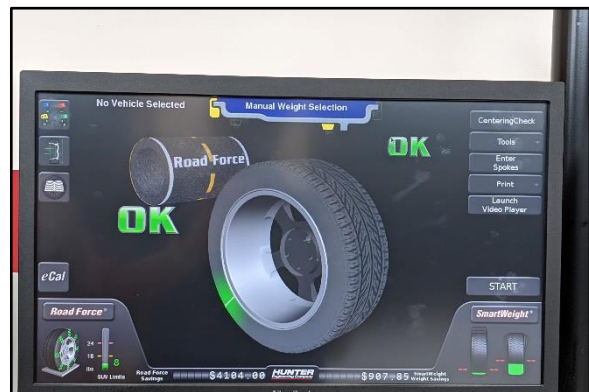
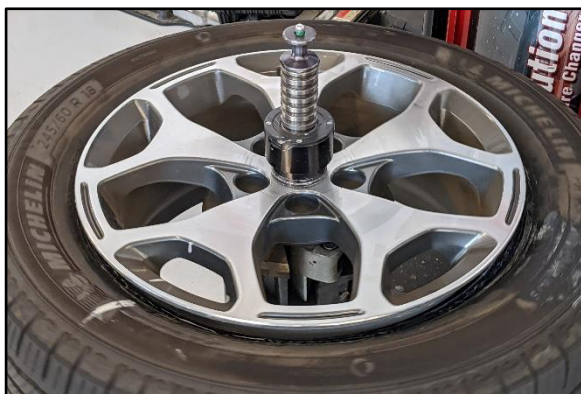
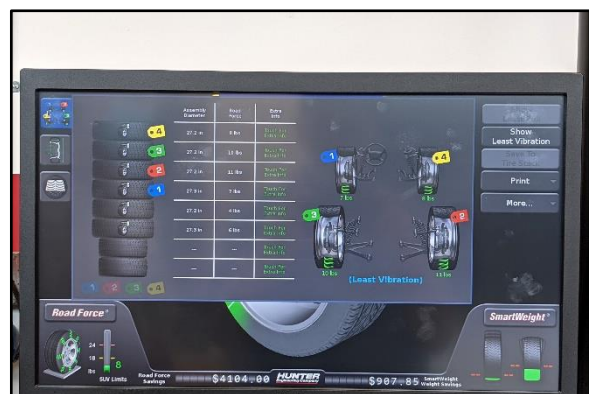
## Tire RFV/Balancing Procedure:

RFV Threshold:

- If RFV reads 30 lbs. or less → **(OK)**
- If RFV reads 31 lbs. or more → **(NG)** Contact Techline
