Service Action

Code: 34J7/34L9

Gear Shift Cover Trim

January 19, 2022

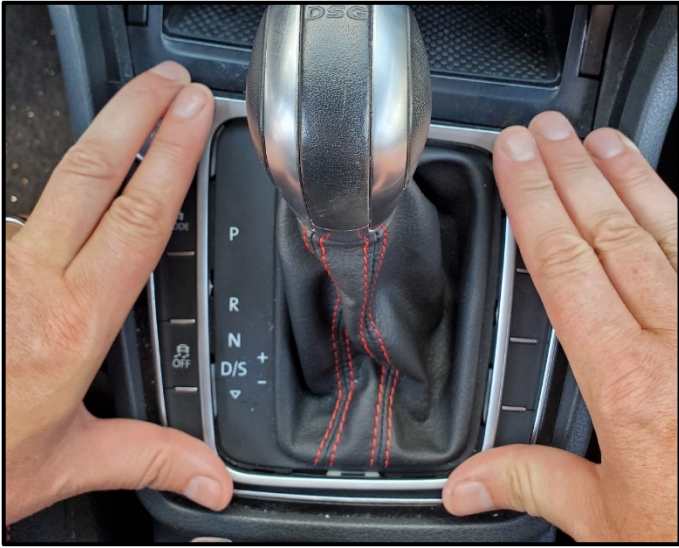
Repair Overview

- Replace gearshift cover trim frame.

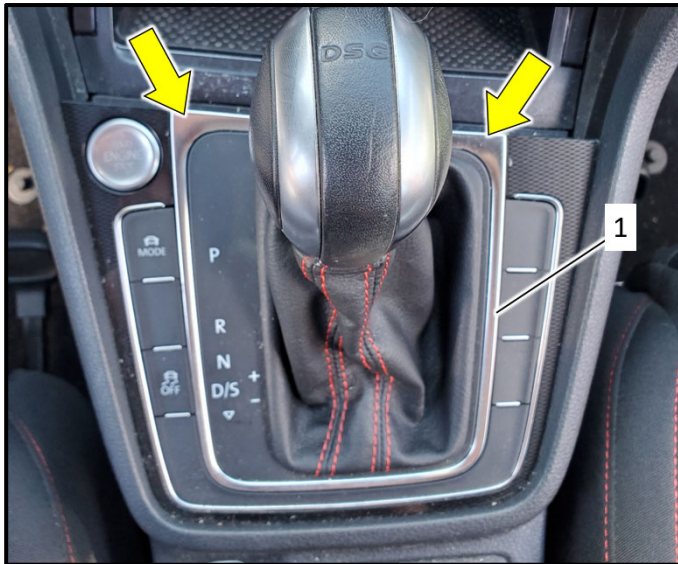
If the trim has started delaminating, the edge may be sharp. Use care when removing the old trim. Wear leather gloves, for example.

- Open the console storage compartment (if necessary).
- Remove trim <1>, starting at either corner <arrows> using a trim removal wedge.

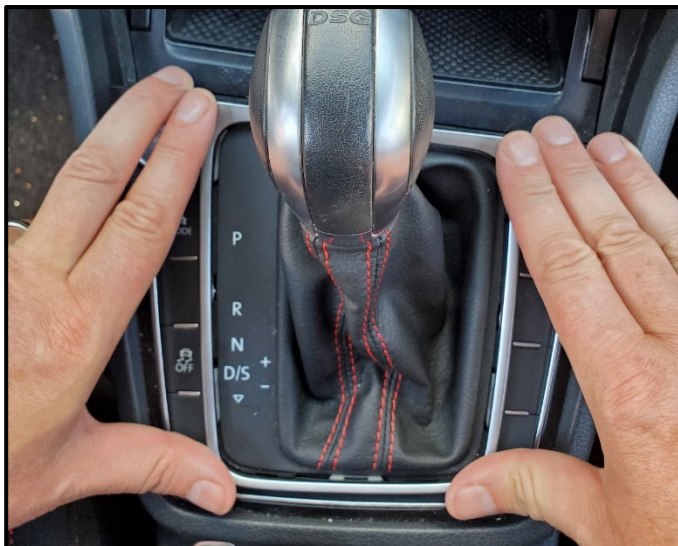
- Install new trim while pressing evenly on all sides as shown.
