# TECHNICAL SERVICE BULLETIN

Technical Service Bulletin: 400-1459

The charge controller for the solar panel charger may be wired incorrectly.

# TECHNICAL SERVICE BULLETIN 400-1459 REMEDY INSTRUCTIONS

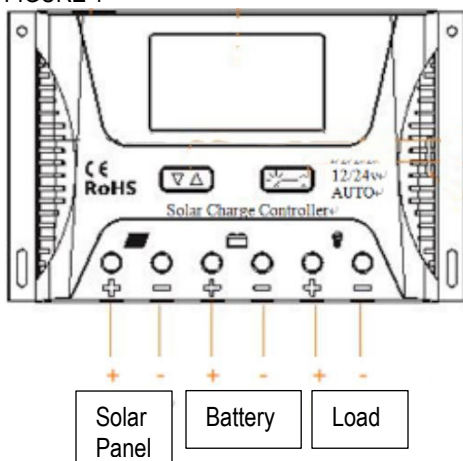
- SEE FIGURE 1 FOR THE LAYOUT OF THE SOLAR CHARGE CONTROLLER, FOR REFERENCE;
- IF THE WIRING IN THE UNIT IS THE SAME AS FIGURE 2, MOVE ON TO THE REMEDY STEPS;
- IF THE SOLAR CHARGER IS THE SAME AS FIGURE 3, THE SOLAR CHARGER IS WIRED CORRECTLY AND DOES NOT NEED THE REMEDY, CLAIM ONLY THE INSPECTION;

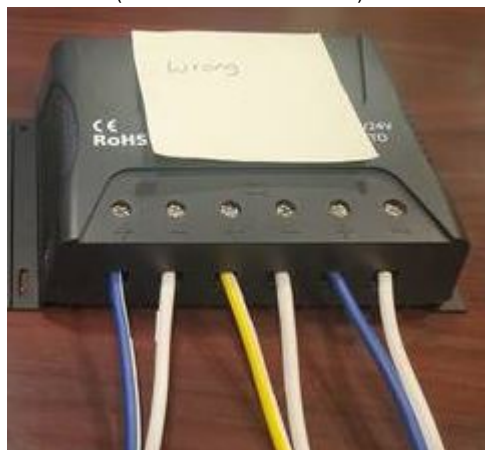
FIGURE 2 (INCORRECTLY WIRED)

STEP 1: REMOVE THE BLUE/WHITE STRIPPED WIRE FROM THE "LOAD POSITIVE" PORT;

STEP 2: REMOVE THE WHITE WIRE FROM THE "LOAD NEGATIVE" PORT;

STEP 3: INSERT THE BLUE/WHITE STRIPPED WIRE INTO THE "SOLAR PANEL POSITIVE" PORT;

- THERE WILL ALREADY BE ANOTHER BLUE/WHITE STRIPPED WIRE HERE, TAKE CARE TO ENSURE BOTH WIRES ARE SECURE;

STEP 4: INSERT THE WHITE WIRE INTO THE "SOLAR PANEL NEGATIVE" PORT;

- THERE WILL ALREADY BE ANOTHER WHITE WIRE HERE, TAKE CARE TO ENSURE BOTH WIRES ARE SECURE;

**NOTE: THE "LOAD POSITIVE AND NEGATIVE" ARE NOT TO BE USED.**

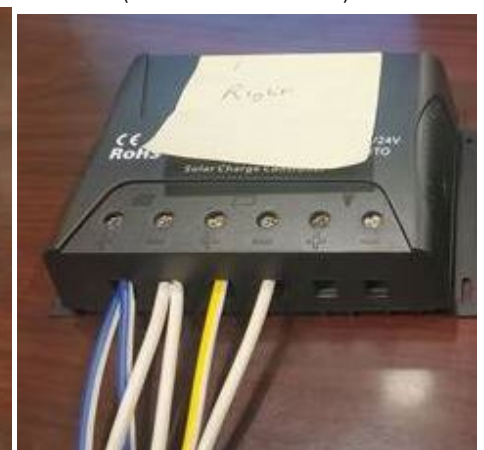
FIGURE 3 (CORRECTLY WIRED)
