GROUP	MODEL
ENG	2021-2022MY Sorento (MQ4a) w/2.5L T-GDI
NUMBER	DATE
235	January 2021

TECHNICAL SERVICE BULLETIN

SUBJECT: **AIR INTAKE SYSTEM CLEANING, PCV VALVE & AIR FILTER
REPLACEMENT DUE TO OIL CONTAMINATION**

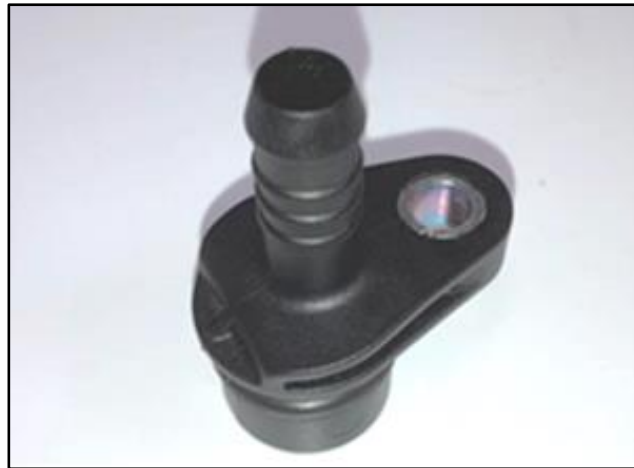
Positive Crankcase Ventilation
(PCV) Check Valve

This bulletin provides information regarding the air intake system which may become contaminated with oil due to a faulty Positive Crankcase Ventilation (PCV) check valve on some 2021-2022MY Sorento (MQ4a) vehicles equipped with Theta III 2.5L T-GDI engine, produced from September 10, 2020 through October 2, 2021, which may allow engine oil to enter the air intake system and contaminate the engine air filter with oil. Follow the procedure outlined in this publication to clean the air intake system and replace the air filter and PCV check valve.
