2064312/3 "35 Gearbox Malfunction warning on, DTC P17F900 is stored in the TCM" 35 22 42 2064312/3 January 13, 2022. Supersedes Technical Service Bulletin Group 35 number 21-40 dated December 22, 2021 for reasons listed below.

Condition

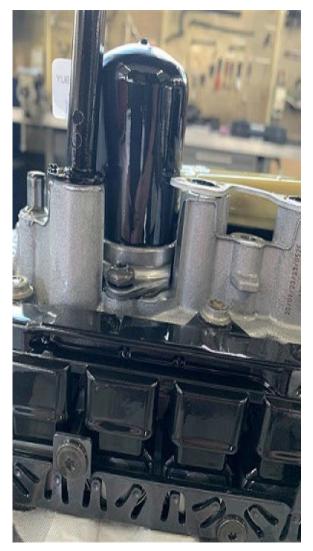
Figure 4. Loose bolts.

One or more bolts are loose (Figure 4).

You may also see the securing ring is not flush to the valve body which would mean the bolts are loose.

If the bolts are loose, replace pressure filter 2 along with the bolts as described in the Workshop Manual. Claim Option 1 in the Warranty Table below.

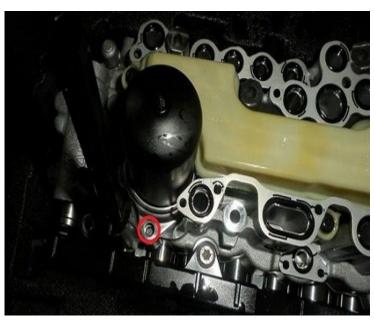
Figure 5. The bolt head is missing.

One or more bolt heads are broken off or missing (Figure 5).

If any of the bolts are broken, replace the Valve Body and reuse the Transmission Control Module per the Elsa Repair Manual. (If no valve body is available for your vehicle replace the Mechatronics unit and note this on the repair order). Claim Option 2 in the Warranty Table below.
