GROUP	MODEL
TRA	2021MY~ K5 GT (DL3a), Sorento (MQ4a) w/2.5L T-GDI
NUMBER	DATE
100	January 2022

TECHNICAL SERVICE BULLETIN

SUBJECT: **8 SPEED WET DUAL CLUTCH TRANSMISSION (WDCT)
JUDDER EVALUATION**

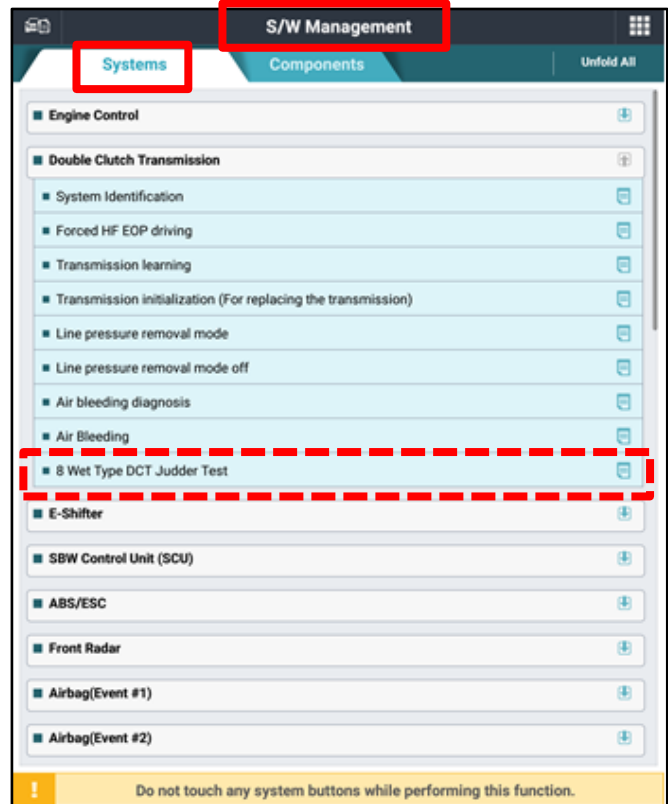
- 4a. Under 'Test preparation' follow the preparation instructions on KDS.

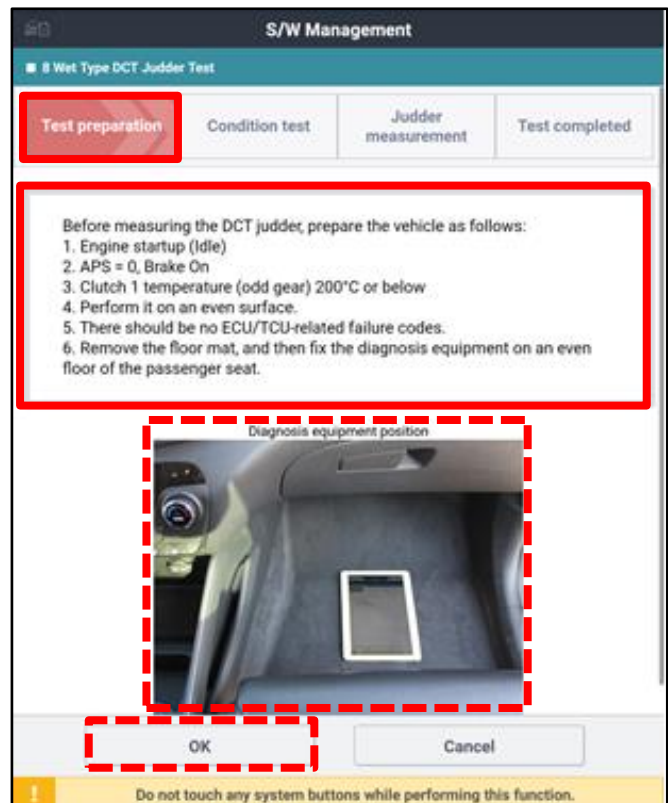
- 4b. Diagnosis equipment position: Place the KDS on the right passenger floor as shown.

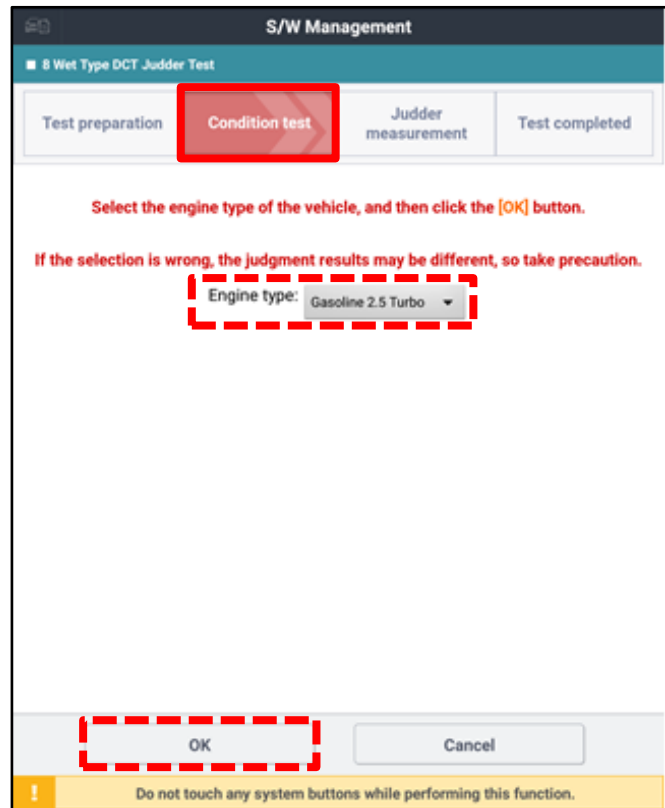
5a. Under 'Condition test', select the correct engine type of the vehicle.

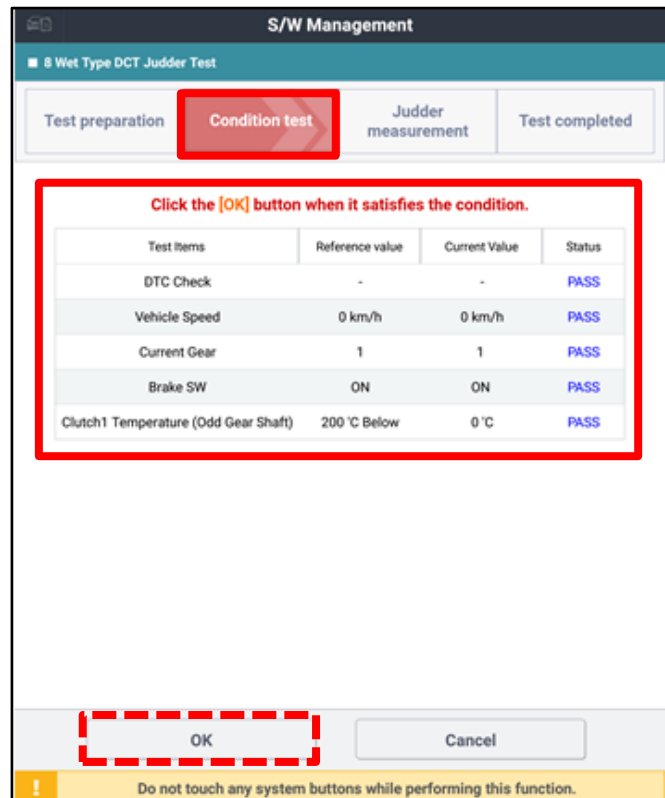
6a. Under 'Condition test', satisfy the listed conditions on KDS.

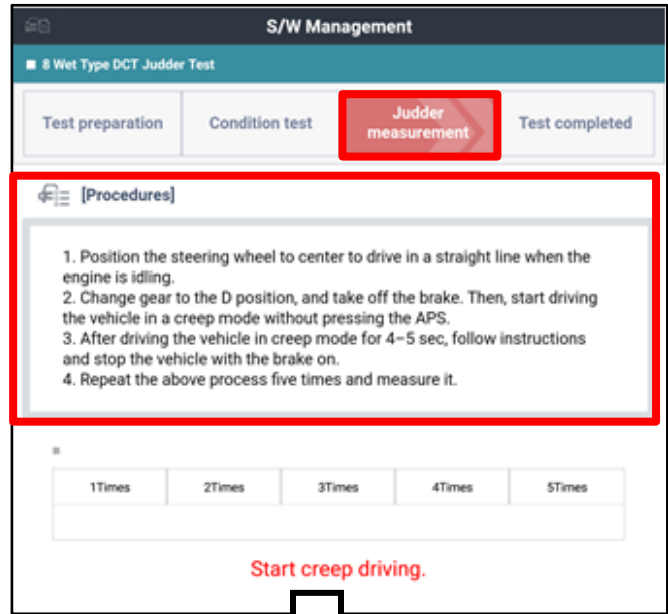
7. Under 'Judder measurement' review the 'Procedures' outlined on KDS to measure DCT judder and follow the instructions on the screen to start creep driving.

Note: Performed a total of five (5x) times.

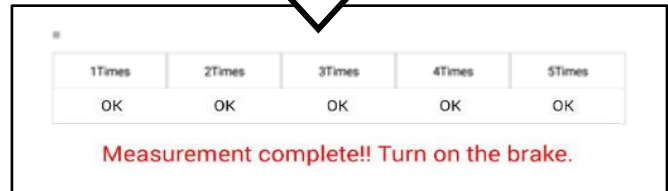
8. After completing the measurement test, apply the brake as instructed on KDS screen.

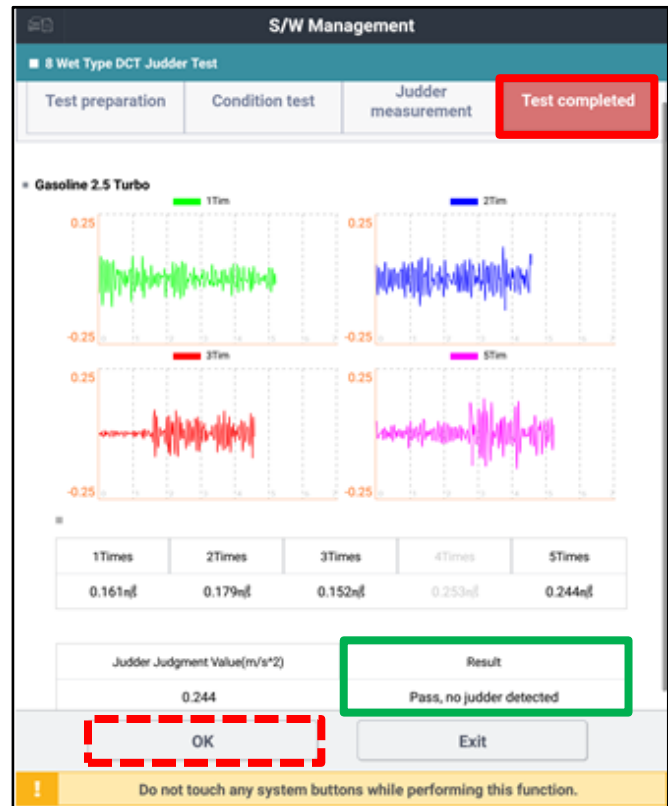
9. Under 'Test completed', take the appropriate action based on the 'Result' as follows:

- 1) If the result is "Pass, no judder detected": No further action is required. Select 'OK' to complete.
- 2) If the result is "Required of examining the double clutch", proceed to the "Dual Clutch Transmission (DCT) Replacement Procedure" below.

1. Replace the clutch with a new one by referring to the "DCT (Dual Clutch Transmission) System → Dual Clutch System → Dual Clutch & Concentric Slave Cylinder (CSC) Assembly → Repair procedures" chapter in the applicable Shop Manual on KGIS.
