# Technical Service Bulletin

## 69 Seat belts twitch

**69 22 78 2056007/2 January 31, 2022. Supersedes Technical Service Bulletin Group 69 number 19-42 dated September 12, 2019 for reasons listed below.**

Model(s)	Year	VIN Range	Vehicle-Specific Equipment
A6, A7, and Q8	2019 - 2020	All	Not Applicable
S6, A6 allroad, S7, SQ8, and RS Q8	2020	All	Not Applicable

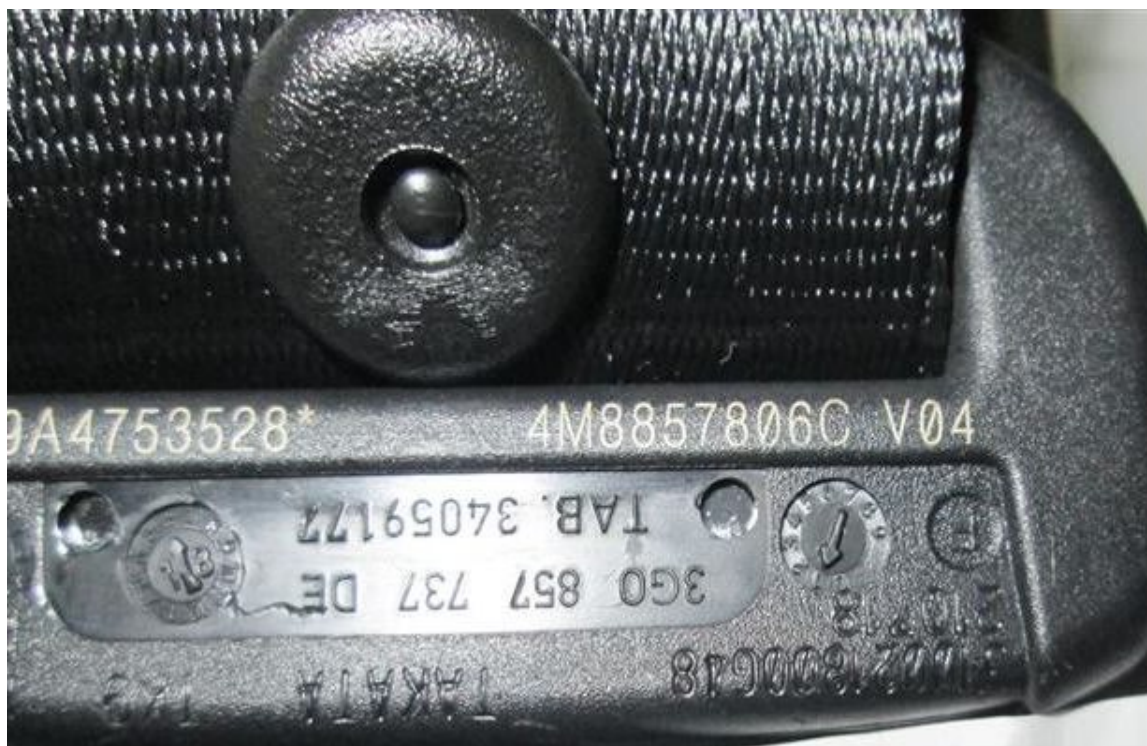
1. Compare the seat belt part numbers located on the seat belt latch plates (Figure 1) with ETKA to determine if the seat belts are installed on the correct side of the vehicle.

*Figure 1. Sample part number of right rear Q8 seat belt shown.*

3. Remove and reinstall the affected seat belts on the correct side of the vehicle according to the Repair Manual.
4. After swapping the seat belts side to side, it is not necessary to adapt them.

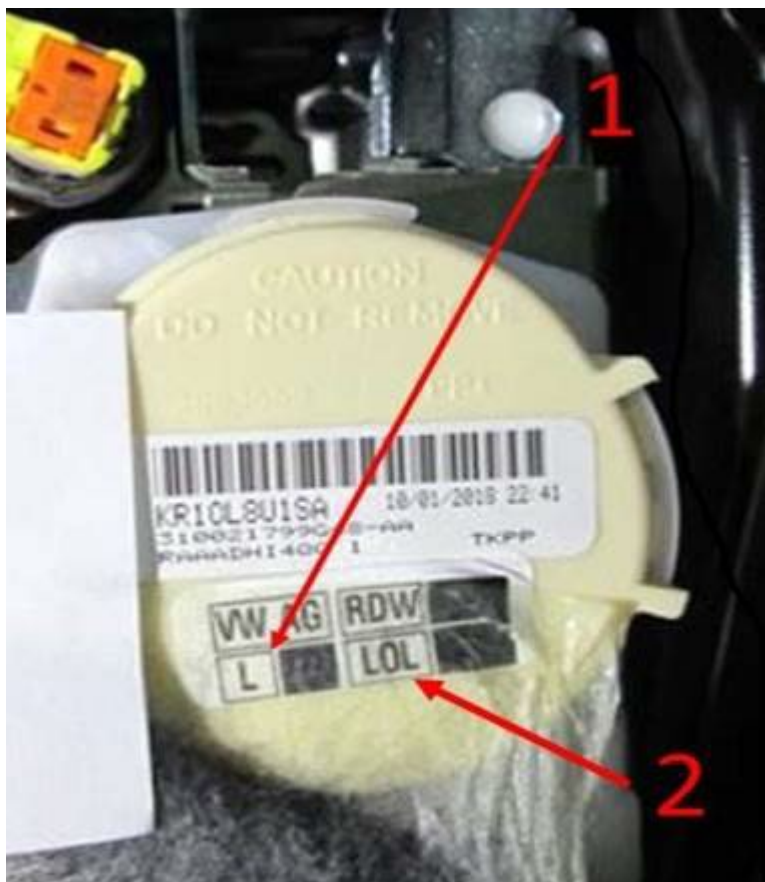
*Figure 2. Example of left Q8 seat belt (-L- pos. -1-) for left hand drive (LHD) car (-L0L- pos. -2-).*

2. If seat belt part numbers differ from ETKA, perform a diagnostic output test in ODIS Service. If during the diagnostic output test the wrong side seat belt is activated, the seat belts were swapped side to side during assembly.
