SS 3076-FTL2022 P4 Main Mirror Arm Covers Loose - Falling Off

All New Cascadia models.

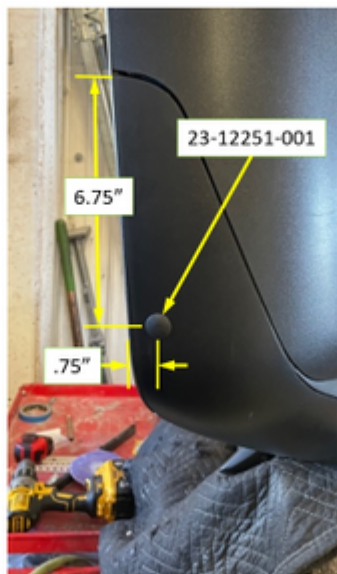
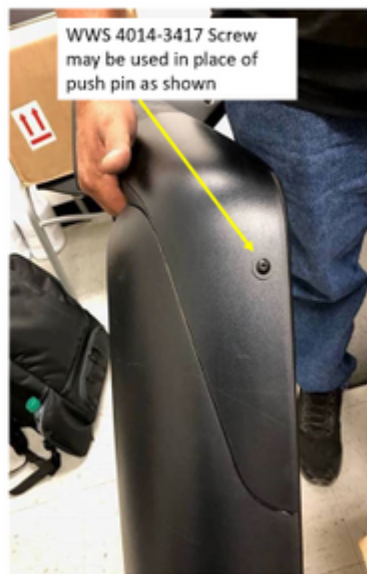
Figure 1: Installation of push pin - screw.

Lower arm covers LH/RH loose or falling off.

Lower arm covers designs have clips that hold the cover on but over time the clips can fail and allow the covers to become loose or fall off.

P4 Mirror - Arm Cover Field Service Fix

- RH mirror shown
- Dimensions are approximate
- Drill 1/8" diameter hole through cover and into bezel to apply push connector 23-12251-001.
- As alternate drill 1/8" diameter hole and use #8 screw WWS 4014-3417 screw instead of 23-12251-001.
- See next slide for process details

Add a push pin or screw to secure the Arm Covers in Place as shown in the following figure:
