# SS 715-WST 2022 49X Transmission Cooler Line Plumbing Fitting

## **Applicable Vehicles**

49X vehicles built with manual or automated manual transmissions.

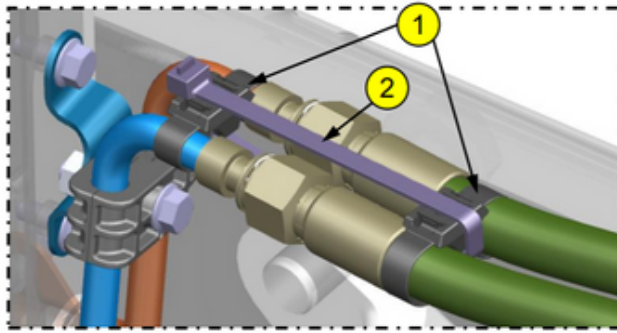
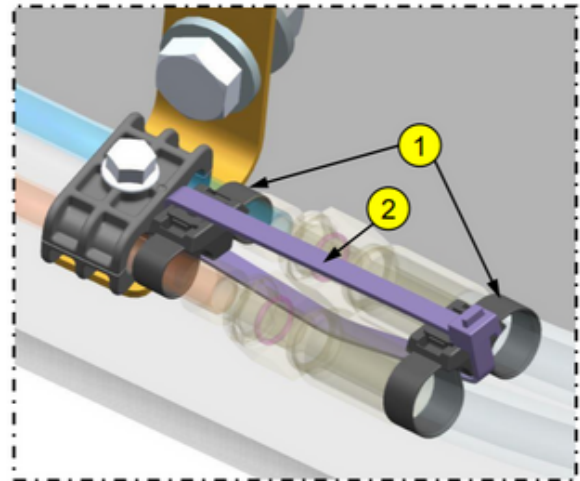
Install parts below to existing trans cooler plumbing lines as shown (fwd and aft locations shown below):

PULL ITEM #2 SNUG TO PROVIDE  
SECONDARY RESTRAINT ACROSS  
QUICK-CONNECT JOINTS.

TYCDCT110HIR Tie cable dual, .375 to 2.25 quantity(4)

23-09796-629 Clamp-cable tie,15", 0-4 bundle quantity(2)
