TECHNICAL SERVICES INFORMATION BULLETIN

TSIB 21-10 Rev C		December 20, 2021
TO:	All Operators	
TITLE:	MCI Main Distribution Panel Protection	
APPLICABILITY:	MCI coaches with Main Distribution Panel, MCI P/N: 07-08-7940: J4500 - All coaches beginning with MY 2017 to 2021. J3500 - All coaches beginning with MY 2018 to 2021. D45CRT - All MY 2021 coaches. D45CRT-LE - All coaches beginning with MY 2018 to 2021. D4520 – All MY 2020 coaches. D4X0X – All coaches beginning with MY 2017 to 2020.

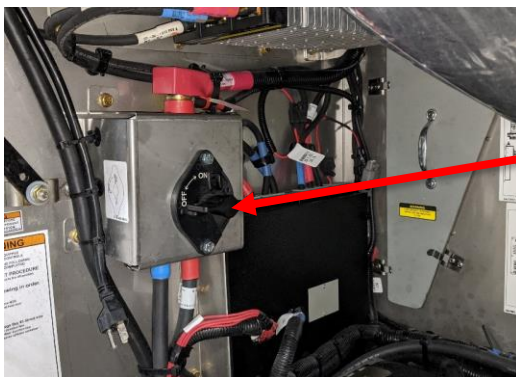
Turn off
MDS.

Locate the Main Battery Disconnect Switch and ensure it is in the off position.

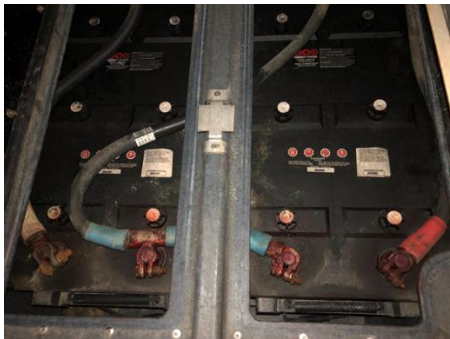
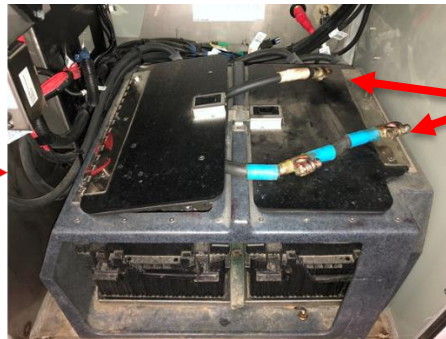
Disconnect all battery cables.

Disconnect GND, 12V, and 24V battery cables from the coach batteries. Ensure the battery cables do not come in contact with each other or the coach.

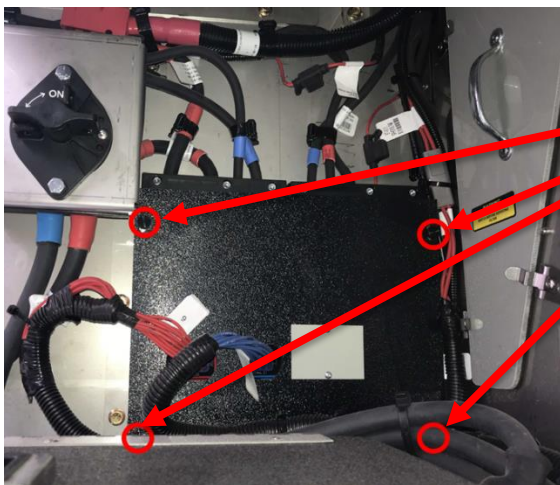
Remove and save 4 thumb screws.

Locate the MDP compartment mounted on the rear wall in the battery compartment. Remove and save the 4 thumb screws to release the MDP cover.

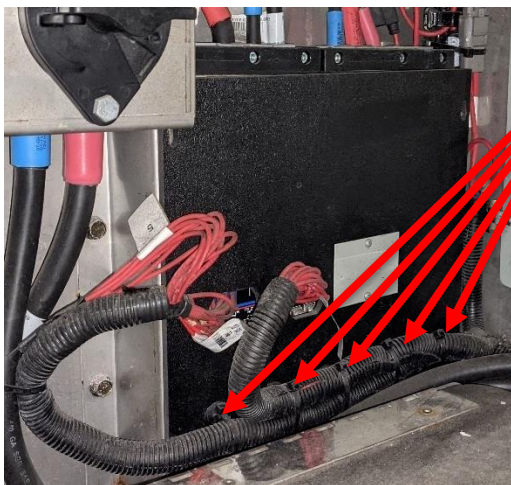
Remove 5 tyrapts & remove cover.

Remove 5 tyrapts located at the bottom of the plastic MDP cover to remove the cover.

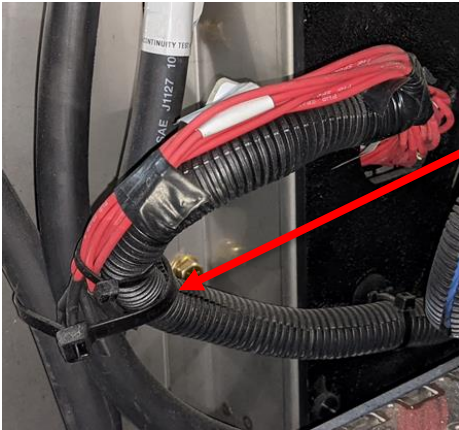
Remove BT-P162 tyrap on battery cables.

Remove tyrap that secure BT-P162 to the Main Disconnect Switch cables.

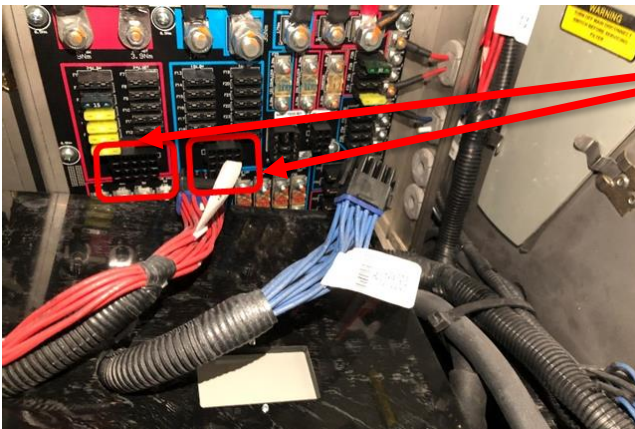
Disconnect BT-P161 and BT-P162.

Disconnect connectors BT-P161 and BT-P162 from MDP.

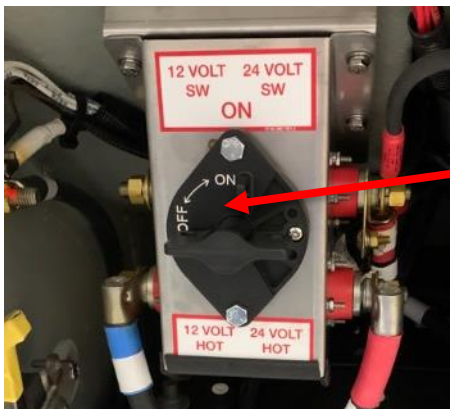
Turn off MDS.

Locate the Main Battery Disconnect Switch and ensure it is in the off position.

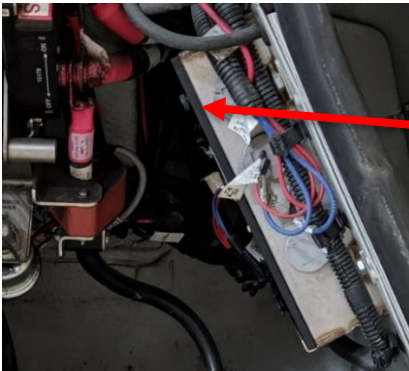
Remove the thumb screws

Remove and save the two thumbscrews from the MDP cover.

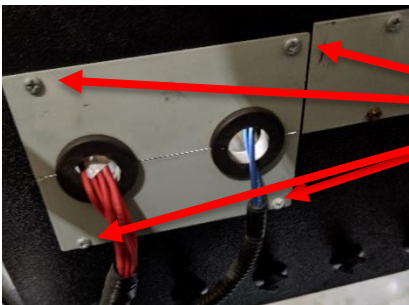
Remove and save the screws

Remove and save 4 screws holding the MDP cut-out part to the MDP cover.

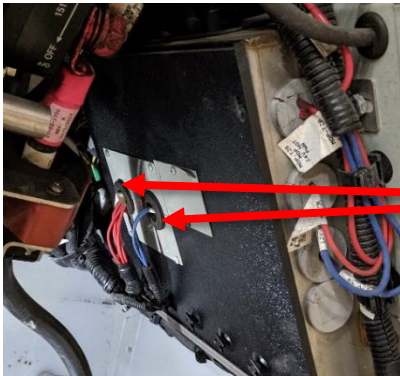
Disconnect the wires

Disconnect the two connectors, BT-P162 and BT-P161, from the main distribution panel.

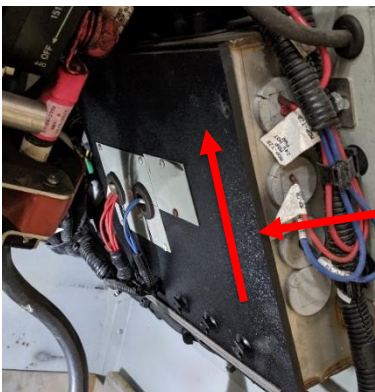
Slide the cover out

Slide out and save the battery compartment cover out of the bracket.

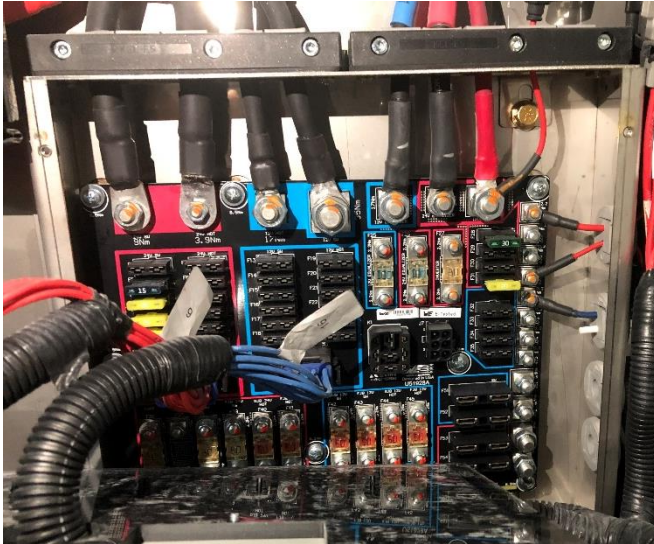
Inspect the front of the MDP for corrosion at all connectors and verify the retaining nuts for all the power cables are properly torqued. If corrosion is found, replace the MDP.

NOTE: Refer to the last page of this procedure for power stud torque specifications of the MDP.

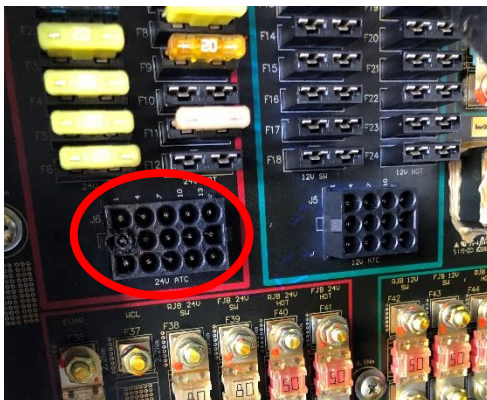
Bad

If no corrosion is found, inspect for heat damage on the BT-P162 connector. If heat damage is observed, perform section 6.0. Otherwise, skip to Section 7.0.

Perform Section 6.0

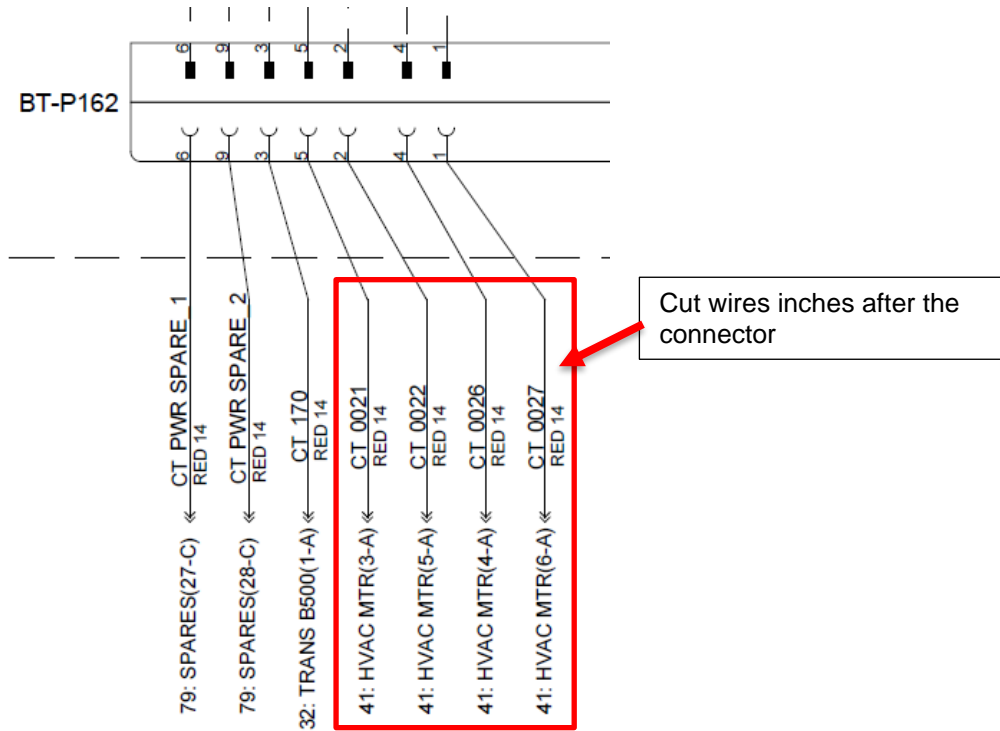
Cut HVAC wires CT0021, CT0022, CT0026, and CT0027 4-5 inches from the 24V BT-P162 connector.

NOTE: Heatshrink and tie back the wire attached to the pins to avoid corrosion.

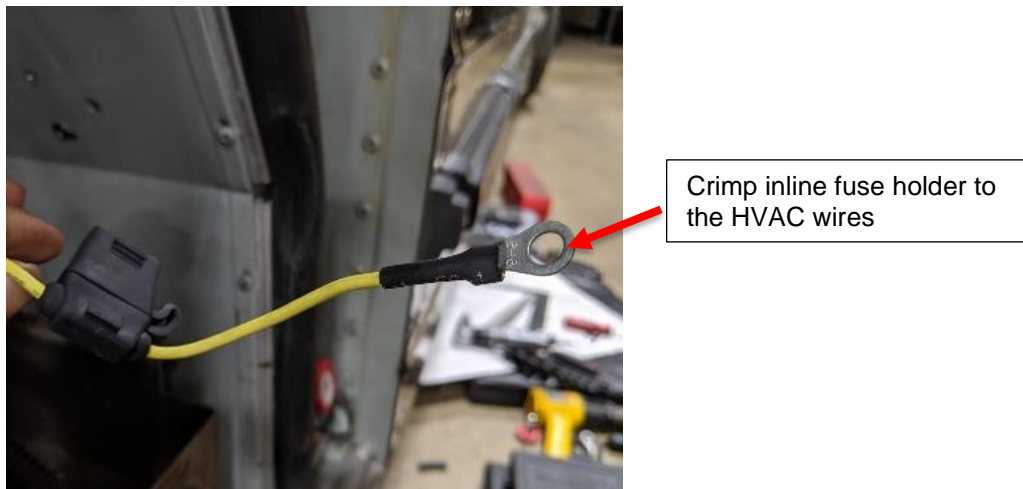
Crimp HHG in-line fuse holders, MCI P/N: T19-1168 or similar, to the HVAC wires and a 1/2" ring terminal at the end, MCI P/N: 19-11-1171 or similar.

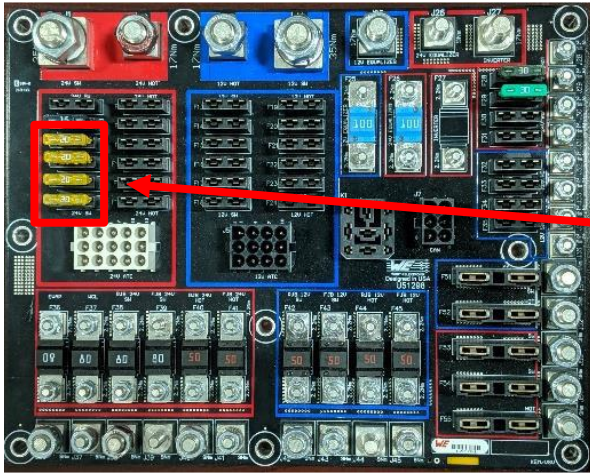
Remove 20A fuses and install in in-line fuse holders

Remove 20A fuses from the MDP and install them in the in-line fuse holders.

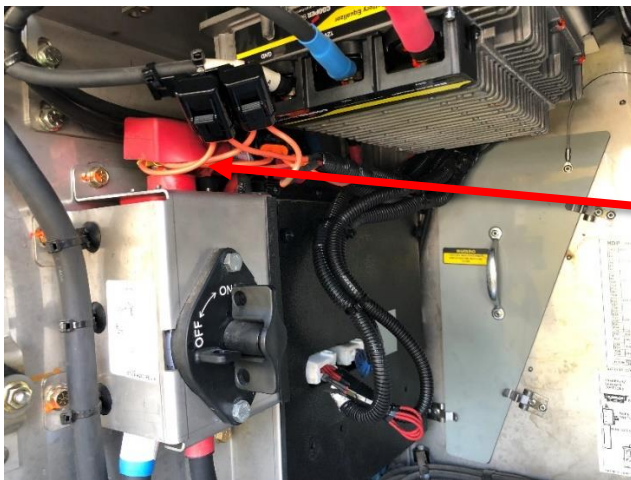
J4500/J3500/D45CRT-
Le/D4520 coach models

Connect the modified HVAC wires to 24V SW stud on MDS

Connect the modified HVAC wires to either 24V SW stud on the MDS as shown below for various coach models. Torque the nut to 300 In-lbs.

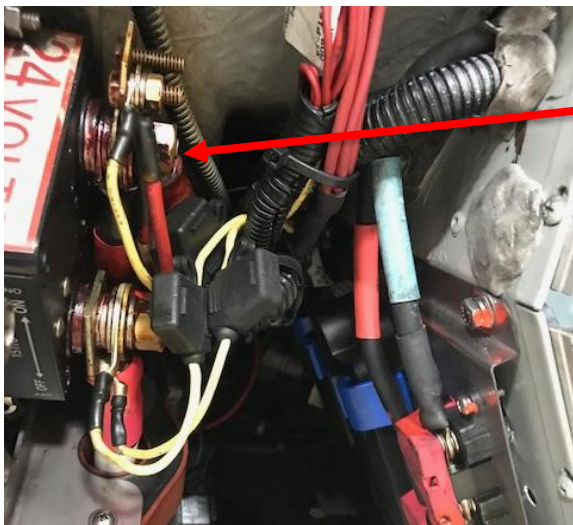
D4X0X coach models

Connect the modified HVAC wires to 24V SW stud on MDS

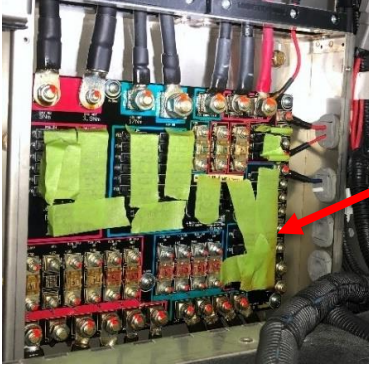
Cover open connectors and fuse slots.

After completing the inspection, cover all open connectors and fuse slots with masking tape.

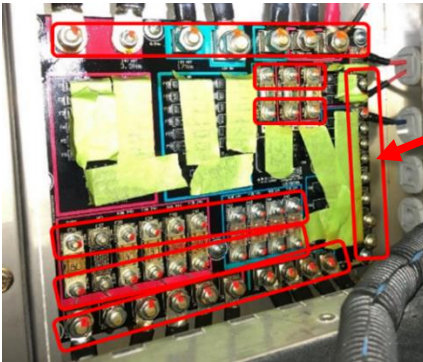
Spray anticorrosive on MDP studs.

Using short sprays, apply the corrosion inhibitor, MCI P/N: 23-02-0119, on all power and fuse studs. Wipe off any excessive corrosion inhibitor from the fuse windows using a dry rag.

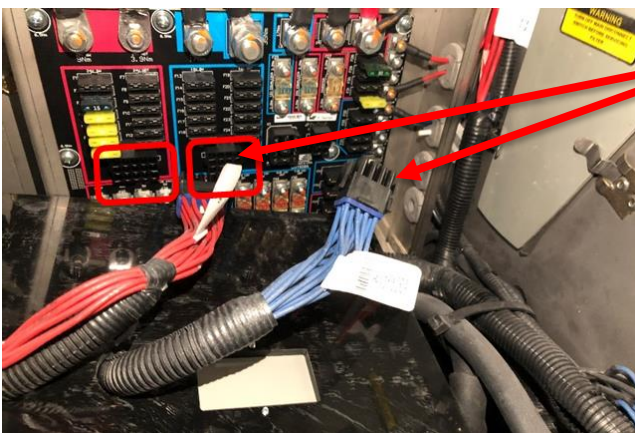
Connect BT-P161 and BT-P162.

Route through the MDP cover holes and secure connectors BT-P161 and BT-P162 to the MDP board.

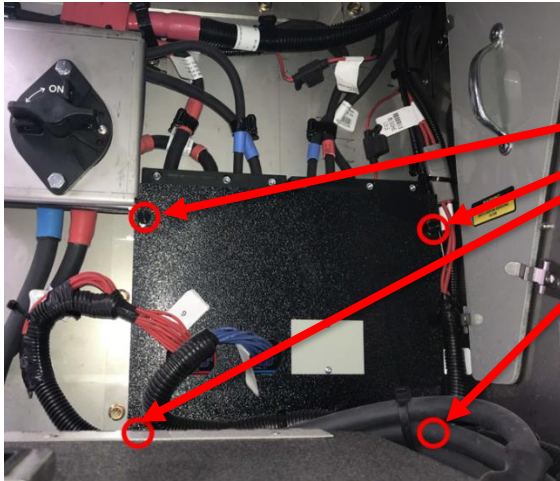
Install 4 thumb screws.

Secure the MDP cover using the 4 thumb screws, MCI P/N: 07-08-9231.

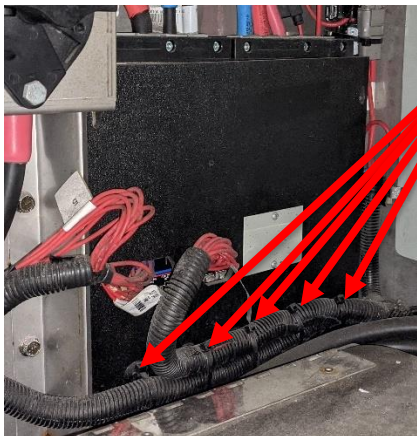
Secure harness using 5 tyrap.

Secure the BT-P161/BT-P162 harnesses to the MDP cover using 5 tyrap, MCI P/N: 19-11-258, and existing mounts.

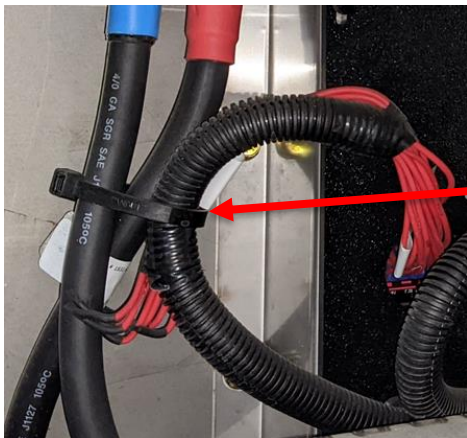
Loosely secure BT-162 to MDS Cables.

Loosely secure the BT-P162 branch to the MDS battery cables, allowing a smooth curve on the harness. Ensure there is no side strain at the connector.

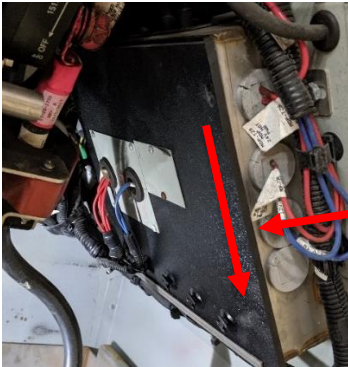
Slide the cover in

Slide in and discard the battery compartment cover out of the bracket.

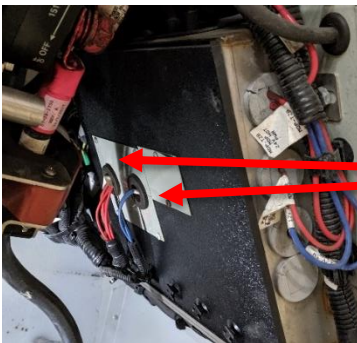
Connect the wires

Connect the two connectors, BT-P162 and BT-P161, to the main distribution panel.

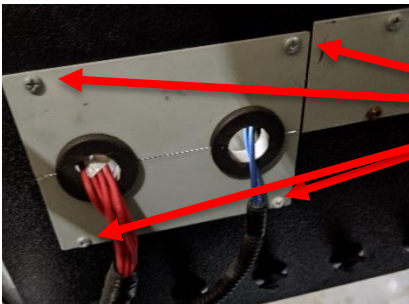
Re-install MDP cut-out part

Re-install the MDP cut-out part to the MDP cover using existing screws.

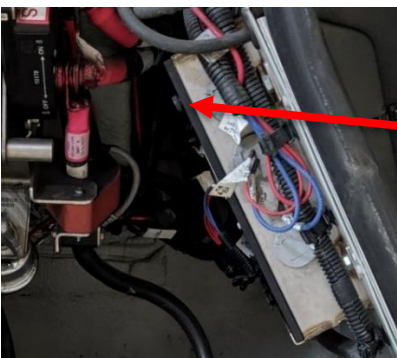
Re-install the MDP cover

Secure the MDP cover using the existing two thumbscrews.

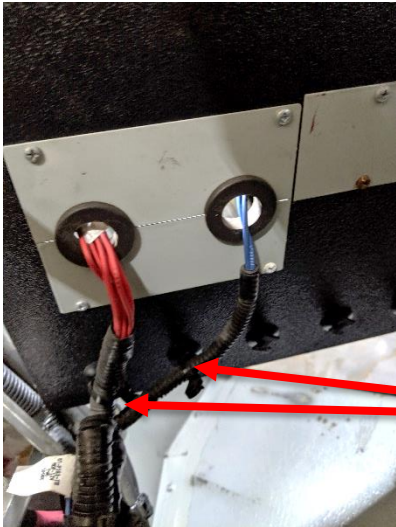
Secure BT-P162/ BT-P161 to MDP cover.

Secure the BT-P162 and BT-P161 connectors to the MDP cover using 2 tyraps, MCI P/N: 19-11-258. Ensure the tyraps do not create tension at the pins or connectors.

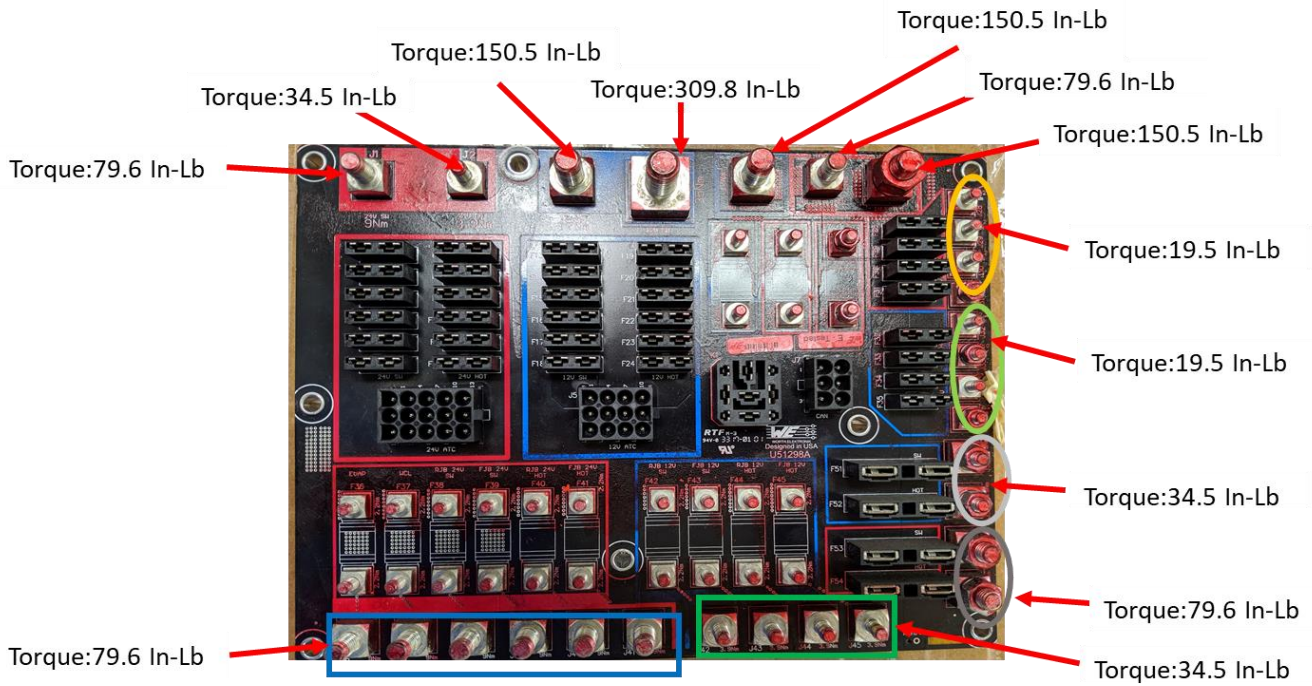
Torque values for Main Distribution Panel studs:
