# Technical product information

<b>Topic</b>	Electronic Parking Brake (EPB) functionality issues
<b>Market area</b>	Russische Föderation (5RU),Australia E04 Bentley rest Asia and Australia (6E04),China 796 VW Import Comp. Ltd (Vico), Beijing (6796),Germany E02 Bentley rest Europe (6E02),Japan E03 Bentley Japan (6E03),Korea, (South) E08 Bentley South Korea (6E08),United Arab Emirates E06 Bentley Middle East and Africa (6E06),United Kingdom E01 Bentley UK (6E01),United States E05 Bentley USA and rest America (6E05)
<b>Brand</b>	Bentley
<b>Transaction No.</b>	2062184/4
<b>Level</b>	EH
<b>Status</b>	Approval
<b>Release date</b>

## New Continental GT/GTC and New Flying Spur

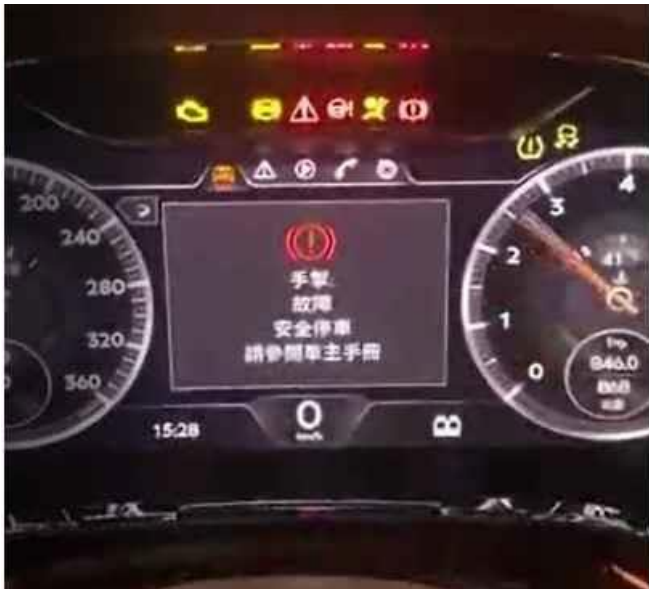
Figure 1

- Electronic Parking Brake (EPB) found not operating to specification
- EPB may not hold the car effectively
- Parking brake components showing signs of wear
- Parking brake warning light may also be evident within the DIP (See example shown in Figure 1)
