GROUP	NUMBER
CAMPAIGN	22-01-007H
DATE	MODEL(S)
JANUARY 2022	Kona (OS) Elantra (CN7)

GEN2 DCT SHIFT SHOCK INSPECTION AND SNAP RING REPLACEMENT (SERVICE CAMPAIGN 17E)

Description: Certain vehicles equipped with 7-speed Double Clutch Transmissions (DCT) may exhibit abnormal shifting caused by an out of specification input shaft snap ring. This bulletin outlines the procedures for inspecting for 1-2 or 2-1 shift shock and replacing the input shaft snap ring.

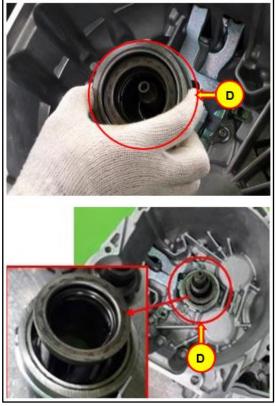
5. Remove the clutch release bearing (D).

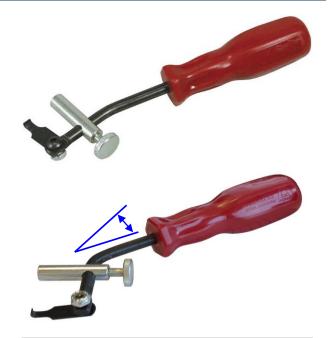
Recommend using a leverage/shaft style oil seal puller modified with a slight bend.

"Lisle 58430 Shaft Type Seal Puller" or equivalent

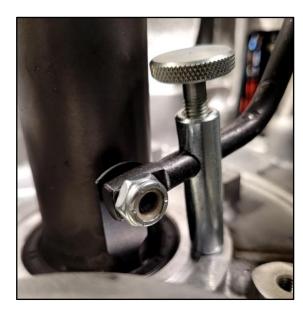
9. Reassemble the hook to the puller assembly and adjust the lever stand-off to rest on the transmission case.

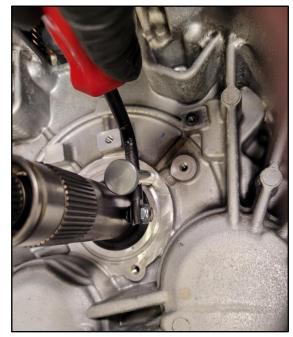
10. Push down on the handle to remove the seal.

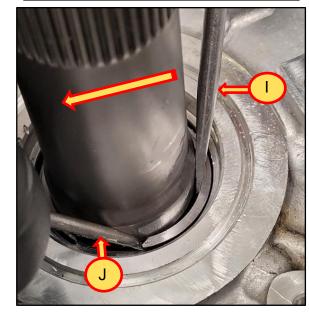
- 12. Insert the flat blade screwdriver (I) about ¼ of the way back from one end of the snap ring.
- 13. Using a 90° pick (J) or similar tool to lift the end of the snap ring out of it groove.
- 14. Remove the screwdriver and slowly rotate the shaft until the snap ring is fully removed.

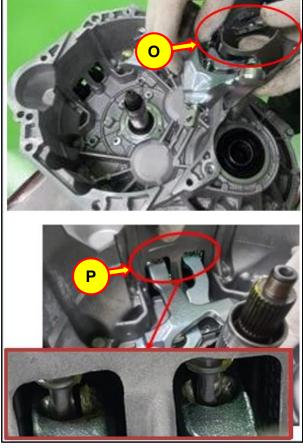
23. Reinstall the clutch engagement fork (O).

Ensure the clutch engagement fork is seated correctly to prevent clutch actuator rod position deviation (P).
