GROUP	NUMBER	
SUSPENSION	22-SS-001H	
DATE	MODEL(S)	
JANUARY, 2022	PALISADE (LX2)

PALISADE (LX2) REAR SHOCK ABSORBER INSPECTION AND UPPER INSULATOR REPLACEMENT

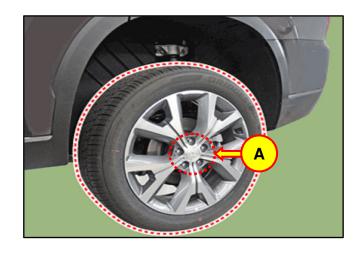
- If knocking or rattling noises are present, continue to step 2 to replace the insulators located on the top of the both rear shock absorbers (left and right sides).
- 2. Using a hoist, lift up the vehicle and ensure it is safe to service.
- 3. Loosen the rear wheel nuts (A) and remove the tire from the rear hub.

Tightening Torque:

79.6 – 94.0 lb-ft (107.9 – 127.5 Nm)

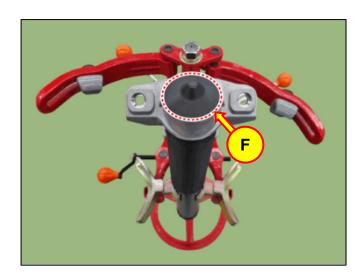
6. Remove the insulator cap (F).

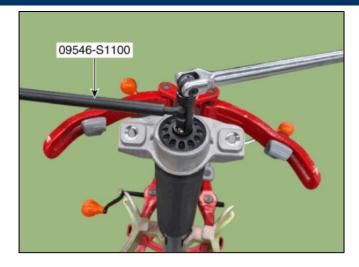
7. Loosen the lock nut using special service tool 09546-S1100.

Tightening Torque: 21.7 lb-ft (29.4 Nm)
