CAMPAIGN BULLETIN

Passenger Knee Air Bag Dealer Inventory

Reference: PC858
Date: January 21, 2022

PC858 – 2022 LEAF RIGHT KNEE AIR BAG (PASSENGER SIDE)

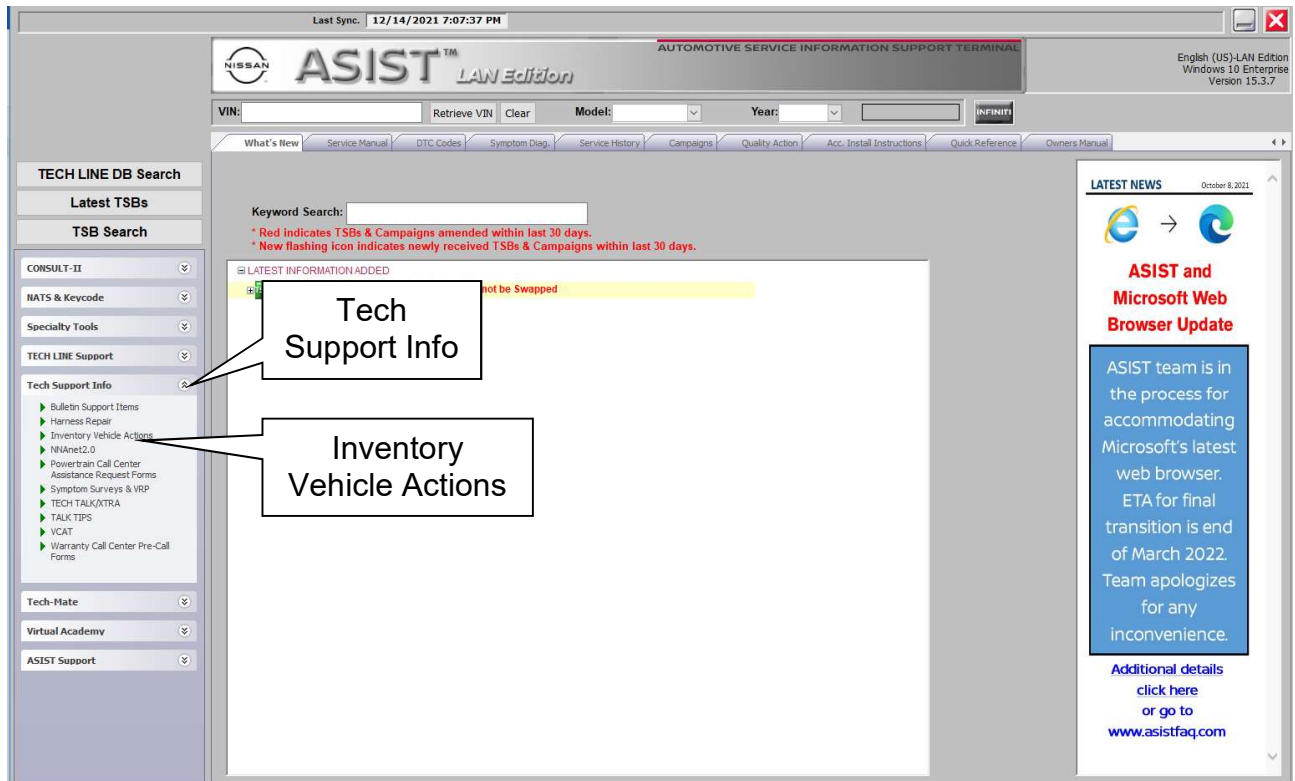
Figure 2

- b. On the left side of the ASIST main menu, select **Tech Support Info**, then **Inventory Vehicle Actions**.

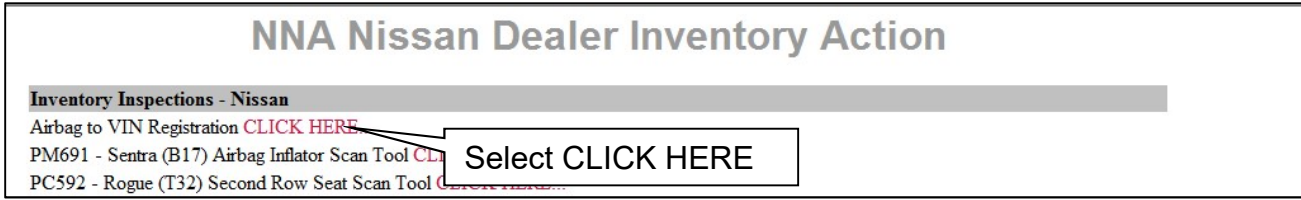
Figure 3

c. Select **CLICK HERE** (Airbag to VIN Registration).

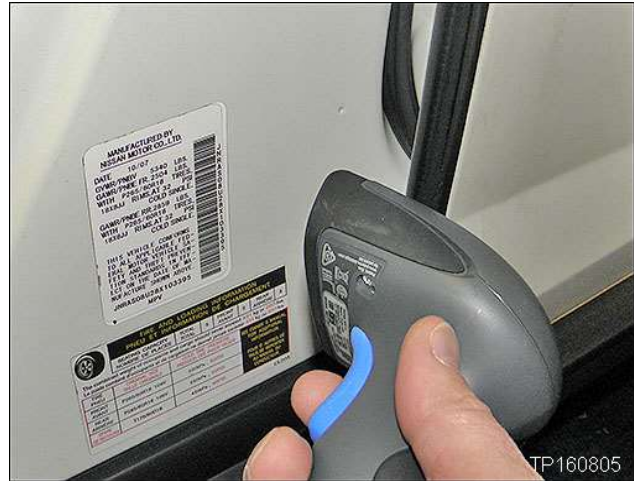
Figure 4

- d. Use the quick scan tool to scan the bar code (VIN) on the B-pillar label.
- Wipe any dirt/debris from bar code before scanning.

- Some labels may not scan quickly.
- Hold the scan tool approximately 6 inches away from the label.
- Hold the trigger down until the label is read (this may take several seconds).
- VIN will automatically populate (see Figure 5).
- If needed, VIN can be entered manually.
