# Wire Harness Repair or Replacement Guide

## Wire Harness Repair or Replacement Guide

This Service Bulletin includes guidelines meant to help determine whether to repair or replace a wire harness assembly based on damage type. This Service Bulletin should be used in conjunction with the applicable model and model year Electronic Wiring Diagram (EWD) and/or Repair Manual.

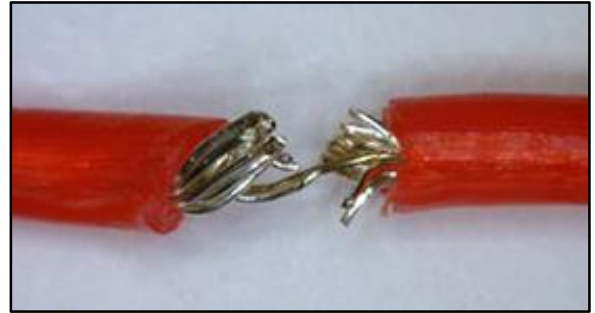
**Figure 2.**

- Broken or separated wire.  
Recommended repair methods:
  - Wire repair
  - Wire harness assembly replacement

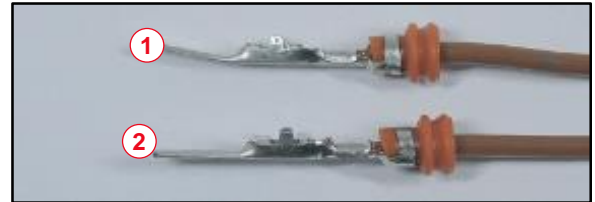
**Figure 3.**

- Bent or damaged male wire terminals.  
Recommended repair methods:
  - Wire terminal repair
  - Wire harness assembly replacement

1	Not Good
2	Good

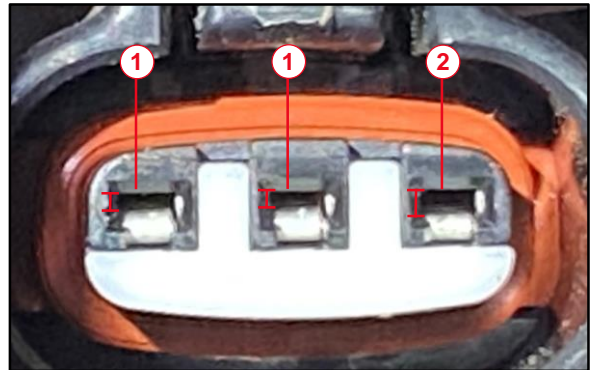
**Figure 4.**

- Loose or damaged female wire terminals with poor tension/fit.  
Recommended repair methods:
  - Wire terminal repair
  - Wire harness assembly replacement

1	Good
2	Not Good (Female Wire Terminal With Poor Tension/Fit)

**NOTE**  
Until the wire terminal gauge tool is available, for a suspected poor terminal tension condition, replace the entire wire harness if unable to effectively diagnose by other reasonable methods such as a wiggle test or visual inspection for looseness.

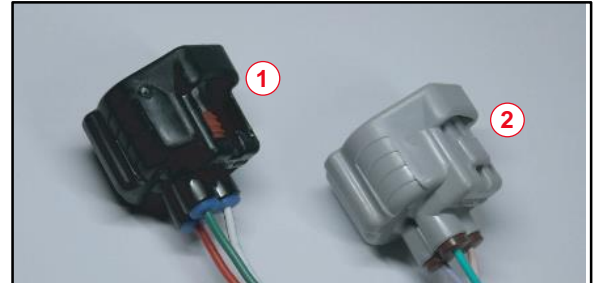
**Figure 5.**

- Broken connector-lock tab  
Recommended repair methods:
  - Connector replacement
  - Wire harness assembly replacement

<b>1</b>	<b>Not Good</b>
<b>2</b>	<b>Good</b>

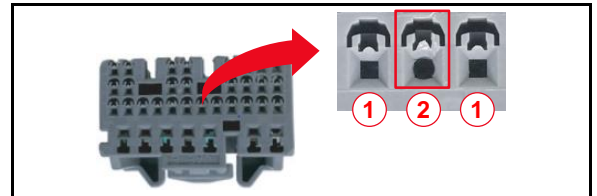
**Figure 6.**

- Connector deformation caused by incorrect terminal probing  
Recommended repair methods:
  - Connector replacement
  - Wire harness assembly replacement

<b>1</b>	<b>Good</b>
<b>2</b>	<b>Not Good</b>

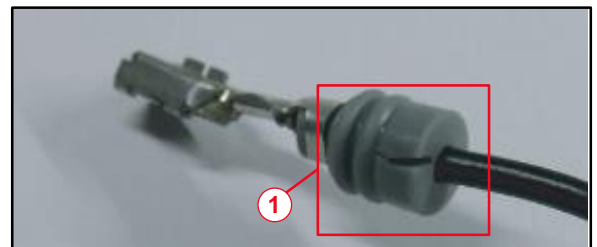
**Figure 7.**

- Damaged weather seal.  
Recommended repair methods:
  - Repair wire replacement
  - Wire harness assembly replacement

<b>1</b>	<b>Damaged Weather Seal</b>
----------	-----------------------------

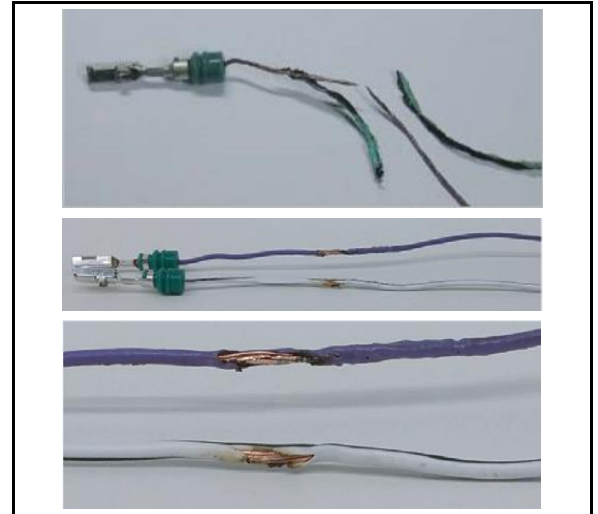
**Figure 8. Melted Wires Examples**

- Melted wires.

- It is difficult to precisely locate ALL areas that were damaged.
- Excessive heat impairs the flexibility and electrical conductivity of the wire harness assembly.

- Wire harness assembly replacement.

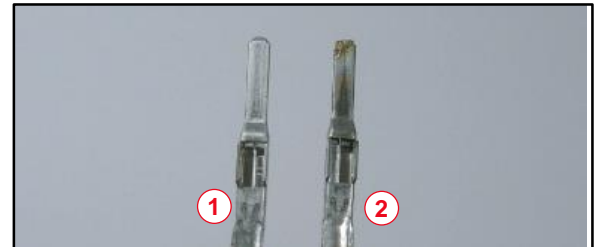
**Figure 9.**

- Wire terminal discoloration

- It is difficult to precisely locate ALL areas that were damaged.
- If a wire harness assembly repair is performed, corrosion or rust may still occur.

1	Good
2	Not Good

- Wire harness assembly replacement

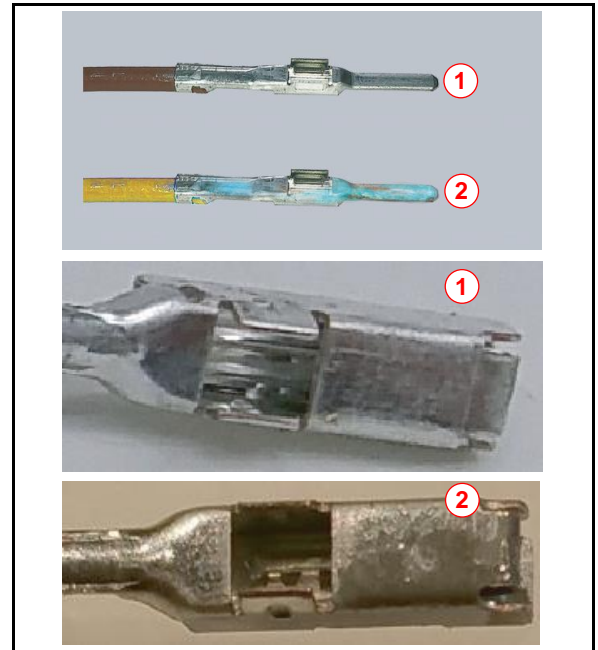
**Figure 10.**

- Wire terminal corrosion

- It is difficult to precisely locate ALL areas that were damaged.
- If a wire harness assembly repair is performed, corrosion or rust may still occur.

<b>1</b>	<b>Good</b>
<b>2</b>	<b>Not Good</b>

- Wire harness assembly replacement

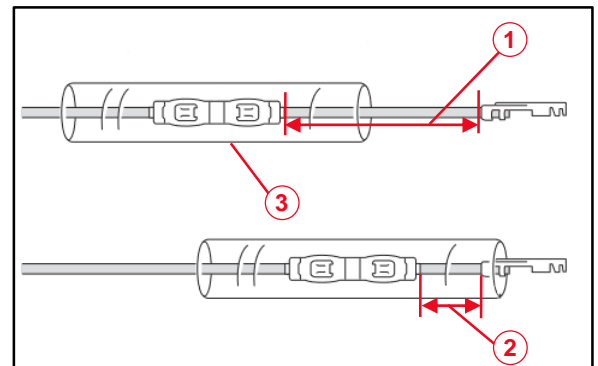
**Figure 11.**

3. Check if the removed protective wire harness assembly covers and clamps can be restored after the completion of the repair. If the protective covers or clamps can NOT be restored, the wire harness assembly may be damaged or produce unusual noise due to vibration or interference with the vehicle body or components. Replace covers and/or clamps as needed.
4. Repairing communication wire harness assemblies is NOT recommended, for example, CAN (Controller Area Network) communication. Repair causes the electrical resistance to vary, potentially blocking communication signals.
5. Ensure the remaining wire length is AT LEAST 30 mm to achieve the waterproof capability and insulation performance of a heat shrink sleeve.

1	Good (30-mm Wire Length)
2	Not Good (Less Than 30-mm Wire Length)
3	Heat Shrink Sleeve

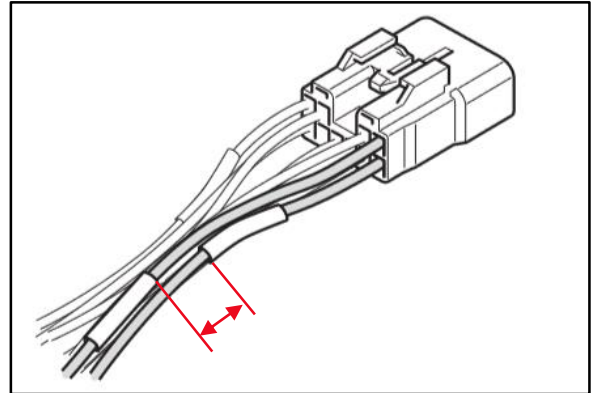
**Figure 12. Heat Shrink Sleeves in Good Locations**

6. Avoid the heat shrink sleeves being adjacent to each other when several wires connected to the same connector need to be repaired simultaneously.

The protective wire harness assembly cover or clamps may NOT be restored if the heat shrink sleeves are adjacent to each other.

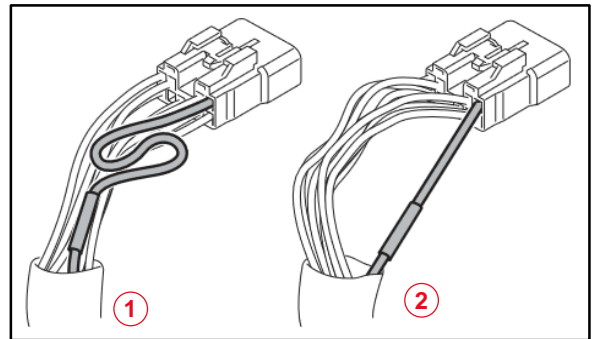
**Figure 13.**

7. Cut the repaired wire or the existing wire, whichever one will help you to obtain the same wire length as the original one AFTER the repair.
  - The repaired wire may have an open or short circuit due to vibration if it is too long.
  - The repaired wire may have an open or short circuit due to vibration if it is too short.
  - Terminal deformation or poor contact may also result from a repaired wire being too long or too short.

<b>1</b>	<b>Repaired Wire is Too Long</b>
<b>2</b>	<b>Repaired Wire is Too Short</b>

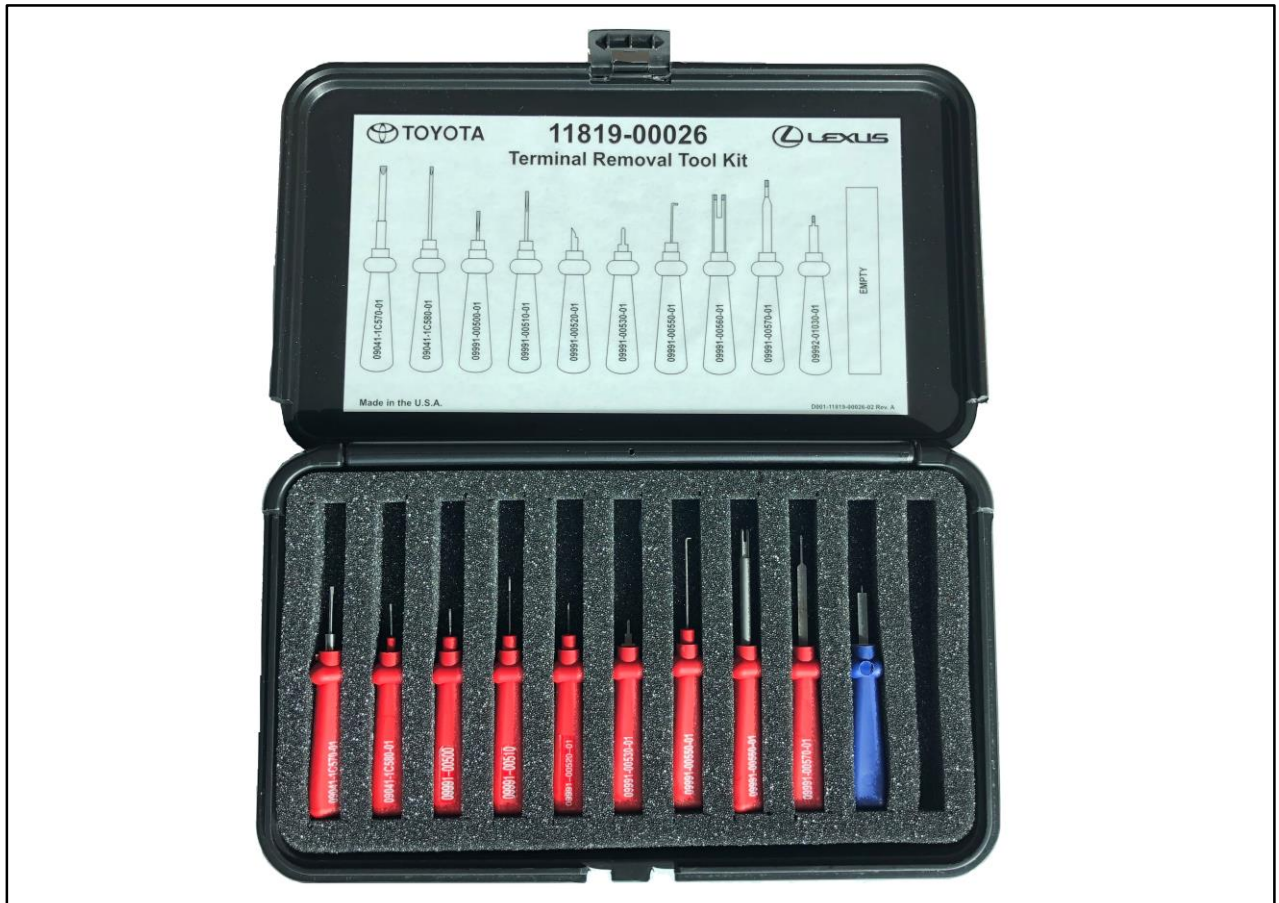
**Figure 14. Terminal Removal Tool Kit**

A NEW terminal removal tool kit was developed for wire harness repair. This kit includes 10 tools that can be used for multiple terminal and connector types. This section includes instructions for using the NEW wire terminal removal tool kit.
