SERVICE ACTION: REPLACE THE MECHANICAL COOLANT PUMP

This Service Information Bulletin (Revision 1) replaces SI B11 05 21 dated September 2021.

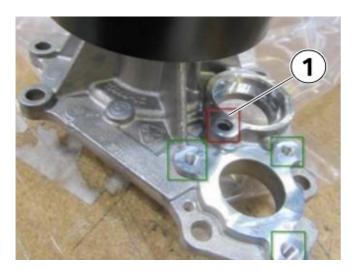
NOTE: The bolt hole for the coolant flange (1) may not be threaded. The self-tapping screw from the original water pump must be re-used.

Follow this tightening sequence (threads or no threads present)

- 1. Tighten to 12.5 Nm
- 2. Loosen the screw 360 degrees (one full turn)
