Technical Service Bulletin

69 Seat belts twitch

69 22 83 2056007/3 February 17, 2022. Supersedes Technical Service Bulletin Group 69 number 22-78 dated January 31, 2022 for reasons listed below.

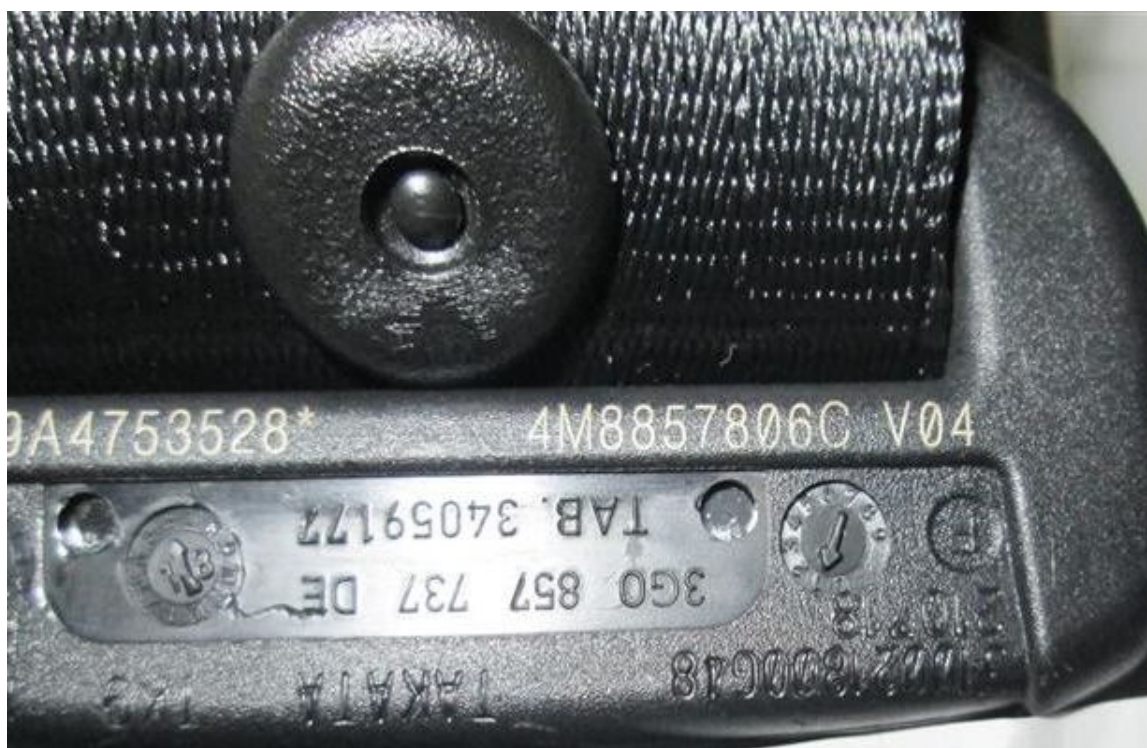
1. Compare the seat belt part numbers located on the seat belt latch plates (Figure 1) with ETKA to determine if the seat belts are installed on the correct side of the vehicle.

Figure 1. Sample part number of right rear Q8 seat belt shown.

3. Remove and reinstall the affected seat belts on the correct side of the vehicle according to the Repair Manual.
4. After swapping the seat belts side to side, it is not necessary to adapt them.

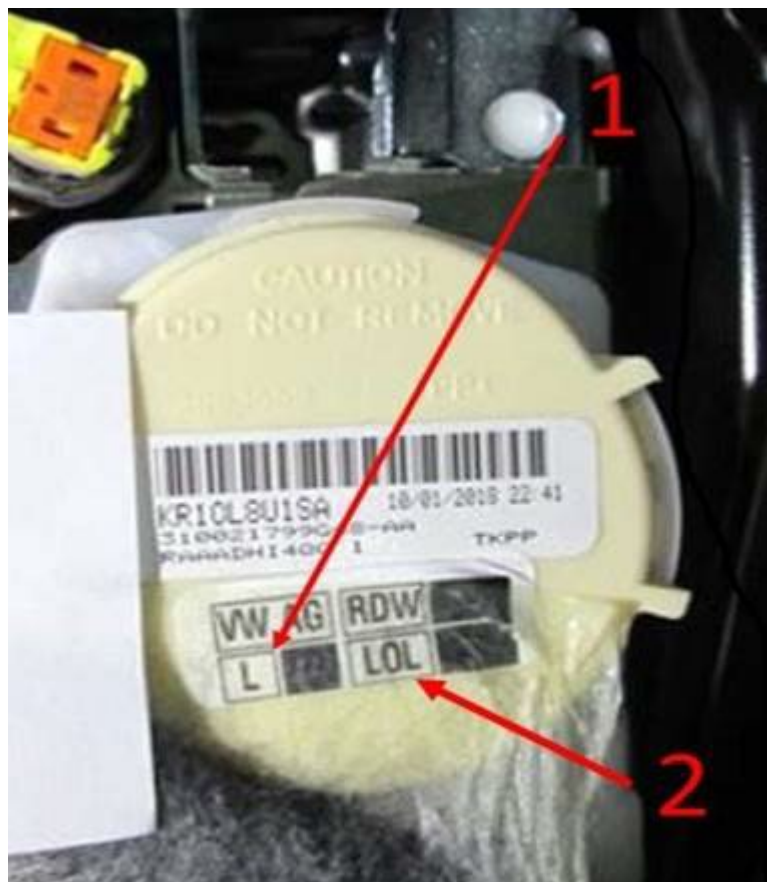
2. If seat belt part numbers differ from ETKA, perform a diagnostic output test in ODIS Service. If during the diagnostic output test the wrong side seat belt is activated, the seat belts were swapped side to side during assembly.

Figure 2. Example of left Q8 seat belt (-L- pos. -1-) for left hand drive (LHD) car (-L0L- pos. -2-).
