August 2021  
D21M6 **REV2**

## **Subject: Gen 5 Customer Demo Unit (CDU) and Pre-Series Unit Retrofits**

**Models Affected: Specific 2021 Freightliner New Cascadia model vehicles, powered with DETROIT™ Gen 5 DD15 Engines manufactured February 3, 2020, through December 14, 2020**

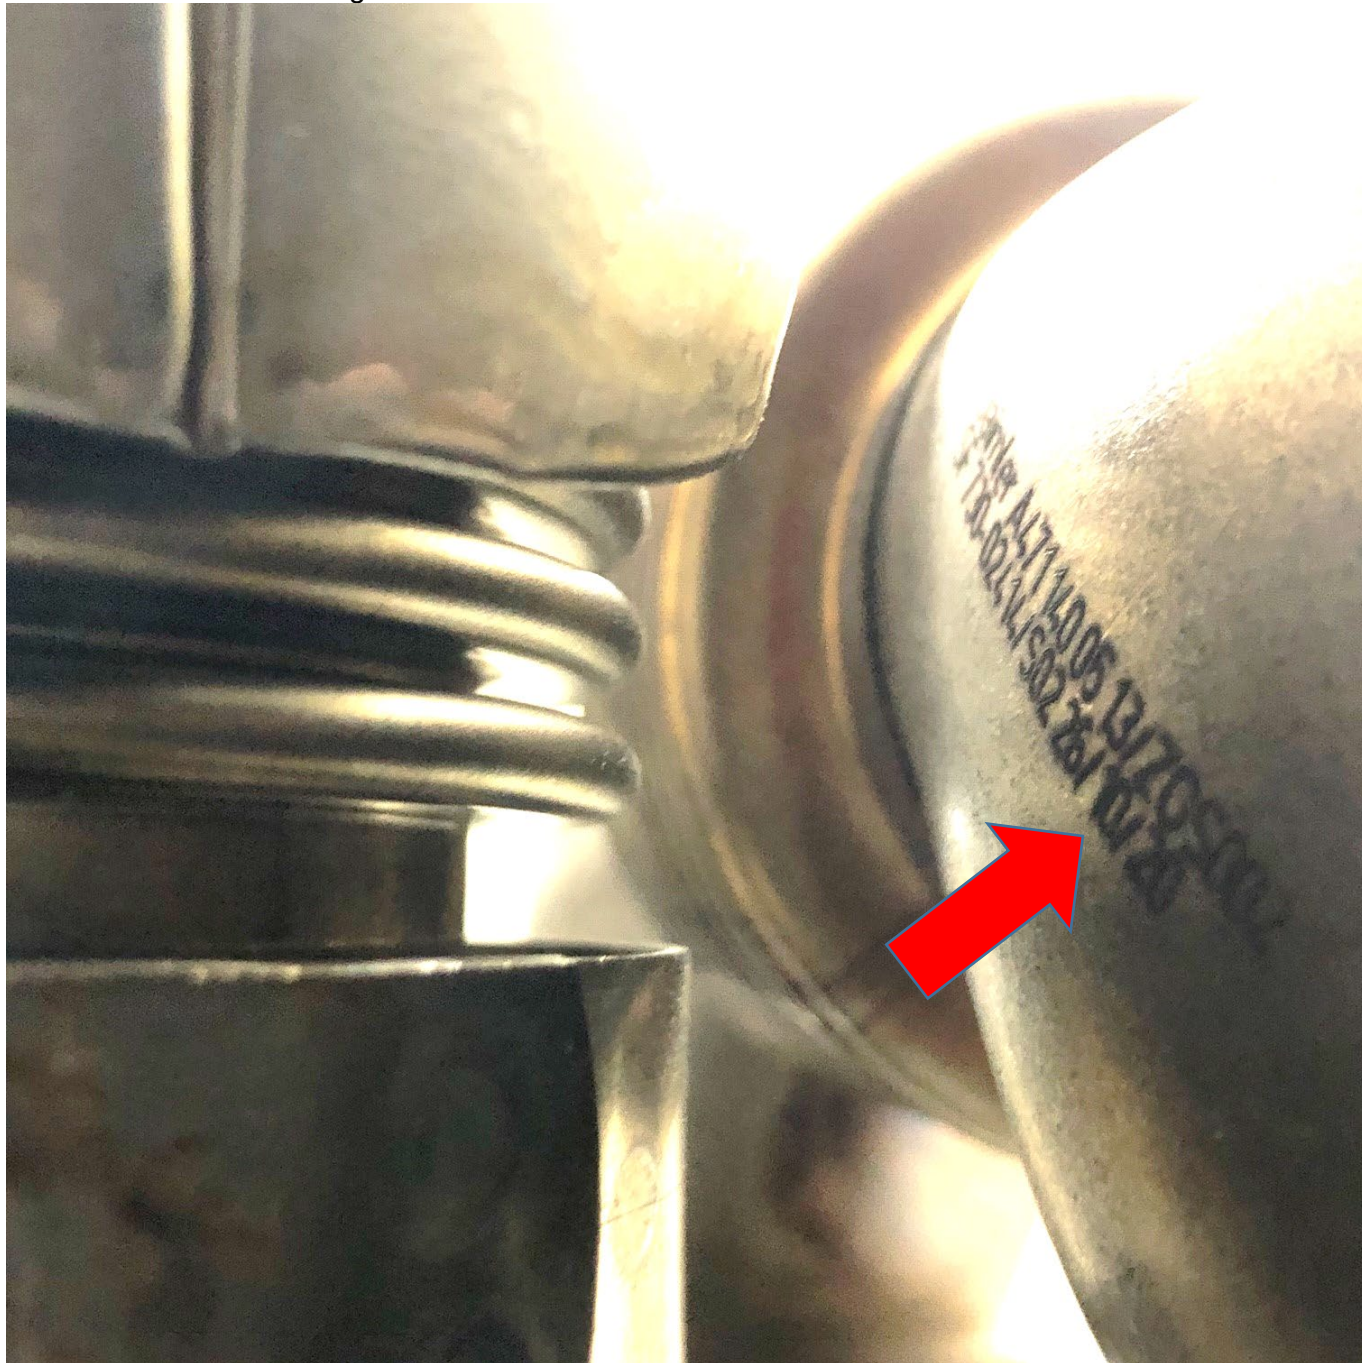
2. The red arrow is pointing to the date found on the EGR hot pipe. The date format is DD/MM/YY.
3. If the date is 31/07/20 or earlier, the EGR hot pipe needs to be replaced. Otherwise, it can be reused.
