SS 723-WST 2022 49X Hood Handle Mounting

49X vehicles

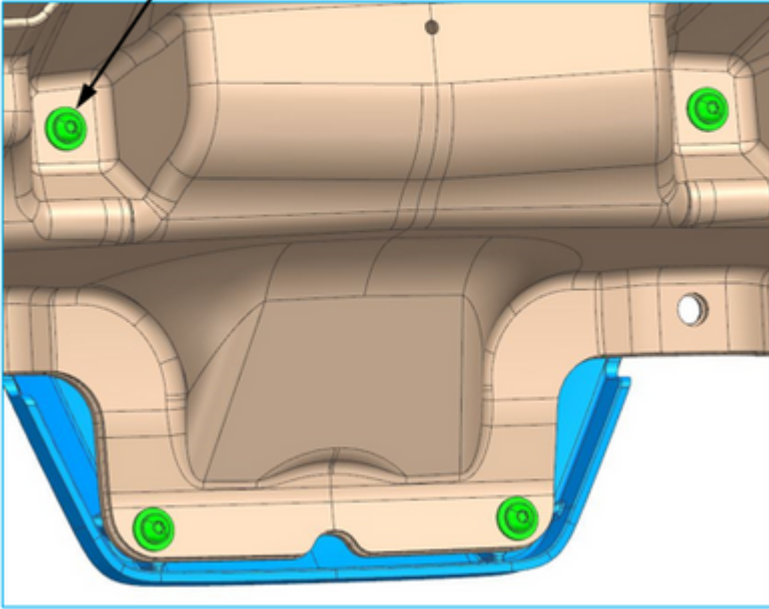
Stud length on hood handle may contact grille on certain installations.

4X 23-13602-025
M6 Capscrew w/Washer

Open hood, remove hood handle stud installations (quantity 4) and replace with part below:

23-13602-025 SCR,RND WSHRHD,HX RECSS,M6X1.0 (4)

Torq fasteners to 4.6ft/lb
