CR225 – Bushing Installation on Rear Rim

Hypermotard RVE DMH Model Year 21-22
Hypermotard 950 STD/RVE/SP DMT MY 19-22
Technical Service Bulletin SRV-TSB-22-001

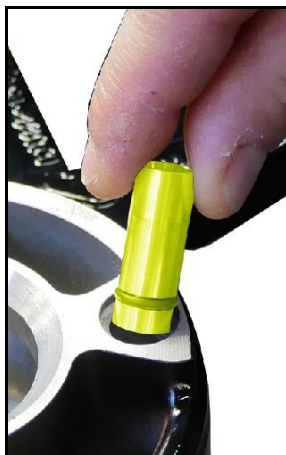
Figure A

4. Insert the first bushing inside the hole on rear wheel rim with the O-ring facing the rim (Figure A).

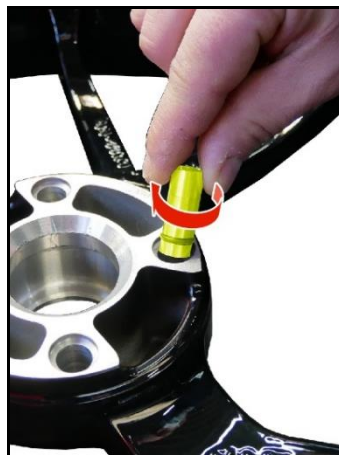
Figure B

To make bushing insertion inside hole easier, push the bushing inside hole and, at the same time, turn it until the O-ring is fitted (Figure B). Then push the bushing fully home (Figure C).

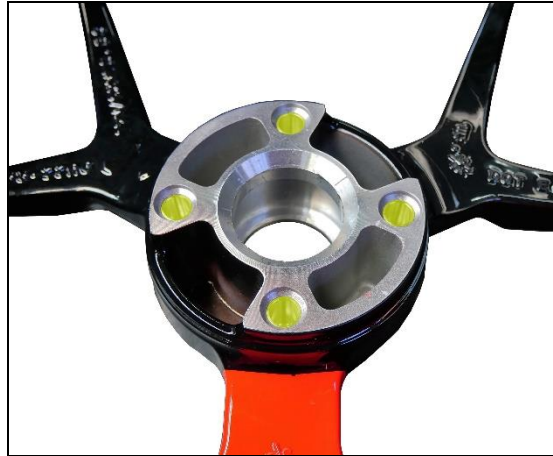
5. Repeat this operation for the other bushings
