Aftertreatment Control Module (ACM) Diagnostic Trouble Codes (DTC) U0001-88 and U0010-88 Lighting The Malfunction Indicator Lamp (MIL); Possible Derate Warning – US10 And Newer Chassis

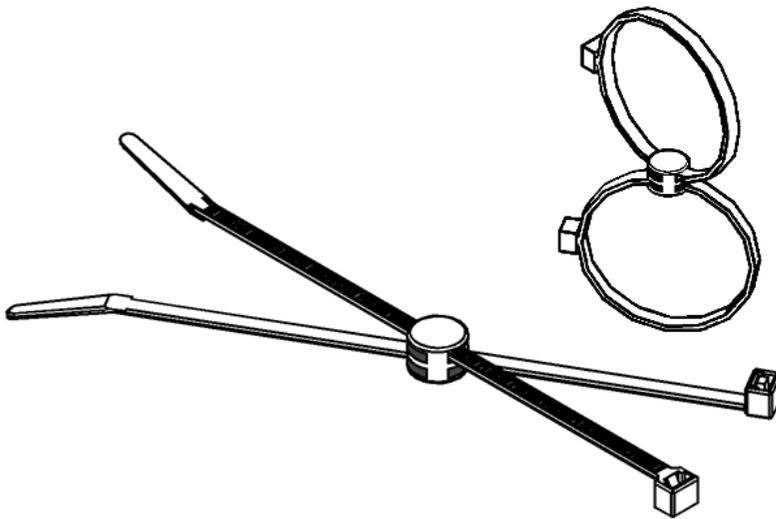
- Separator Tie, Part 20885497:

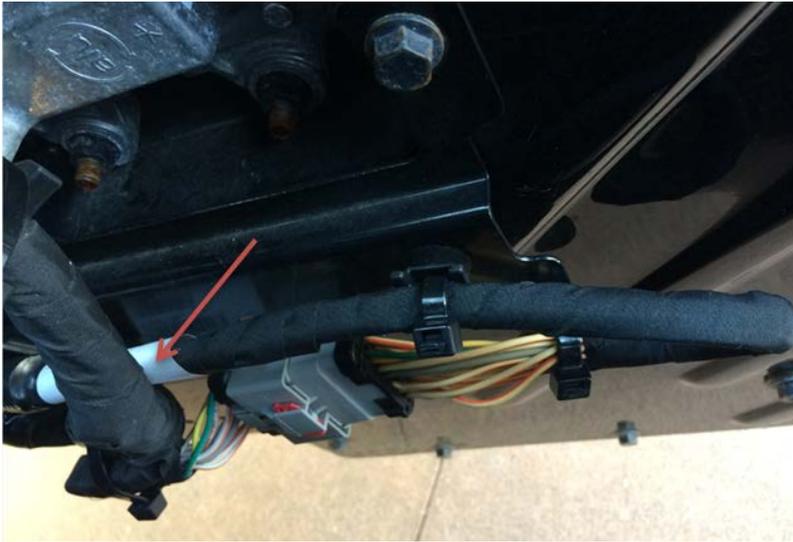
A. Chafing or Rubbing between harnesses:

I. ACM Breakout Harness:

If contact between the harnesses is found, resecure them with a separator tie to keep them apart.

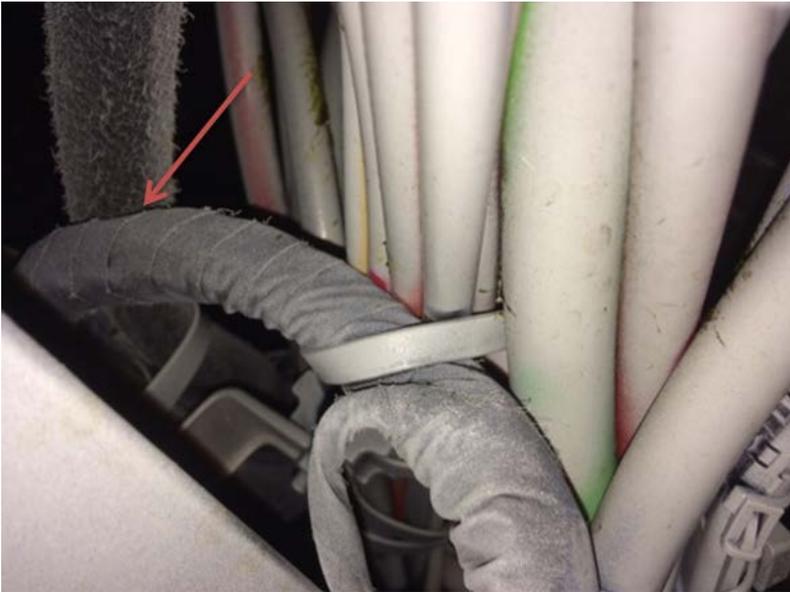
II. Air Compressor Discharge Hose

Check the section of the AHI harness that passes by the air compressor discharge line:

If the ACM harness is rubbing the air compressor discharge hose, make sure the harness is clipped to the airline bundle securely as shown above. Attach a separator tie between the harness and the discharge hose to keep the two apart.

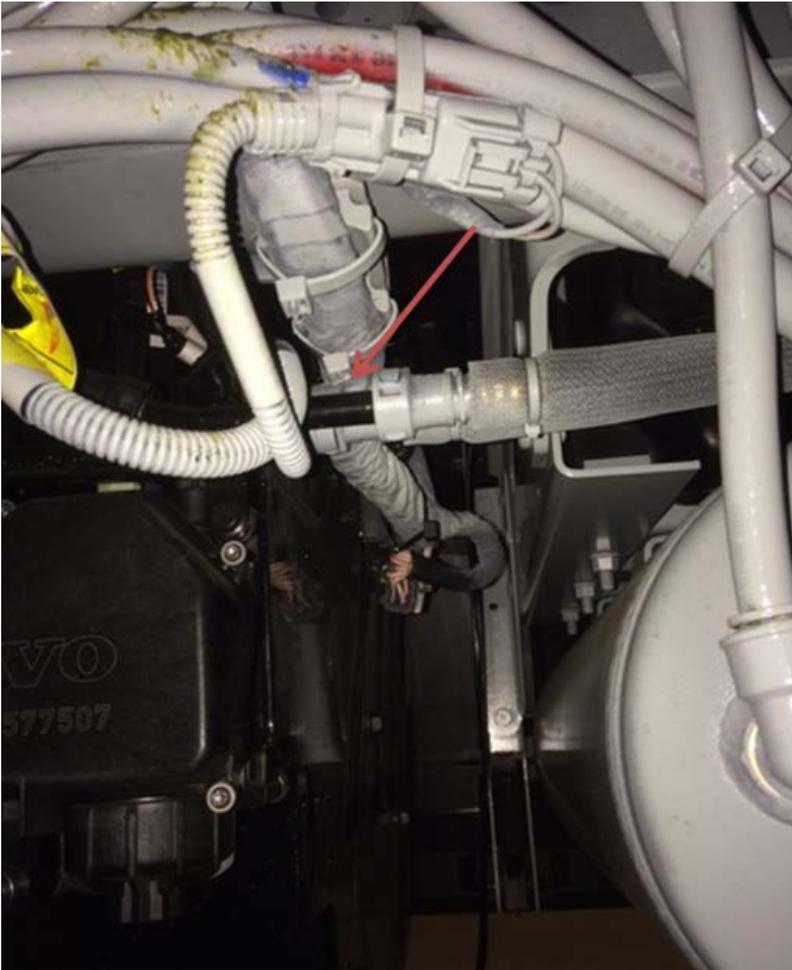
III. Diesel Exhaust Fluid (DEF) Supply and Return Lines

Check the section of the AHI harness that passes by the DEF supply and return lines:

If the harness is contacting the DEF lines, attach a separator tie between the harness and the lines to keep them apart.

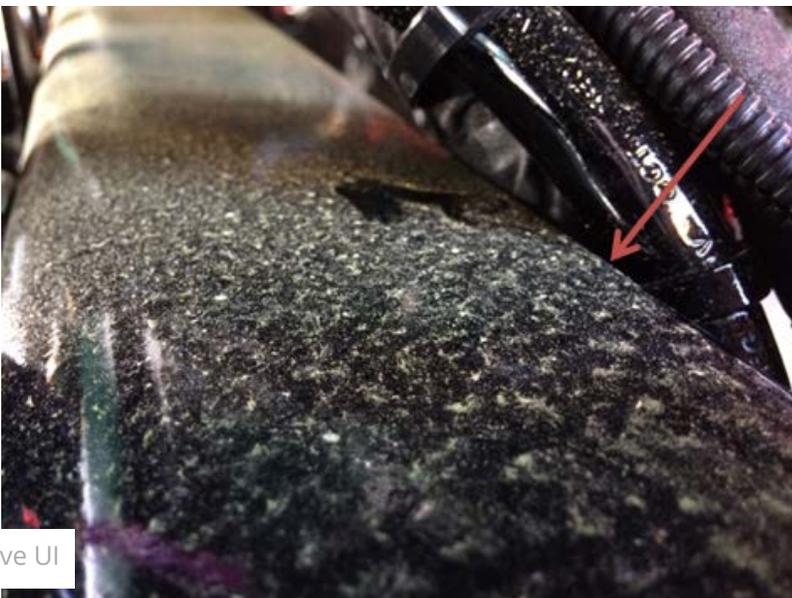
IV. Frame Rail

Check the area where the ACM harness passes by the frame rail:

The harness should not contact tthe edge of the frame rail. If there is contact with the edge, the harness needs to be properly secured to its clipping brackets so it is able to clear the rail.
