TECHNICAL SERVICE INFORMATION BULLETIN

TSIB 22-01 Rev A		February 04, 2022
TO:	All Operators	
TITLE:	MCI Main Distribution Panel Inspection and Cleaning for Harsh/Corrosive Environment	
APPLICABILITY:	MCI coaches with Main Distribution Panel, MCI P/N: 07-08-7940, and operating in harsh or corrosive environment: J4500 - All coaches beginning with MY 2017 to 2021. J3500 - All coaches beginning with MY 2018 to 2021. D45CRTLE - All coaches beginning with MY 2018 to 2021. D4520 – All MY 2020 coaches. D4500 – All coaches beginning with MY 2017 to 2020. D4505 – All coaches beginning with MY 2017 to 2020. D4000 – All coaches beginning with MY 2017 to 2020. D4005 – All coaches beginning with MY 2017 to 2020. D4500 – All coaches beginning with MY 2017 to 2020. D4000ISTV – All coaches beginning with MY 2017 to 2020.

1.0 Description

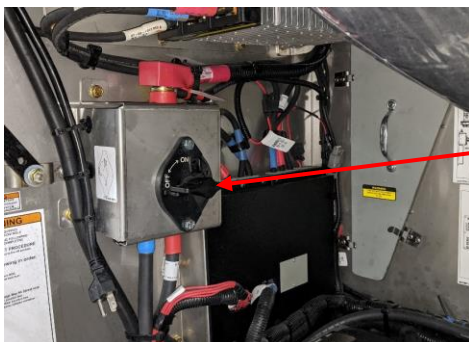
Turn off
MDS.

Locate the Main Battery Disconnect Switch and ensure it is in the off position.

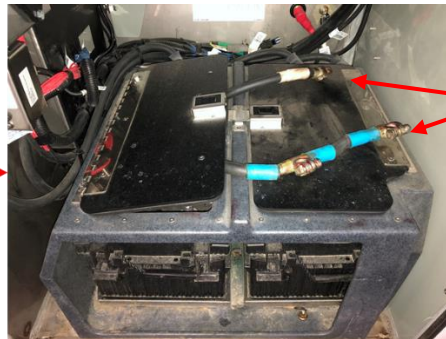
Disconnect all battery cables.

Disconnect GND, 12V, and 24V battery cables from the coach batteries. Ensure the battery cables do not come in contact with each other or the coach.

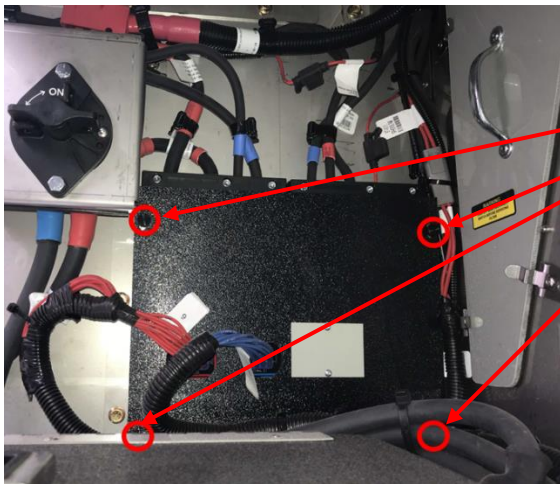
Remove and save 4 thumb screws.

Locate the MDP compartment mounted on the rear wall in the battery compartment. Remove and save the 4 thumb screws to release the MDP cover.

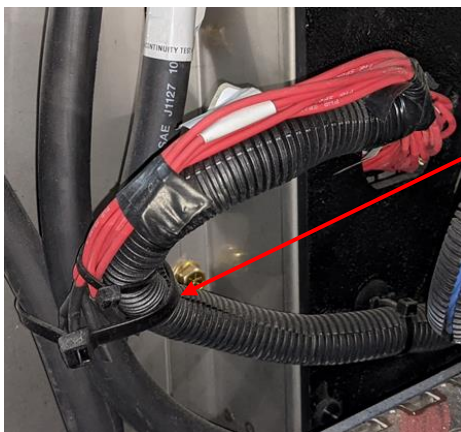
Remove BT-P162 tyrap on battery cables.

Remove tyrap that secure BT-P162 to the Main Disconnect Switch cables.

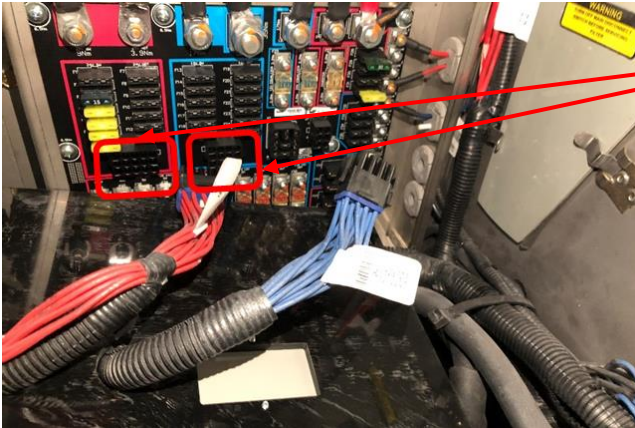
Disconnect BT-P161 and BT-P162.

Disconnect connectors BT-P161 and BT-P162 from MDP.

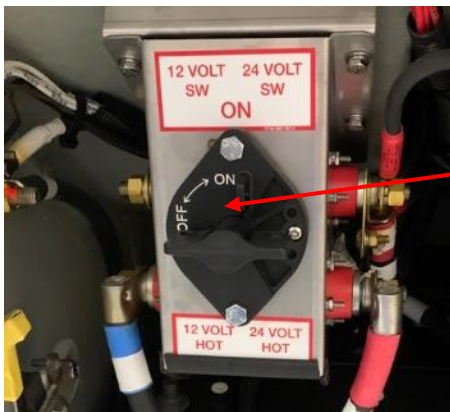
Turn off MDS.

Locate the Main Battery Disconnect Switch and ensure it is in the off position.

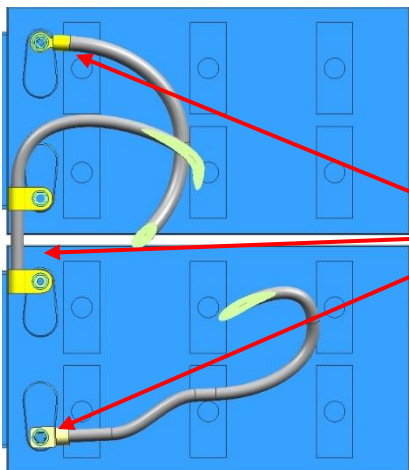
Disconnect battery cables

Disconnect GND, 12V, and 24V battery cables from the coach batteries. Ensure the battery cables do not come in contact with each other or the coach.

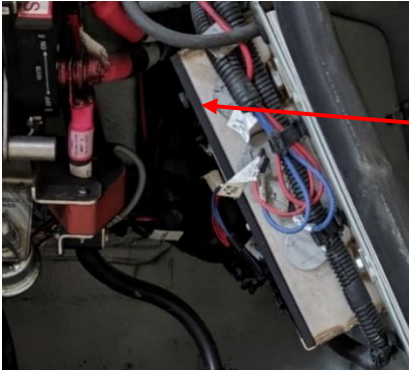
Remove the thumb screws

Remove and save the two thumbscrews from the MDP cover.

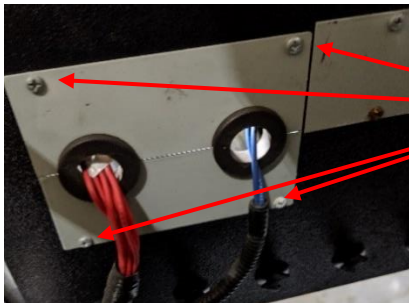
Remove and save the screws

Remove and save 4 screws holding the MDP cut-out part to the MDP cover.

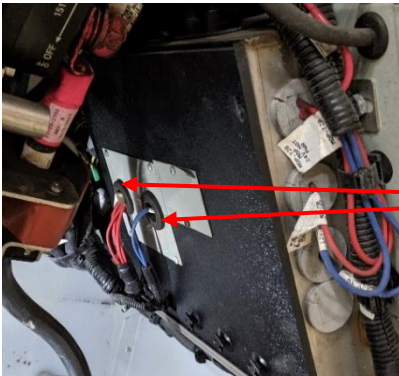
Disconnect the wires

Disconnect the two connectors, BT-P162 and BT-P161, from the main distribution panel.

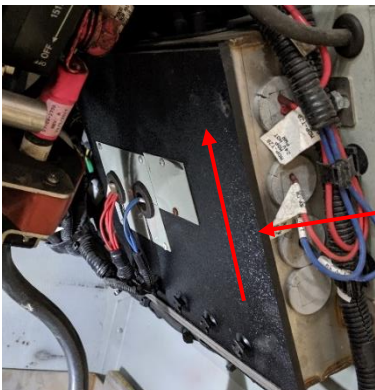
Slide the cover out

Slide out and save the battery compartment cover out of the bracket.

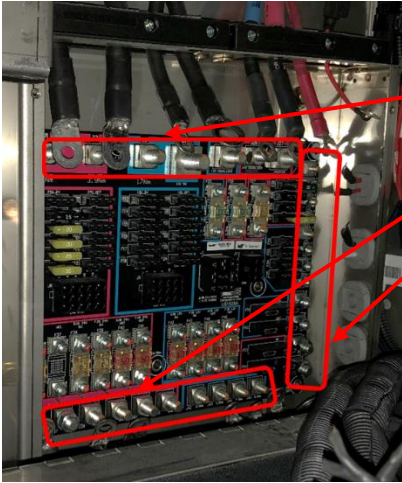
Remove all cables from MDP.

Remove all cables from MDP. Make a note of where each cable is connected on the board. Place nuts and lock washers back on studs after the cables are removed.

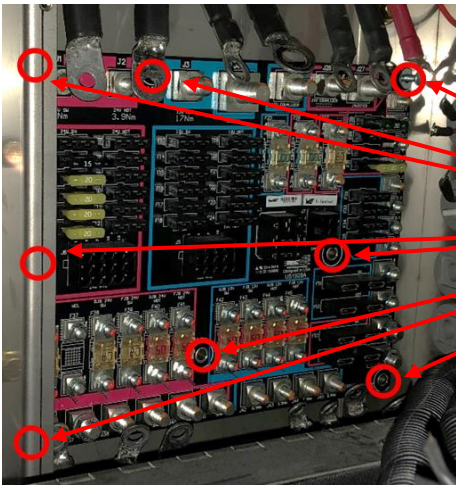
Remove mounting screws.

Remove & save 8 MDP mounting screws and washers to remove the MDP from the coach.

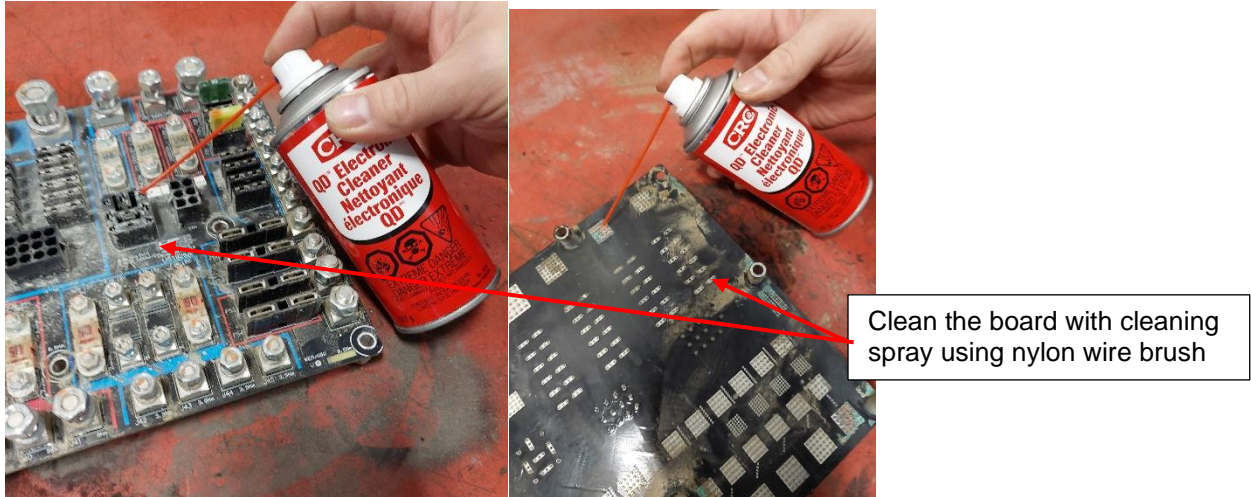
Blast the MDP board with air and clean the board with hard nylon wire brush by spraying cleaning spray lightly to eliminate the dirt.

NOTE: Maintain caution to spray the cleaner lightly as it could remove the existing conformal coating and also maintain caution not to damage the pins on the MDP.

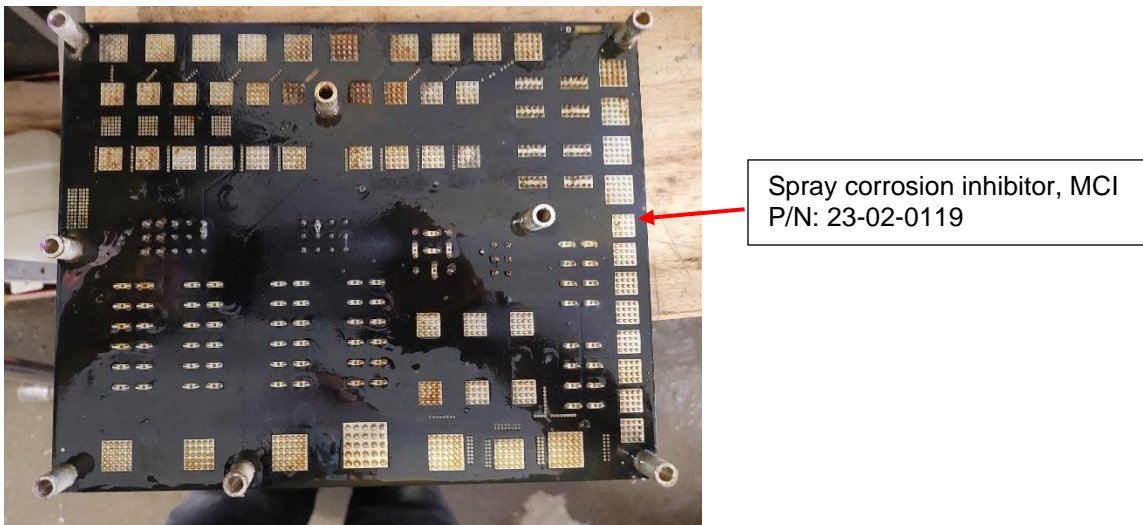
Using short sprays, apply the corrosion inhibitor, MCI P/N: 23-02-0119, on back of the board and allow 5-10min for it to dry.

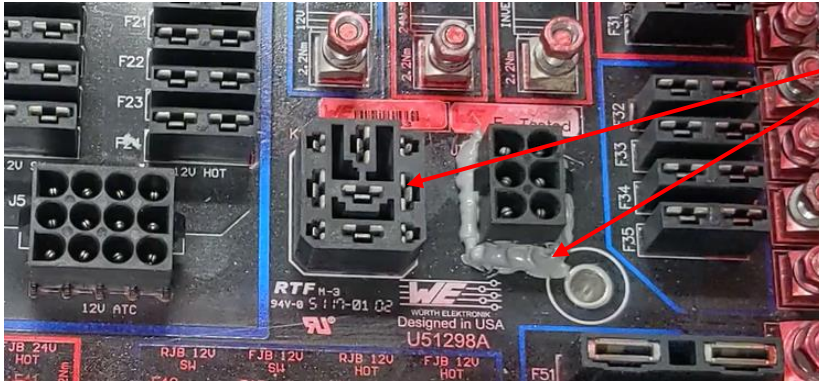
Apply RTV around K1 and J7 connectors.

Using RTV silicon, place a bead of silicone around fuse checker connectors K1 and J7.

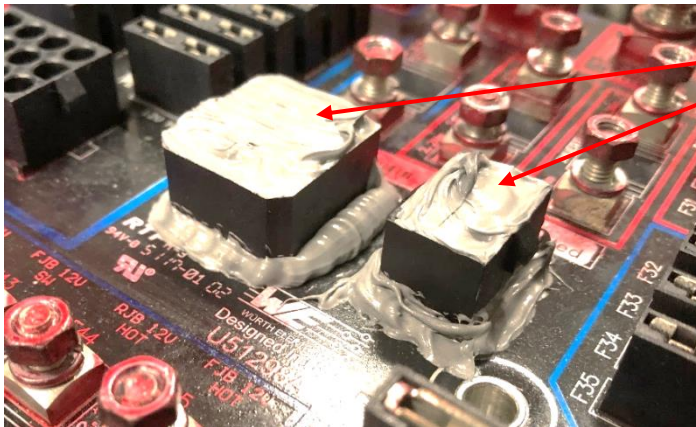
Apply RTV on top of K1 and J7 connectors.

Using RTV silicon, seal the top of fuse checker connectors K1 and J7. Let the silicon dry (approximately 30 minutes).

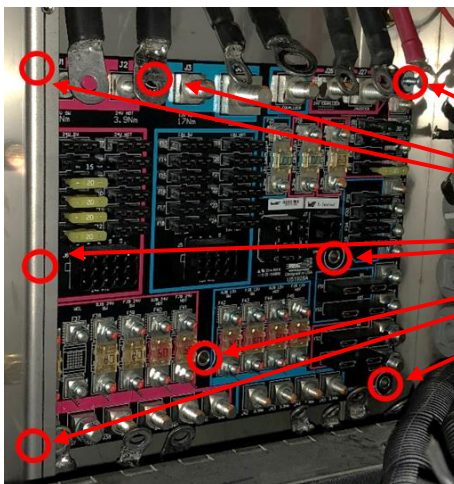
Re-install the board using existing screws

Re-install the MDP to the wall using existing screws and torque the screws to 75 In-Lbs. Re-install the cables referencing the torques specified in Section 9.0.

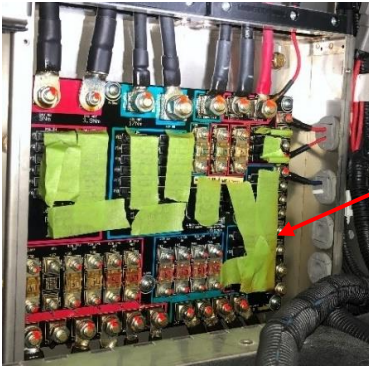
Cover open connectors and fuse slots.

Cover all open connectors and fuse slots with masking tape.

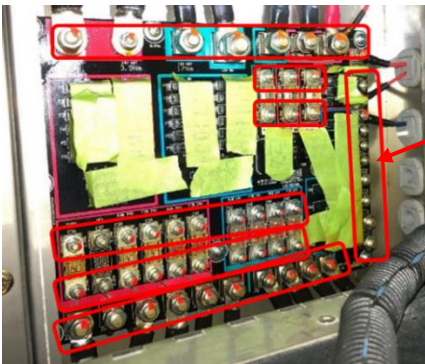
Spray anticorrosive on MDP studs.

Using short sprays, apply the corrosion inhibitor, MCI P/N: 23-02-0119, on all power and fuse studs. Wipe off any excessive corrosion inhibitor from the fuse windows using a dry rag.

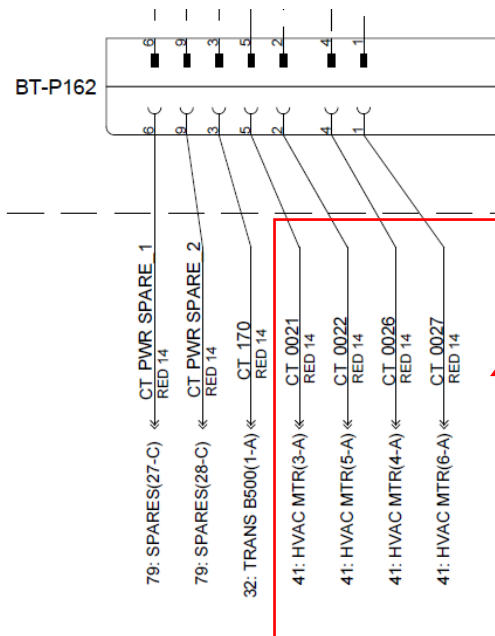
Cut wires 4-5 inches after the connector

Cut HVAC wires CT0021, CT0022, CT0026, and CT0027 4-5 inches from the 24V BT-P162 connector.

NOTE: Heatshrink and tie back the wire attached to the pins to avoid corrosion.

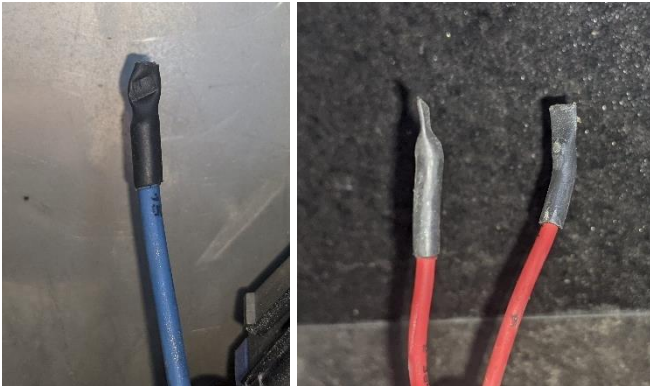
Cut and tie back all spare wires from BT-P161 and BT-P162 using heat shrink, MCI P/N: 6819239. Also tie back Alt 55SI sense wire CT 0012D. These two connectors will not be re-installed to the MDP.

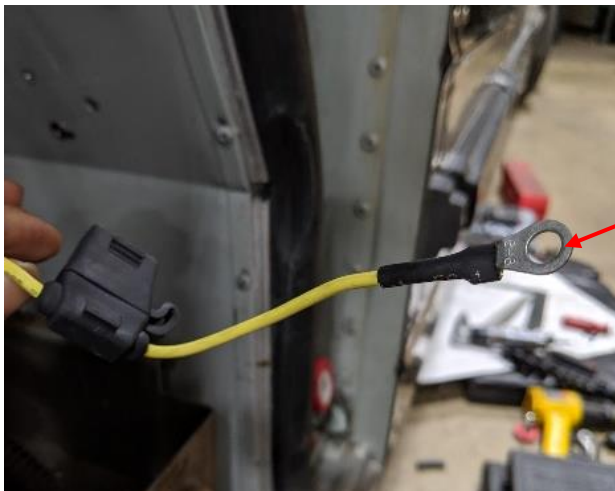
Crimp inline fuse holder to the HVAC wires

Crimp HHG in-line fuse holders, MCI P/N: T19-1168 or similar to the HVAC wires and a 1/2" ring terminal at the end, MCI P/N: 19-11-1171 or similar.

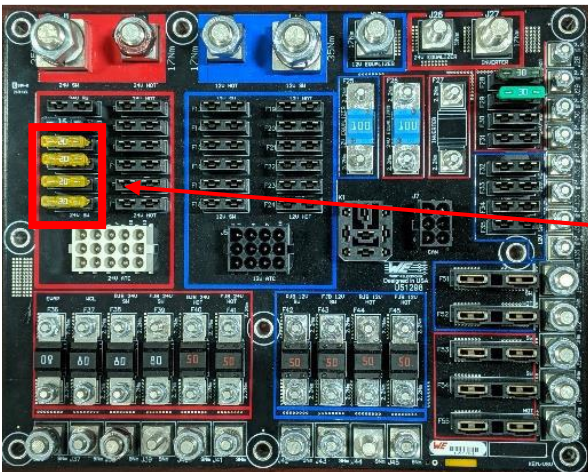
Remove 20A fuses and install in in-line fuse holders

Remove 20A fuses from the MDP and install them in the in-line fuse holders.

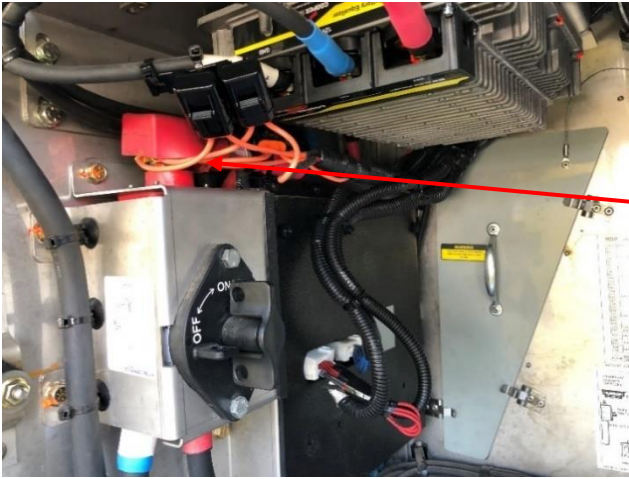
J4500/J3500/D45CRT-Le/D4520 coach models

Connect the modified HVAC wires to 24V SW stud on MDS

Connect the modified HVAC wires to either 24V SW stud on the MDS as shown below for various coach models. Torque the nut to 300 In-lbs.

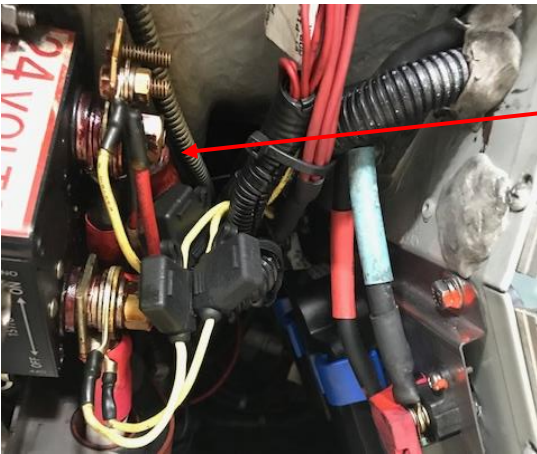
D4X0X coach models

Connect the modified HVAC wires to 24V SW stud on MDS

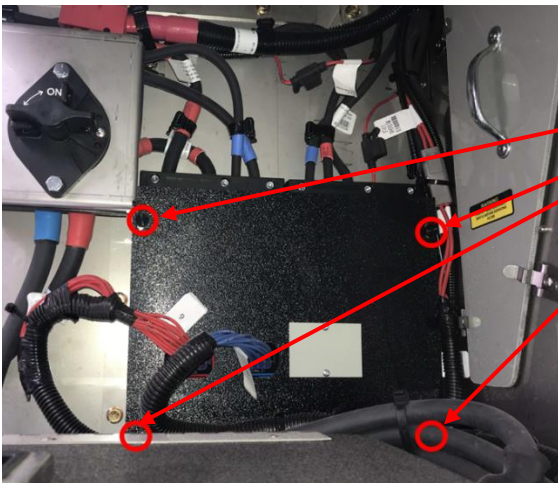
Install 4 thumb screws.

Secure the MDP cover using the 4 thumb screws, MCI P/N: 07-08-9231.

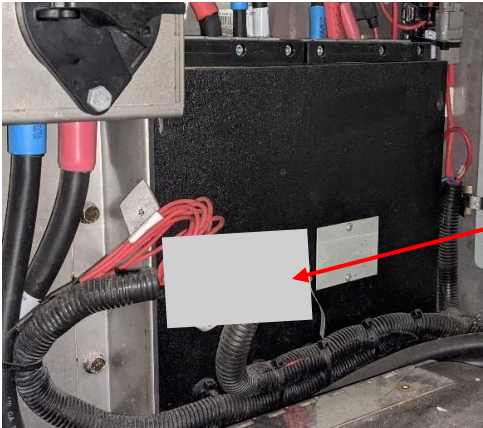
Cover the openings with duct tape

Cover the opening on MDP cover for BT-P161 and BT-P162 connectors with duct tape.

NOTE: Although this is not a sealed housing, covering this two openings will greatly reduce the amount of moisture/contamination from entering the housing.

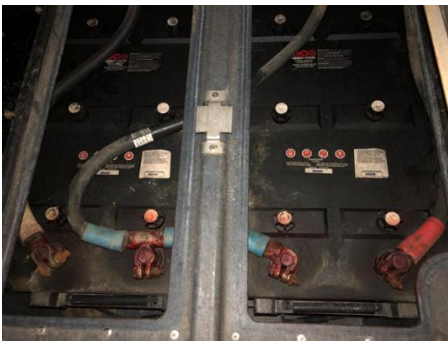
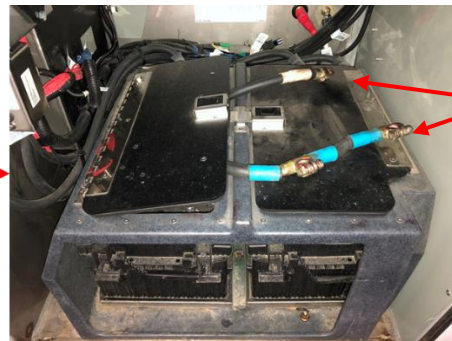
Reconnect all battery cables.

Re-install the battery cables and torque the studs following the maintenance manual.

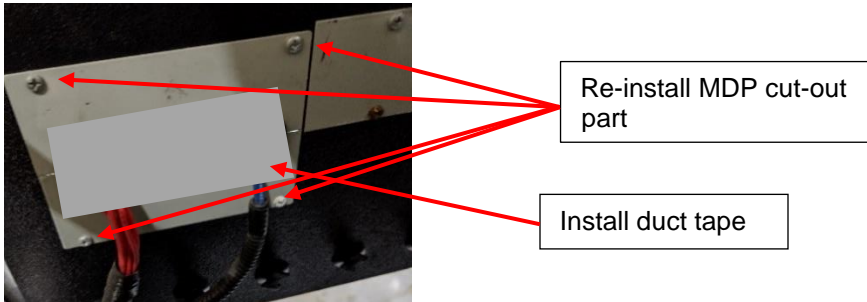
NOTE: Above picture is not an accurate representation of the final assembly as the BT-P161 and BT-P162 connectors and respective wires no longer connect to MDP

Prior to installing the MDP cover, re-install the MDP cut-out part to the MDP cover using existing screws. Duct tape over the openings on the MDP cover, the BT-P161 and BT-P162 connectors will not be re-installed.

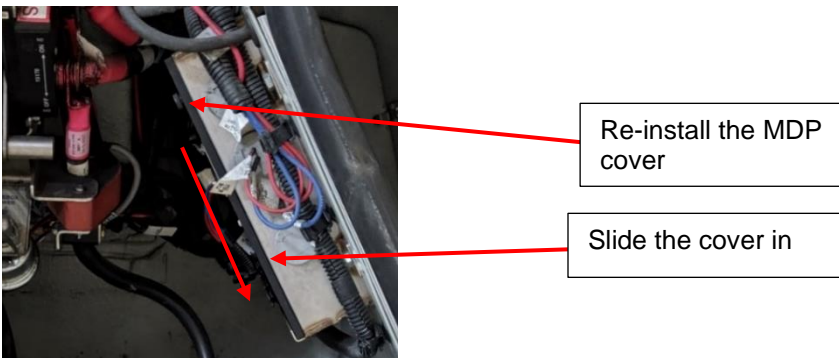
Slide in and re-install the MDP cover using the existing two thumbscrews.

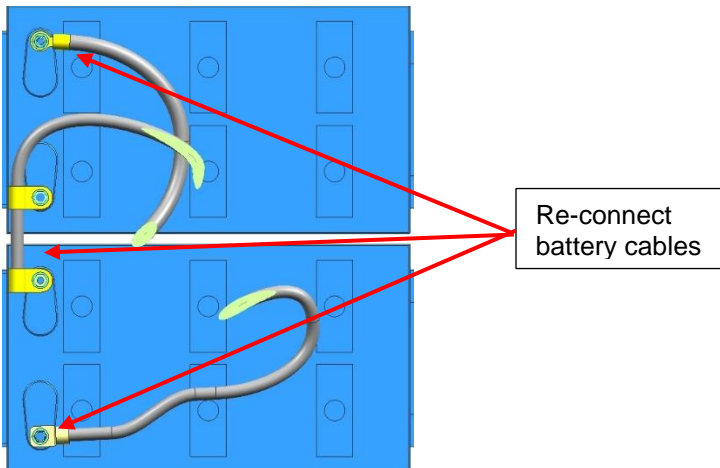
Re-install the battery cables and torque the studs following the maintenance manual.
