ANC Booms/Rumbles

AFFECTED VEHICLES

Year	Model	Trim
2018–20	Accord (Except Hybrid)	ALL
2019–20	Insight	ALL

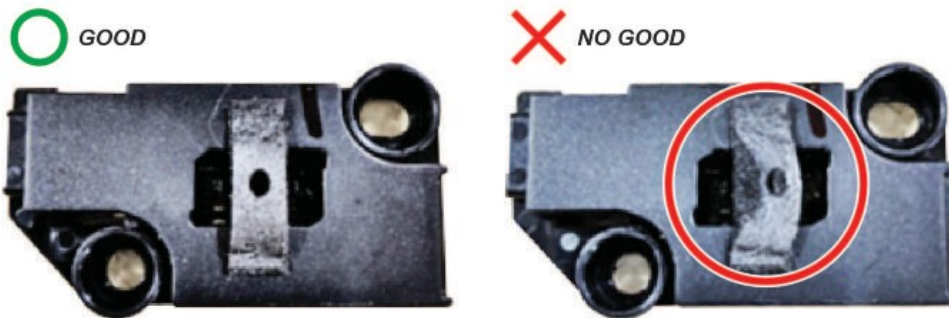
Are you hearing a booming or rumbling through the speakers? If you get a vehicle in for this, remove the covers in the headliner for the ANC microphones and check if the insulating foam is damaged or folded over as shown below. We've found this may be the reason for the noise.

Inspect the microphone assembly using the ANC MICROPHONE CHECK procedure on the next page.

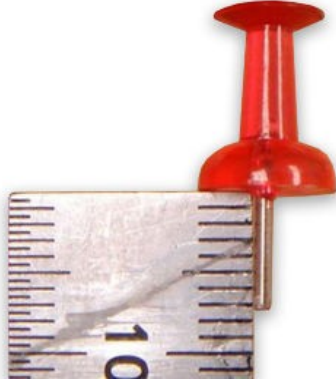
- The Accord has three microphones: front, middle, and rear. This procedure can be done only on the middle and rear microphones.
 - The Insight has two microphones: front and rear. This procedure can be done only on the rear microphone.
1. Take a push pin with a diameter of **1 mm**, and trim it to a length of **7 to 8 mm**.

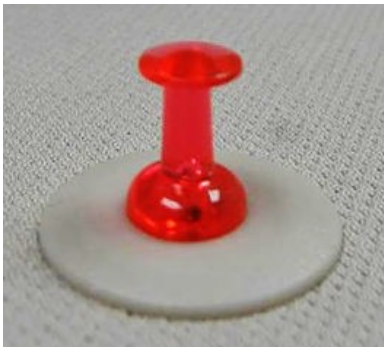
2. Insert the push pin into the microphone cushion hole.

- If the push pin sits flush on the mic cover without resistance, the microphone assembly is good.

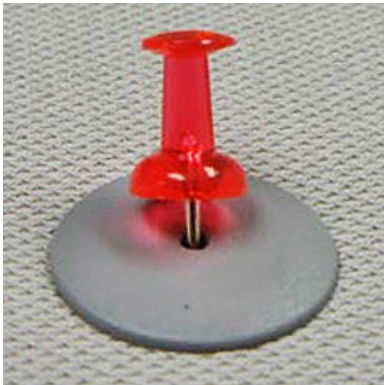
- If the push pin doesn't sit flush or there's resistance, you need to replace the microphone assembly.

3. Once the assembly is replaced, use the ANC MICROPHONE CHECK to make sure the repair was done correctly.

If the pin doesn't sit flush, depending on how damaged the foam is, you might have to replace the assembly again.
