## RYKER 2022 Front Wheel Studs Inspection - 139755

### Problem:

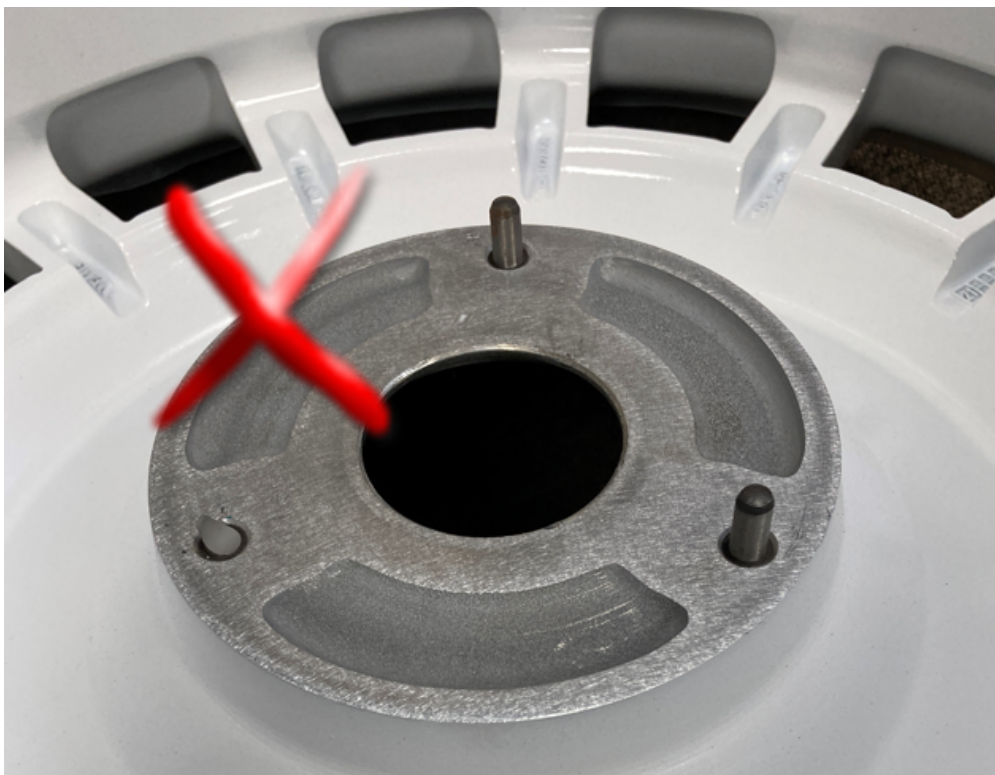
The front wheels guided studs might be broken from the factory on MY22 Rykers. These studs are required (all 3) and need to be aligned in the front brake rotor holes. If a stud is found broken, the wheel needs to be replaced.

The next picture is showing a broken stud.

At PDI, before installing the wheels on the unit, pay attention to the front wheels make sure that all studs are in good condition and not damaged.

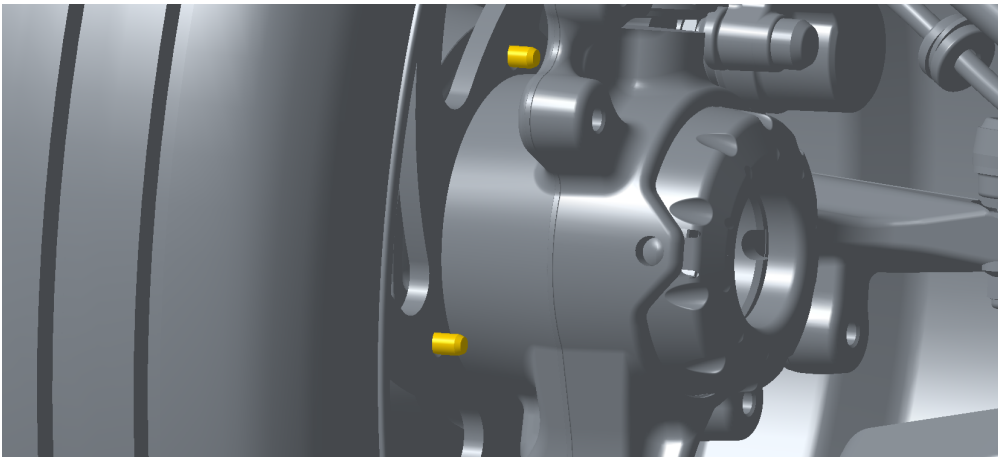
If a unit is already registered, the inspection can be done at the next unit's service. Again, the inspection is visual only. No needs to remove the wheels. Simply lift up the front end and slowly turn the wheel to see the studs aligned in the front brake rotor as shown in the attached picture.

Visual inspection only

Warranty Type 03 or 01 with job code 07-80 has to be used if a wheel is replaced
