CONVENTIONAL DIESEL EXHAUST FLUID (DEF) TANK VENT HOSE REPLACEMENT SERVICE CAMPAIGN

CAMPAIGN NO: T0490
DATE: 2-24-2022

SUBJECT VEHICLES: Certain 23MY Conventional trucks equipped with a Cummins B6.7 engine.

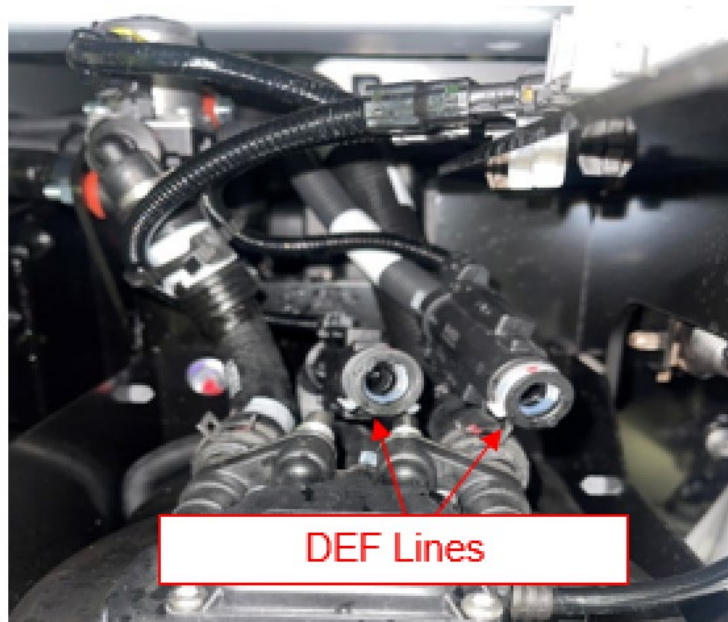
2. Release the two DEF lines from the top of the DEF sending unit by depressing the white locking ring and then disconnect by pushing the lines off the sending unit.

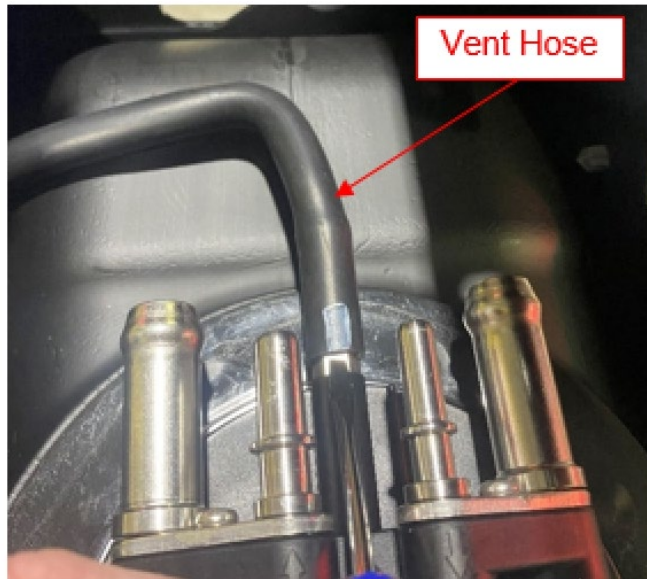
3. Remove the original DEF tank vent hose from the small fitting in the middle of the DEF sender as shown in the picture below.

NOTICE: The picture shown below was taken off the vehicle for clarity, do not remove the large coolant hoses.

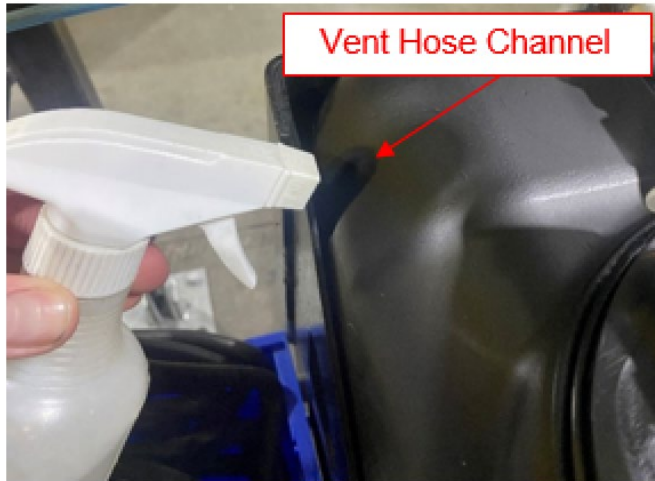
5. Spray soapy water down into the channel on the rear side of the DEF tank and install the new DEF tank vent hose in this channel. Remove the plastic trim tool. Inspect the installation of the vent hose to make sure it is not pinched.

NOTICE: The picture below was taken off the vehicle for clarity. Do not remove the DEF tank from the vehicle.

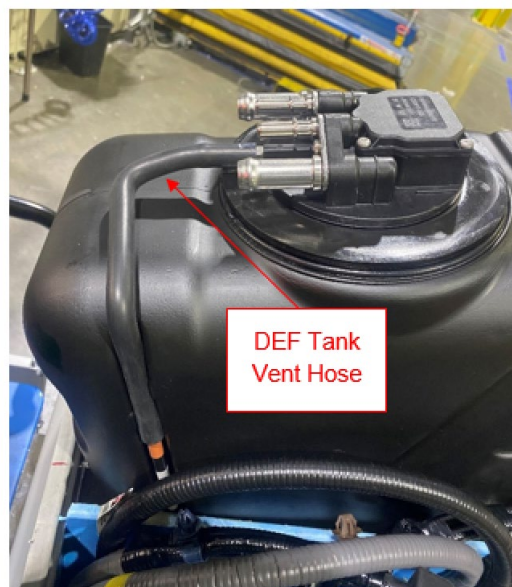
6. Spray soapy water on the vent hose nipple of the DEF sending unit and install the vent hose on the DEF sending unit. Ensure that the DEF tank vent hose is fully seated on the hose nipple and is inserted in the channel on the side of the DEF tank as shown in the picture below.

NOTICE: The picture below was taken off the vehicle for clarity. Do not remove the DEF tank from the vehicle.
