Technical Service Bulletin

19 MIL on, DTCs P218100, P017B00, P308100, and/or P01E400 are stored in the ECM

19 22 29 2058767/8 March 7, 2022. Supersedes Technical Service Bulletin Group 19 number 21-13 dated March 2, 2021, for reasons listed below.

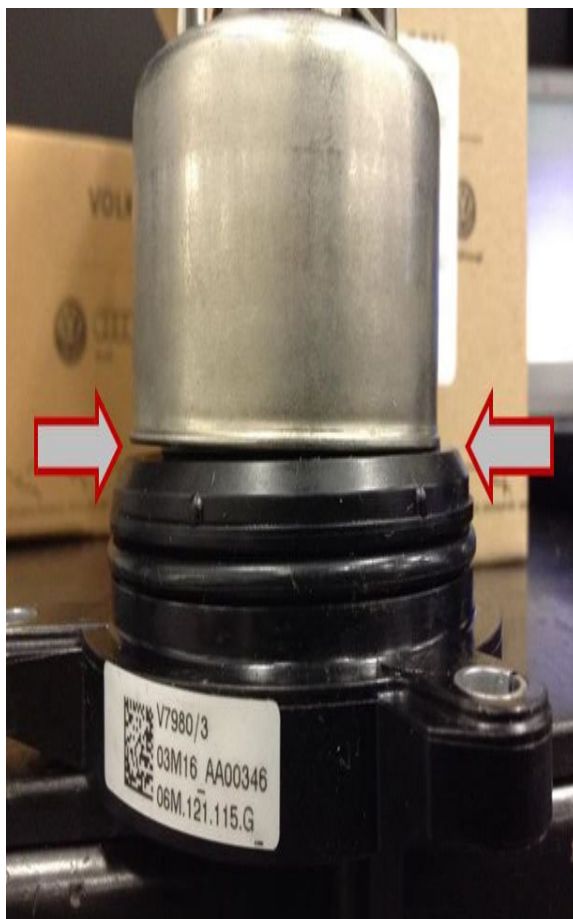
1. Remove the thermostat and check whether it closes completely. If the coolant is still warm, put the thermostat in cold water to restore its original condition. If there is a gap between the chamber and seal, the thermostat is faulty and needs to be replaced.

Figure 1. Gap between chamber and seal.

2. Attach photos to the repair order which clearly shows that the thermostat does not close neatly.

After the repair, fill with G12evo coolant in the coolant circuit.
