SERVICE BULLETIN

Classification: BT21-025A	Reference: NTB22-002A	Date: February 22, 2022
------------------------------	--------------------------	----------------------------

2013-2018 ALTIMA; FRONT COMBINATION LAMPS (HEADLAMPS) INSPECTION

APPLIED VEHICLES: 2013-2018 Altima (L33)
APPLIED SYSTEMS: Front Combination Lamps (Headlamps) – Halogen ONLY

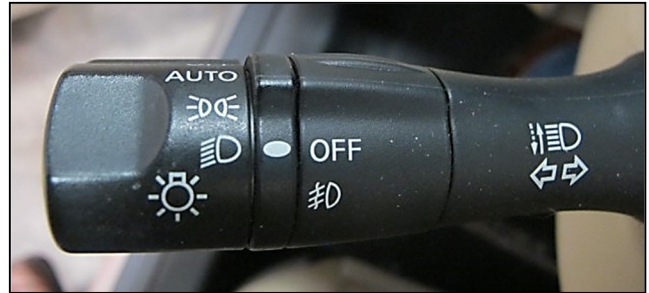
Figure 1

1. Open the driver (LH) side door.
2. Set the parking brake.
3. Start the engine.
4. Turn the headlamps ON using the combination switch.
 - Ensure the low beams are ON, high beams are OFF.
 - If equipped, turn the fog lights OFF.

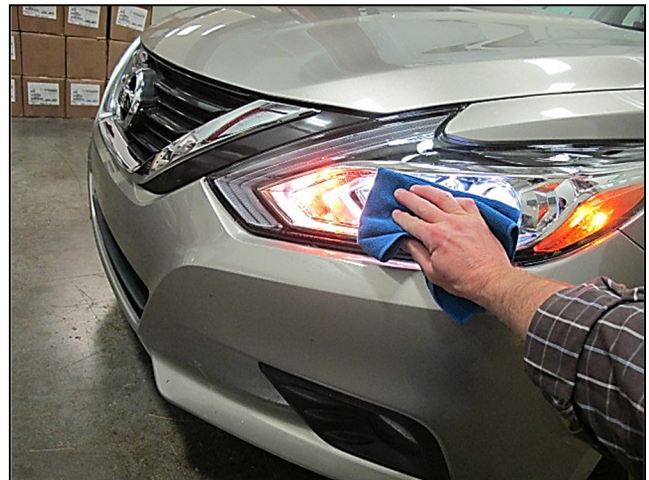
Figure 2

5. Clean both front headlamp assemblies using clean water and a clean soft car towel.

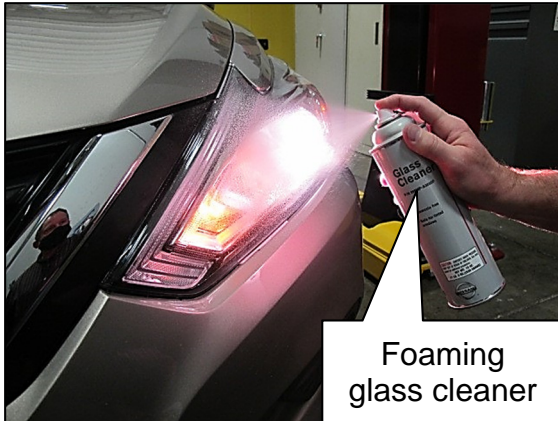
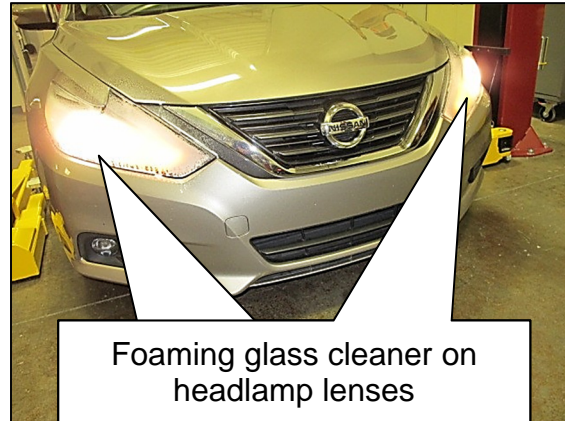
HINT: To help highlight the headlamp low beam light pattern on the headlamp lenses, you can spray both headlamp assemblies with Nissan Foaming Glass Cleaner (PN: 999MP-A3050P) or an equivalent foaming glass cleaner (Figure 3 and Figure 4).

- Do not use glass cleaner containing ammonia.
- Do not use any other harsh chemicals to clean the headlamp lenses.

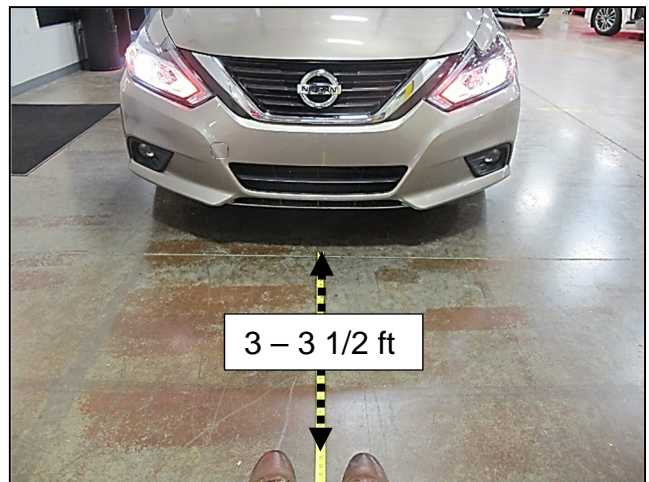
Figure 5

6. Stand approximately 3 – 3 1/2 feet back from the center of the front bumper to view the headlamp low beam light pattern on the headlamp lenses.

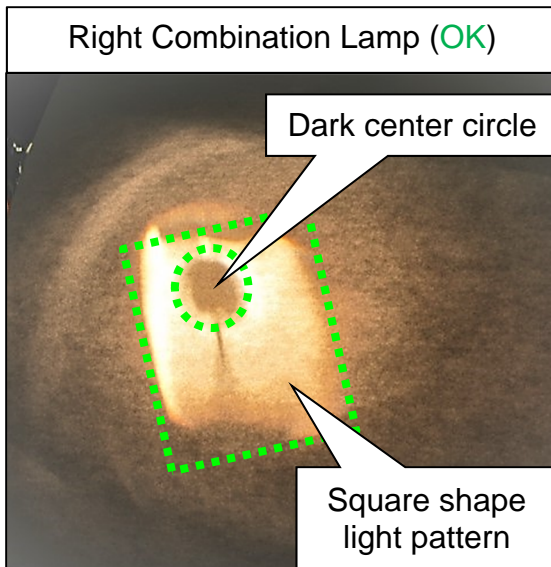
Good (OK) Examples

NOTE: The figures below show the low beam light pattern enhanced with Nissan Foaming Glass Cleaner.

2016-2018 Models

7. Visually inspect and compare the low beam light pattern projected on both of the headlamp lenses to the Good (OK) Examples (Figure 6 - Figure 11 on pages 4 and 5) and the No Good (NG) Examples (Figure 12 - Figure 15 on page 6).
- If the headlamp low beam light pattern condition is OK, the inspection process is complete.
 - Write the inspection result of each headlamp assembly on the repair order.
 - If the headlamp low beam light pattern condition is No Good (NG) for either of the headlamp assemblies:
 - a. Write the inspection result of each headlamp assembly on the repair order.
 - b. Proceed to step 8 on page 7 to replace both headlamp assemblies.
