## 2003–08 Pilot Rear Subframe Body Mount Rust Repair (Customer-Pay Repair)

Supersedes 21-019, dated December 2021, to revise the information highlighted in **yellow**.

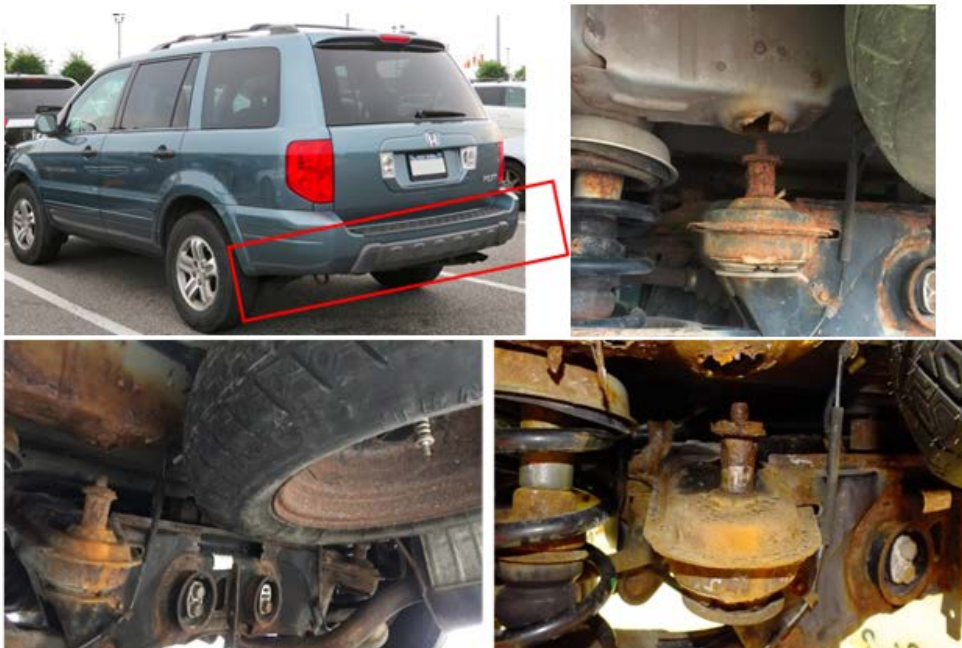
Corrosion of the frame rail that supports the rear subframe may occur on some vehicles that are commonly driven in harsh environments. The subframe mounts may pull away from the body of the vehicle (see images below), but extensive testing has concluded that vehicle stability will be maintained. As an alternative to a complete frame replacement, a frame repair kit has been developed.

Install cast frame inserts to replace the damaged frame rail that supports the rear subframe.

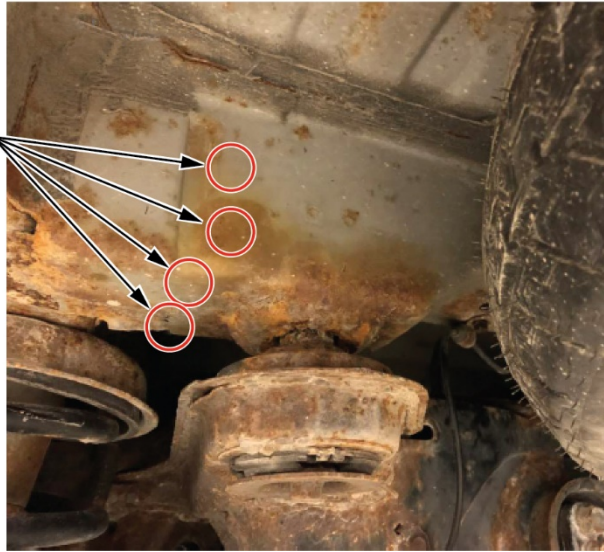
**PUNCH LOCATIONS**

2. Perform a punch test using the frame inspection tool at the locations shown in the photos below for the frame areas that are to be repaired.

- Place tip of the frame inspection tool against frame where the test is to be performed. Slide the weight to end of the tool and with moderate force slide the weight towards the punch location until it stops.
- Strike each point twice. If the punch does not pierce the frame at any point, continue to REPAIR PROCEDURE (MUST PASS ALL 6 LOCATIONS).
- If the punch pierces the frame (even if only one point), the vehicle cannot be repaired using this method. Consult a Honda Profirst Certified Body Shop for repair options.

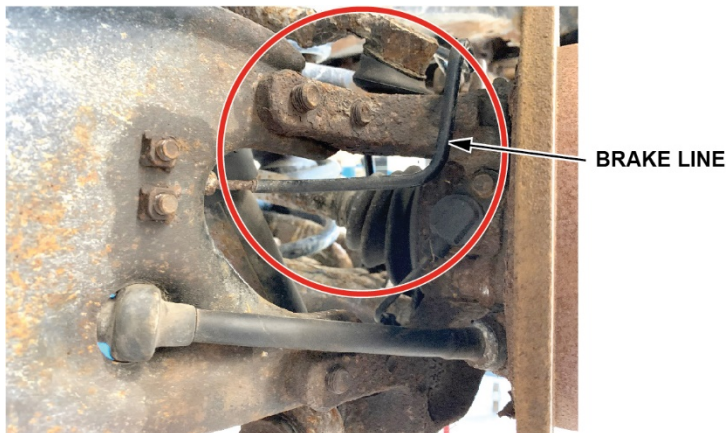
1. Remove the exhaust pipe and muffler, muffler heat shield, brake caliper/lines, rear shocks, rear subframe, and any other components surrounding the repair area. Before attempting to remove the subframe and to prevent the vehicle from tipping forward and becoming unstable, remove the rear lower control arms and coil springs. Refer to the service information.

NOTE: Do not disconnect the brake lines. Remove the caliper, caliper bracket, and brake line brackets from the control arm assembly. Guide the brake components through the hole in the trailing arm, as shown below, and hang them out of the way using zip/cable ties. Attempting to remove brake lines could damage them and require replacement.

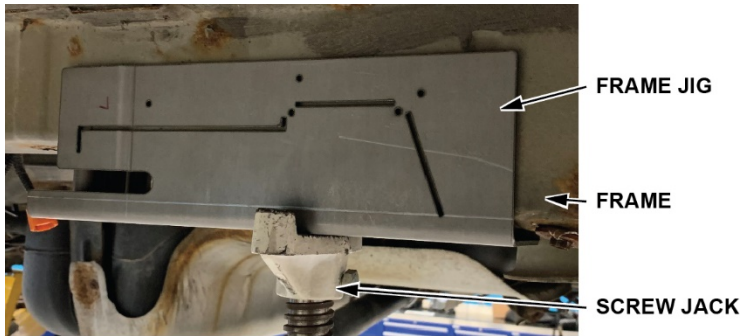
2. Fit the frame jig around the repair area. Use a screw jack to hold the frame jig against the frame.

NOTE: The frame jig works for both driver's and passenger's side of the vehicle (Passenger side shown).

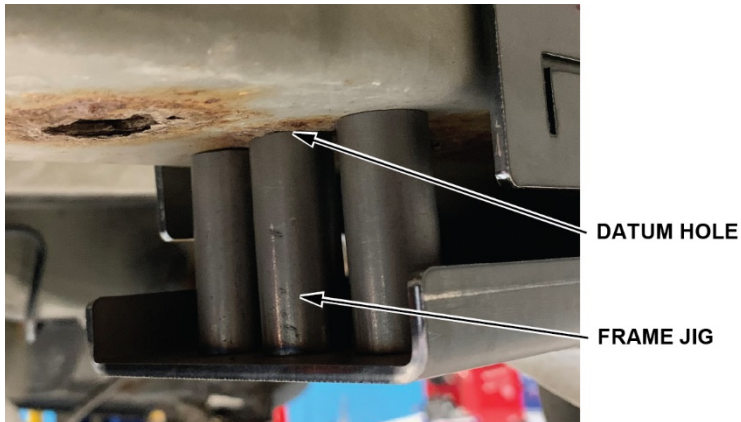
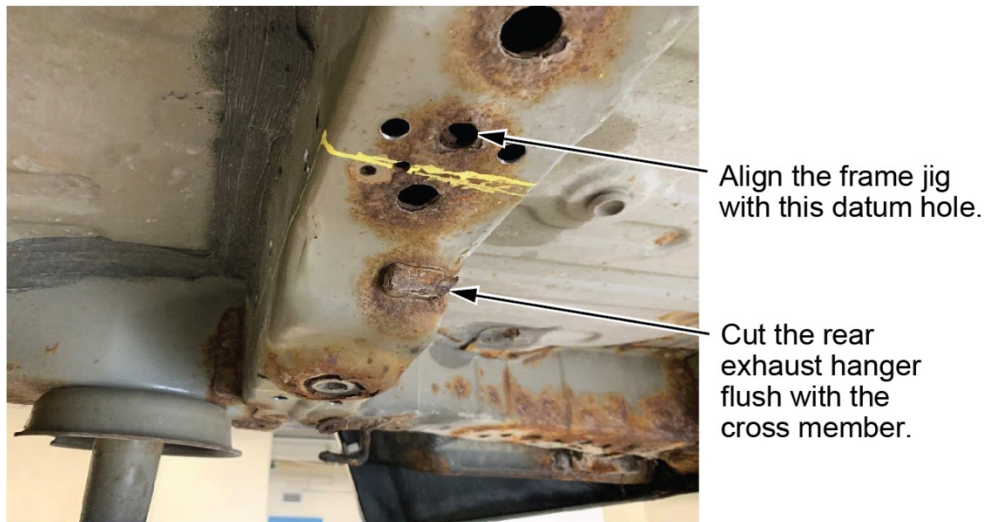
- Make sure the center frame jig fits into the frame datum hole as shown.
- The passenger's side repair will require cutting off the exhaust hanger to fit the frame jig.

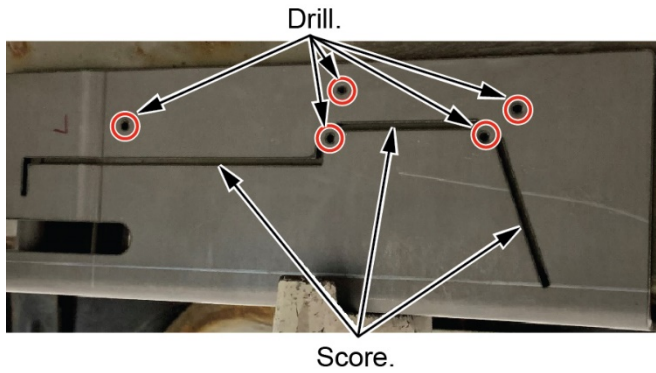
3. Drill out the five holes per side using 1/8" drill bit, then score the cut lines using a sharp tool.

NOTE: There are five holes on the front and back side of the jig that need to be drilled.

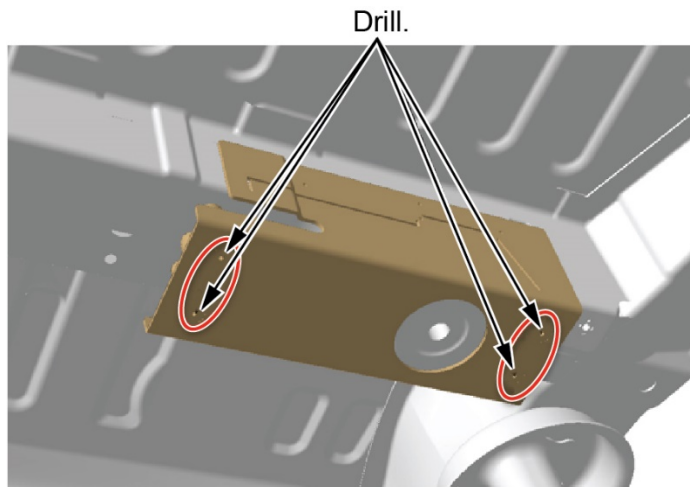
4. Drill the four mounting holes on the bottom side of frame rail using a 1/8" drill bit.

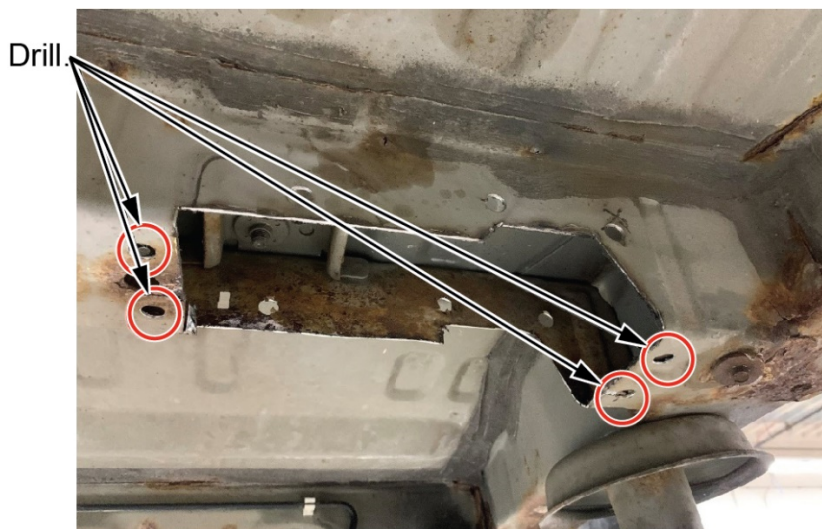
5. Remove the frame jig, then drill out all 1/8" holes using a 14 mm RotoBroach tool (P/N BLR11201SO).
6. Cut the frame along the scored cut lines using a cutoff wheel being careful not to cut into the frame insert mounting holes.

NOTE: Use a straight edge along the bottom side of the cross member to connect the front and back lines.

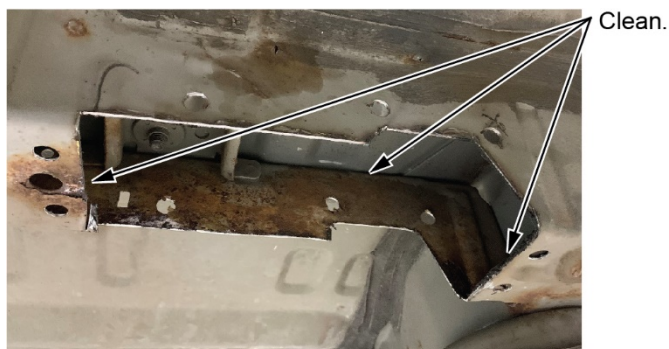
7. Using a brush and compressed air, clean the inside of the frame rail of loose rust, dirt, and metal shavings.

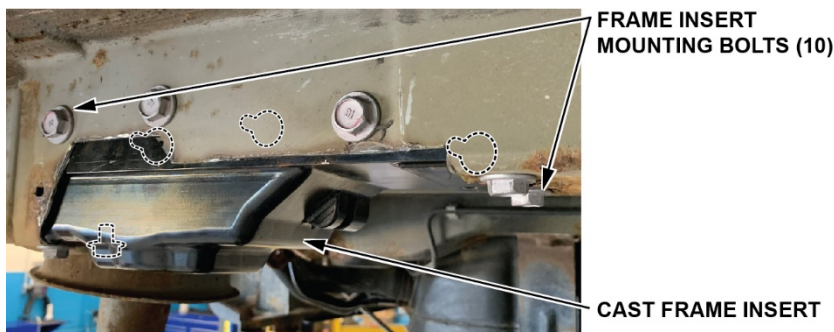
8. Install the cast frame insert and hand-tighten the frame insert mounting bolts in order, 2 inside the bottom, 2 outside the bottom, and the remaining 6 (total 10). When all 10 bolts have been set, torque the bolts to **38 N.m (28 lb-ft)**.

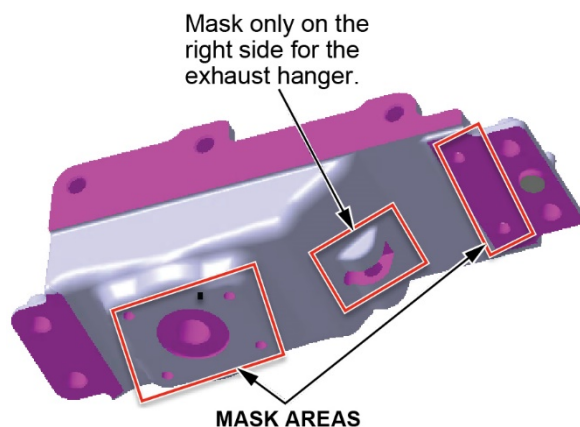
9. Now, masking off the frame insert in the area shown.

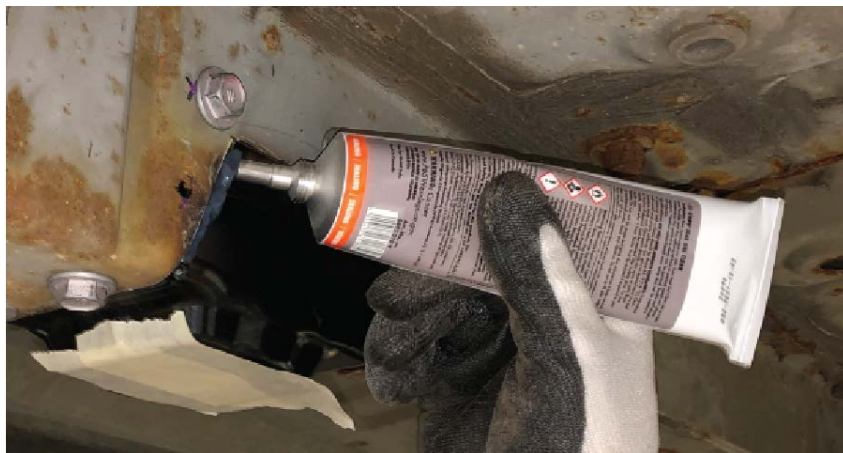
10. Apply body/seam sealer to the cut edge of the frame.

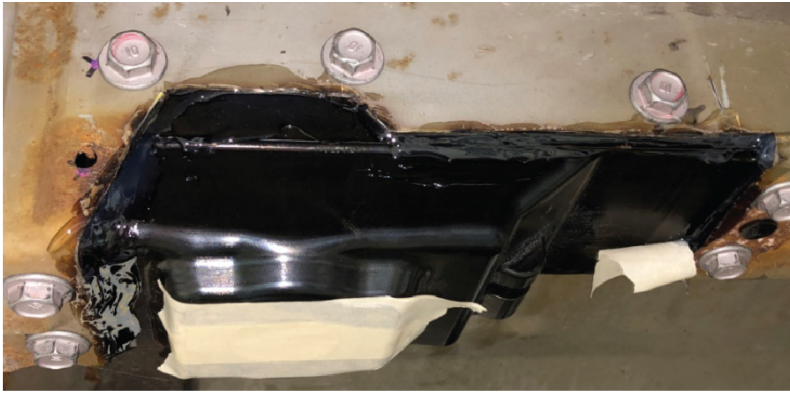
11. Spread sealant to cover the edges and fill the gap between the frame and insert as shown below.

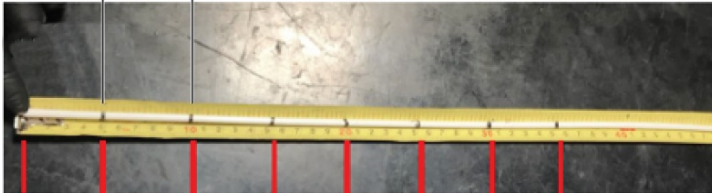
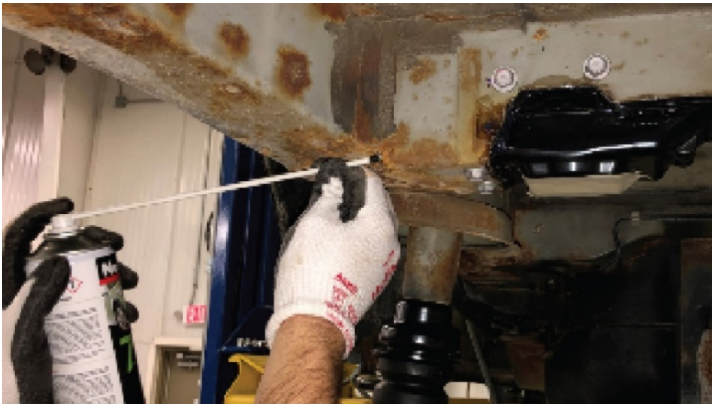
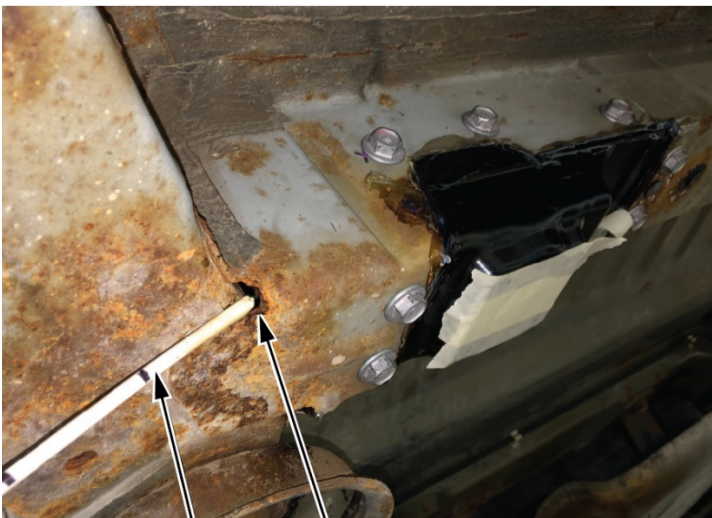
12. Apply cavity wax to the inside of both left and right sides of the crossmember.

NOTE: Mark the cavity wax nozzle every two inches from the end making seven marks for a total of 14 inches. Insert the straw all the way into the cavity to the last marking on the nozzle. Begin spraying at this mark, after five seconds, slide the straw out to the next marking and begin spraying. Repeat until you reach the last marking on the straw.

2" apart.

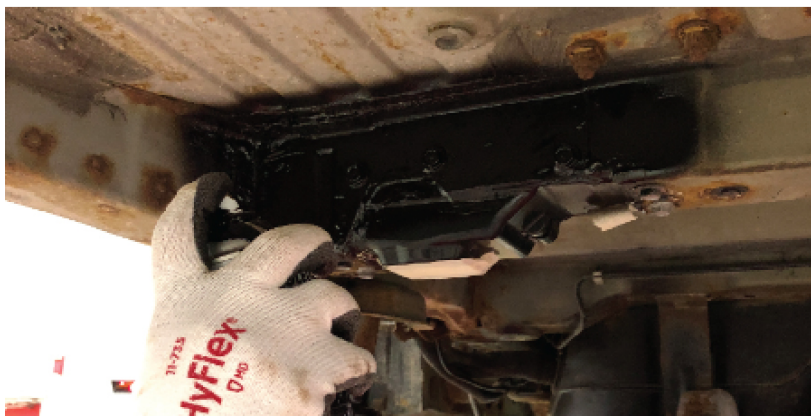
13. Apply the under-body coating to the frame edges.

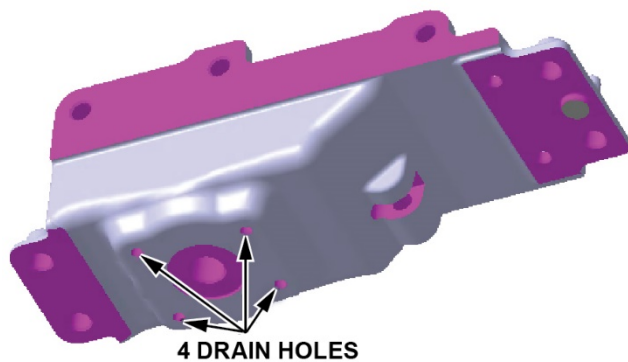
14. Remove the masking tape and clear the four drain holes in the frame insert of wax.

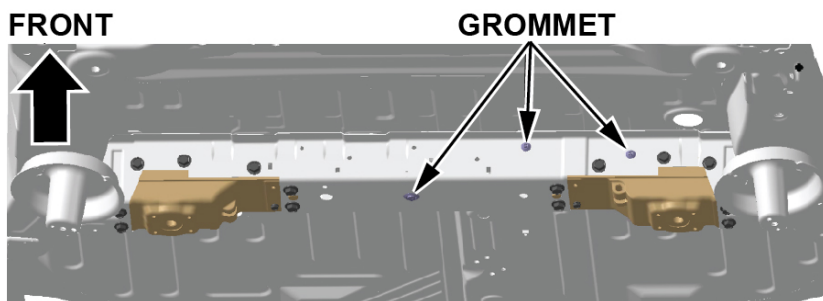
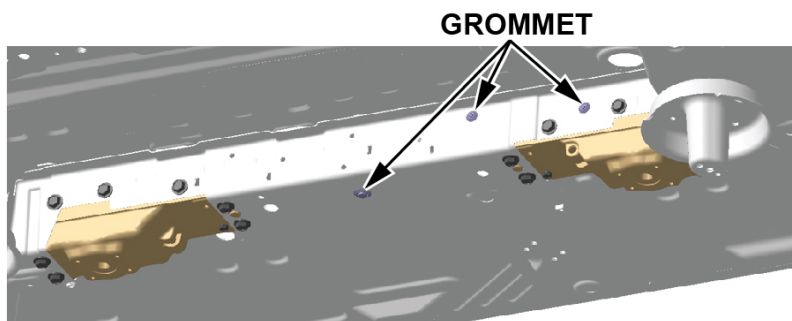
15. Install the five supplied grommets into the frame.

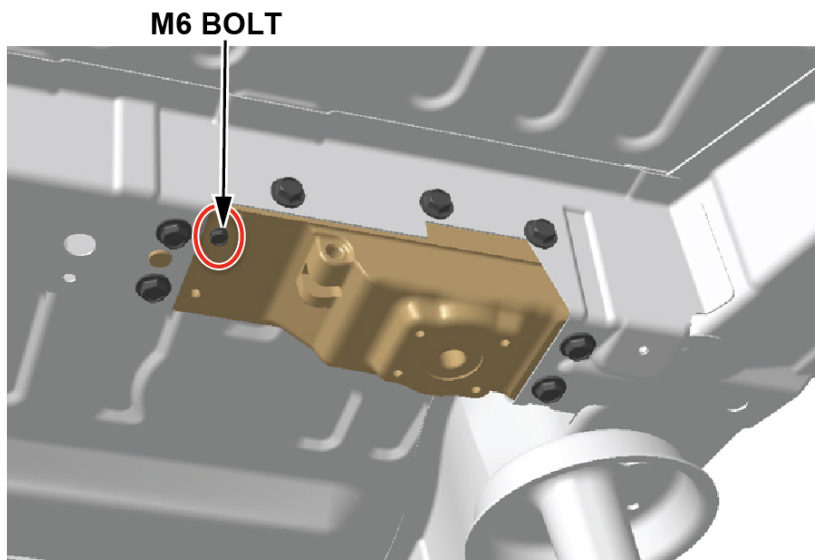
17. Install an M6 bolt to plug the unused hole where the ABS wire goes as shown (there are two M6 holes in the casting, but only one is used per side due to the left and right differences of the ABS harness).

NOTE: Passenger's side shown.

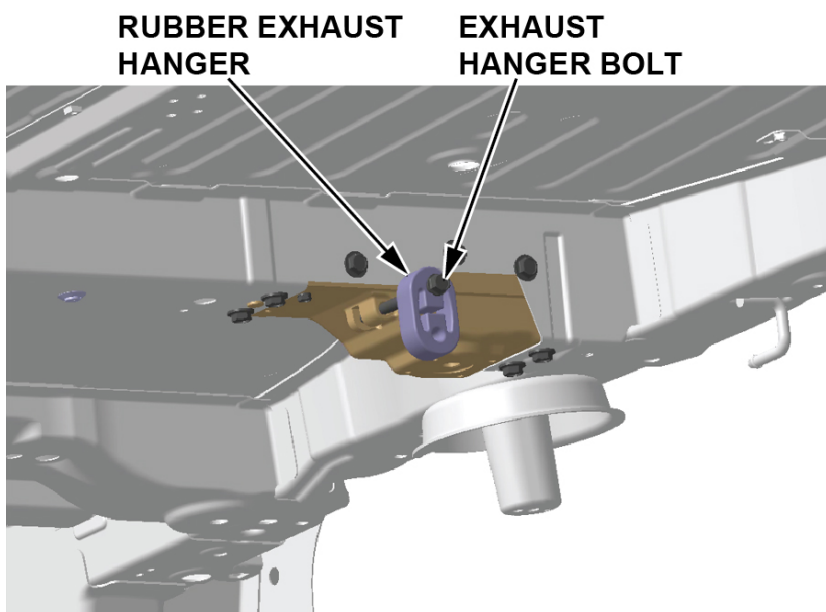
18. On the passenger's side casting, install the bolt thru the rubber exhaust hanger into casting and torque to **38 N.m (28 lb-ft)**.
