TECHNICAL SERVICE BULLETIN

Seat Pan Looseness, Lateral Movement, And/Or Clunk/Thump Noise On Turns

22-2101

Lincoln
2017-2020 Continental
2018-2022 Navigator

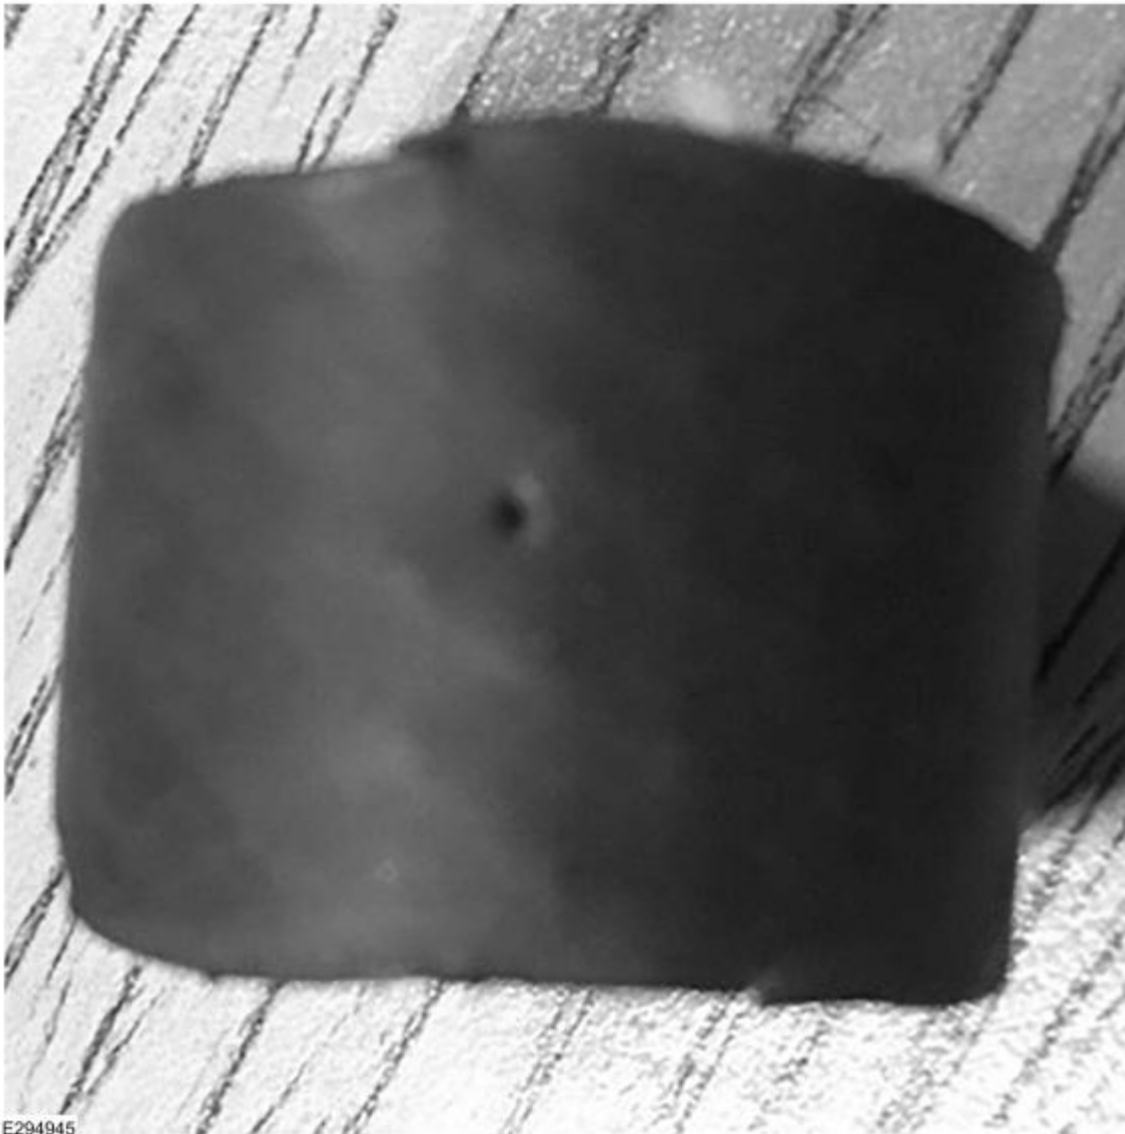
Figure 1

2. Remove the driver front seat module (DSM) and passenger front seat module (SCMB). Refer to Workshop Manual (WSM), Section 501-10A.
3. Remove the seat module mounting bracket.
4. Cut a 25.4 mm (1 in.) long piece of 19 mm (3/4 in.) diameter heater hose. (Figure 1)

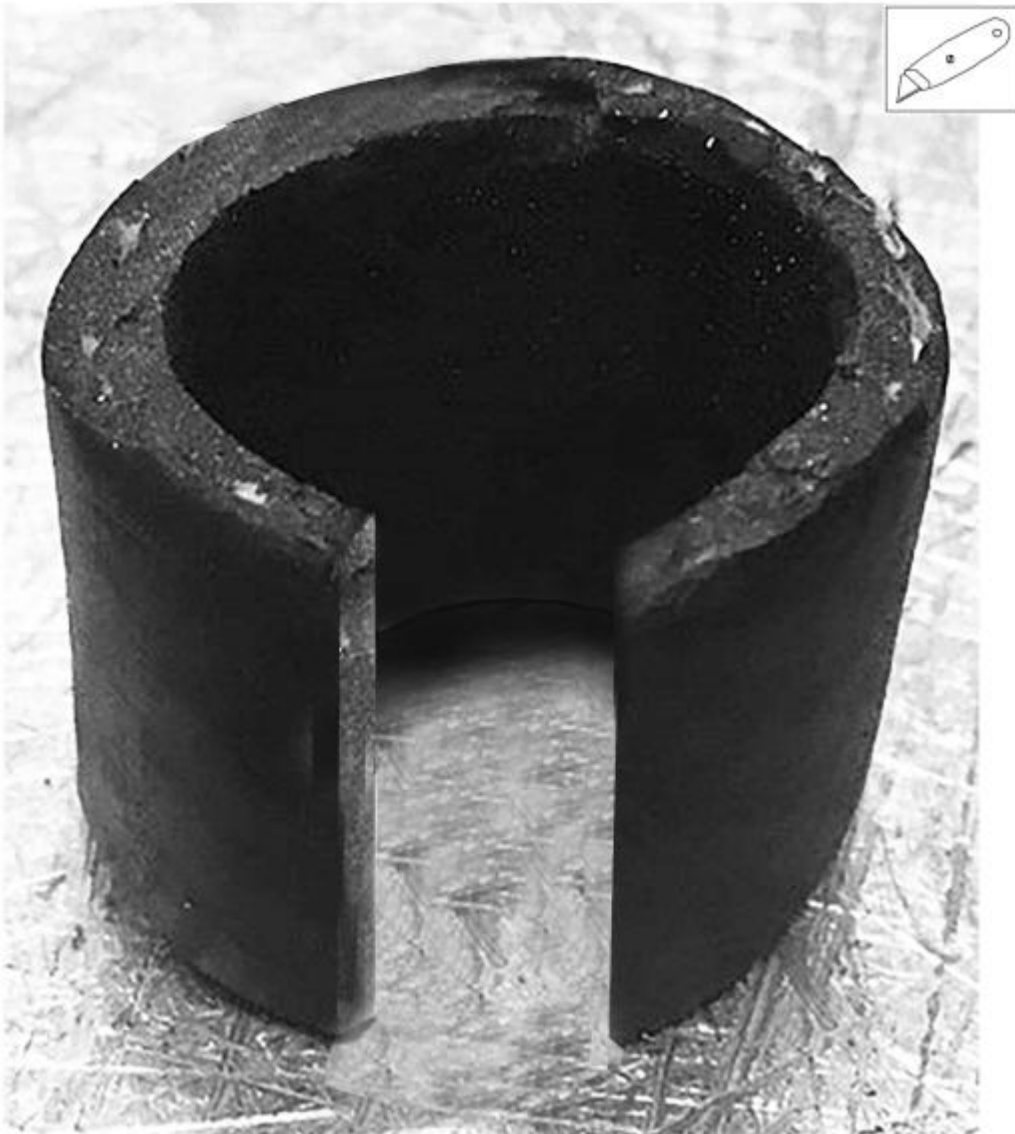
Figure 2

5. Cut a slit in the 25.4 mm (1 in.) piece. (Figure 2)

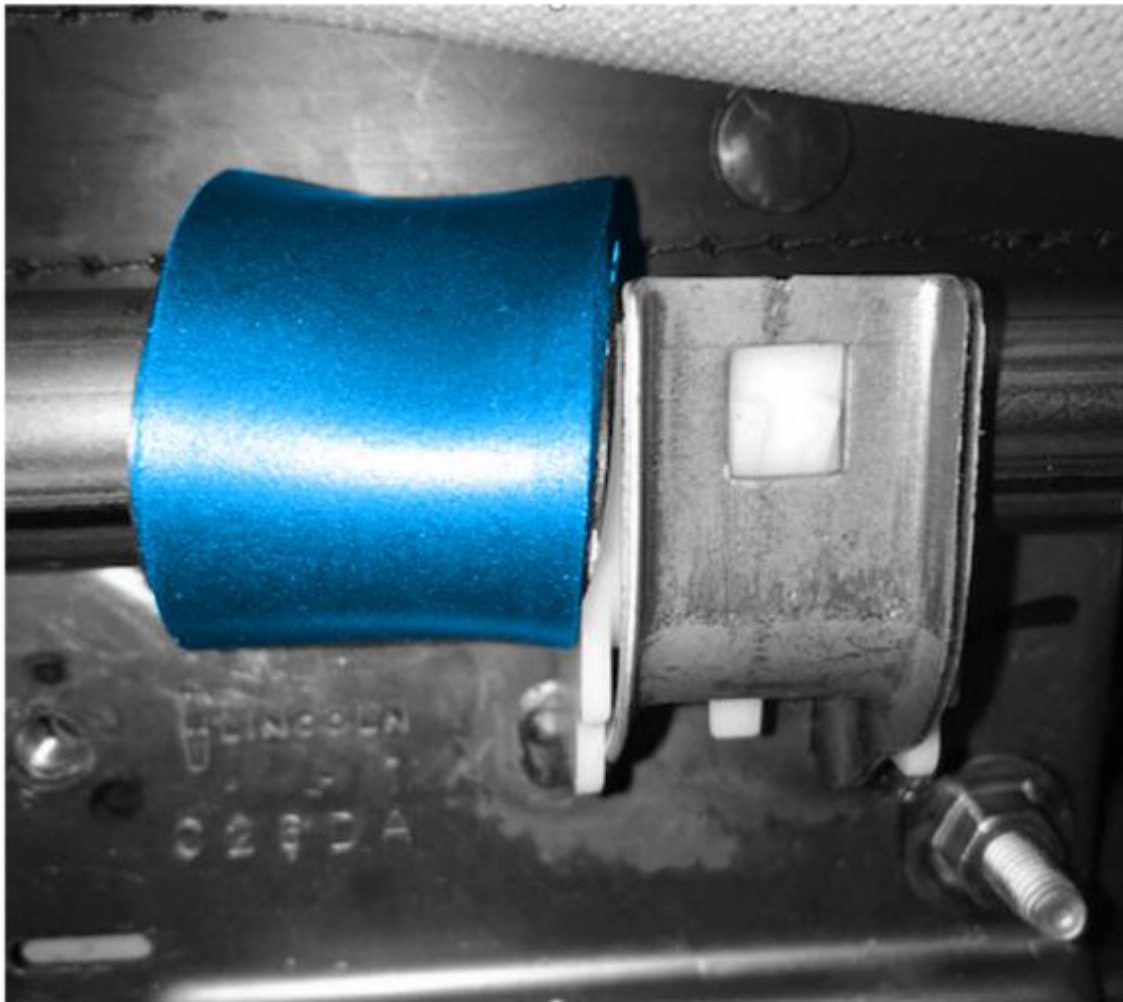
Figure 3

6. Install the hose over the front cross tube. (Figure 3)

7. Open the hose clamp and slip the hose clamp over the heater hose, securing the heater hose to the front cross tube.

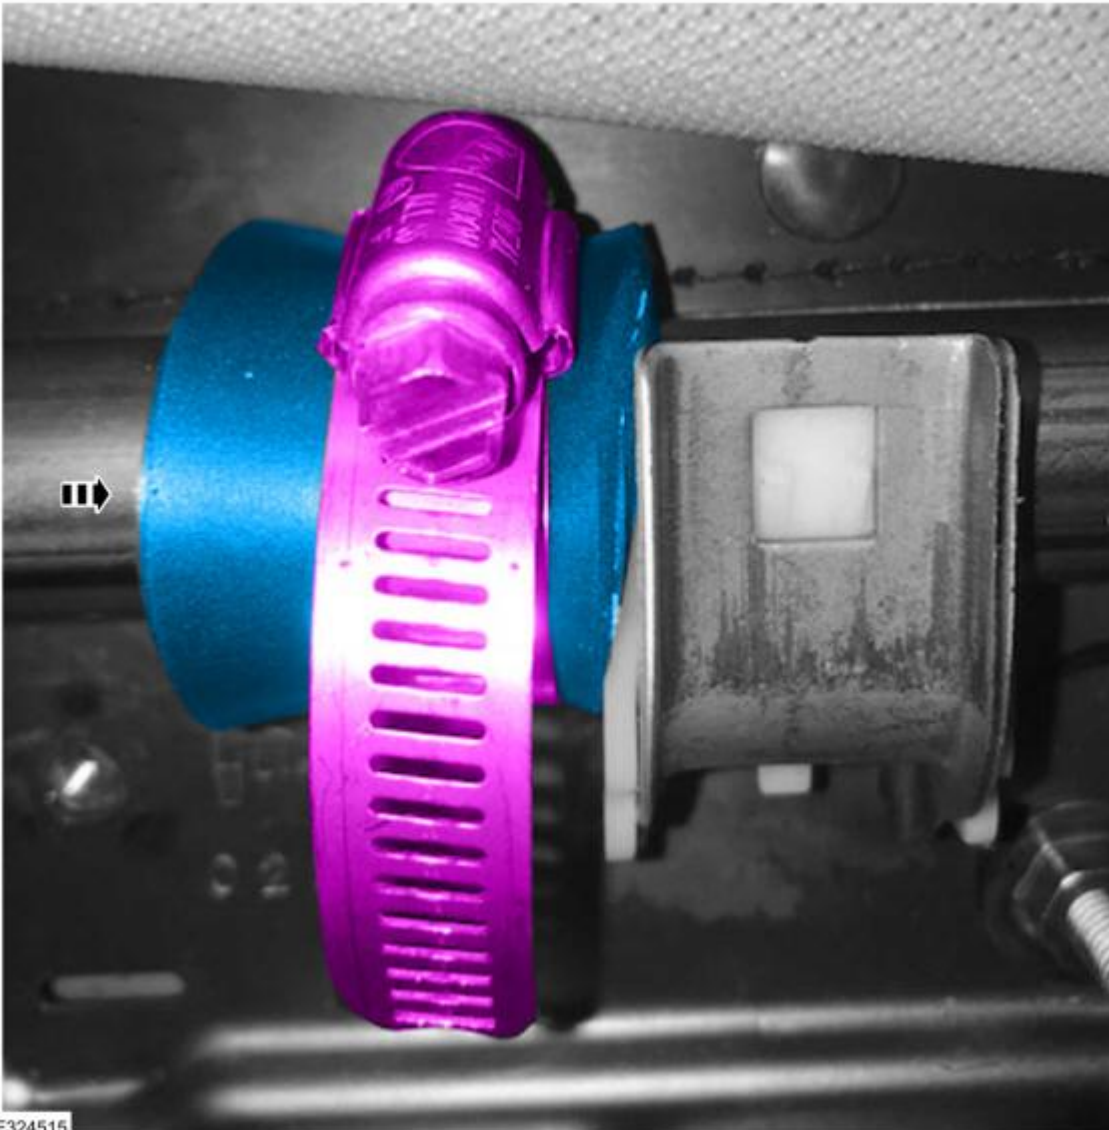
Figure 4

8. Push the heater hose against the cushion hook and tighten the hose clamp to 3.7 Nm (33 lb-in). (Figure 4)

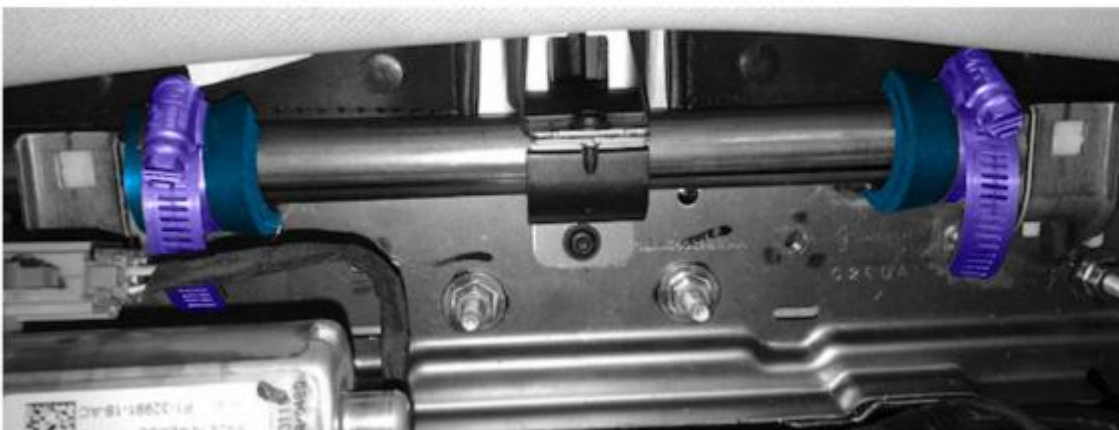
Figure 5

9. Repeat Steps 4 through 8 on the other side of the seat track. (Figure 5)
