TECHNICAL SERVICE BULLETIN

Technical Service Bulletin: 225-1471

TECHNICAL SERVICE BULLETIN 225-1471 REMEDY INSTRUCTIONS

DESCRIPTION:	MERCEDES SPRINTER BIKE RACK SUPPORT BRACKET KIT
APPLICATION:	2019 AND NEWER MERCEDES SPRINTER
PART NUMBER:	108079_A

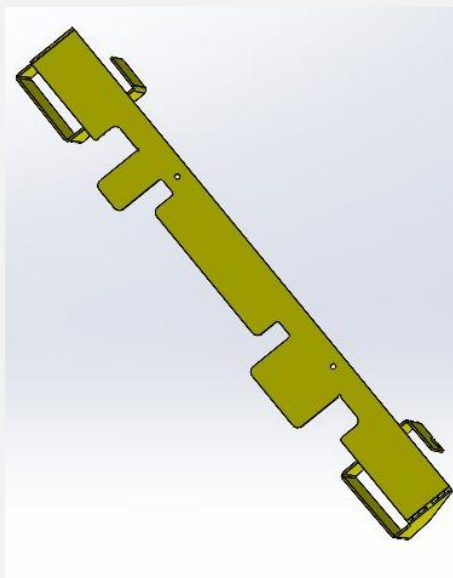
INTERIOR DOOR SUPPORT

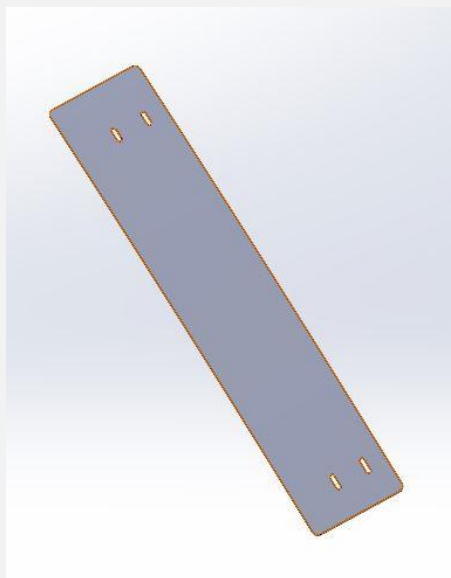
EXTERIOR DOOR SUPPORT

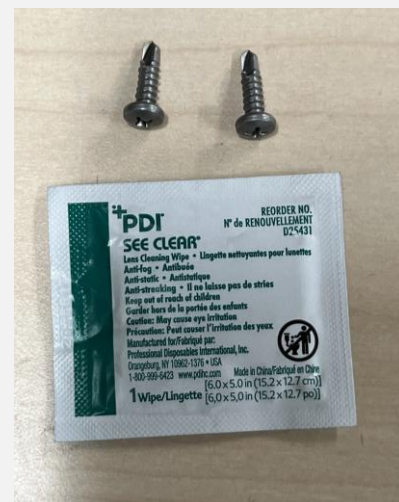
(2) #8 SELF TAPPING SCREWS AND ALCOHOL CLEANING PAD
