Technical Service Bulletin

40 Shock absorber leaks: assessment aid

40 22 34 2018194/10 March 15, 2022. Supersedes Technical Service Bulletin Group 40 number 19-97 dated October 7, 2019, for reasons listed below.

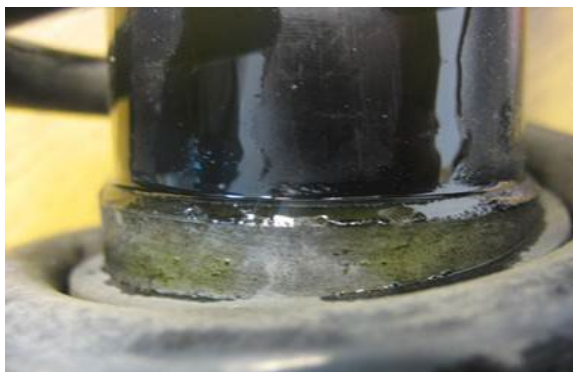
A leaking shock absorber is characterized by a wet film of oil running down the pipe (Figure 1 and Figure 2).

Figure 1. A leaking shock absorber.

Leaking shock absorbers need to be replaced.

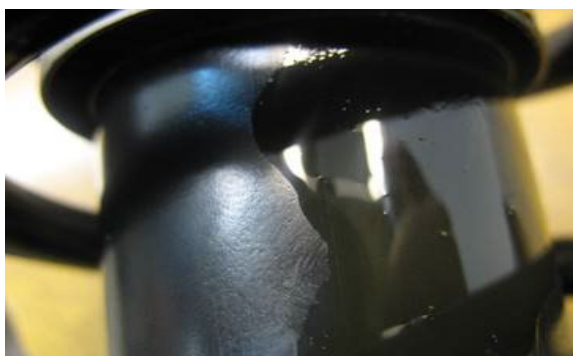
Figure 2. A leaking shock absorber.

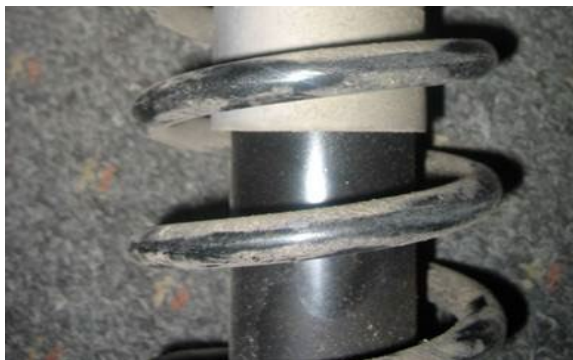
A light film of dried oil or oil marks on the pipe beneath the dust guard is not a clear indicator of a leaking shock. These marks are a result of residue from when the shock was filled during production, or of slight condensation in the seal area. This small amount of oil is for lubrication and it reduces wear on the seal (Figure 3 and Figure 4).

Figure 3. A shock absorber that is not leaking.

This condition does not affect the shock absorber. No repair is necessary.

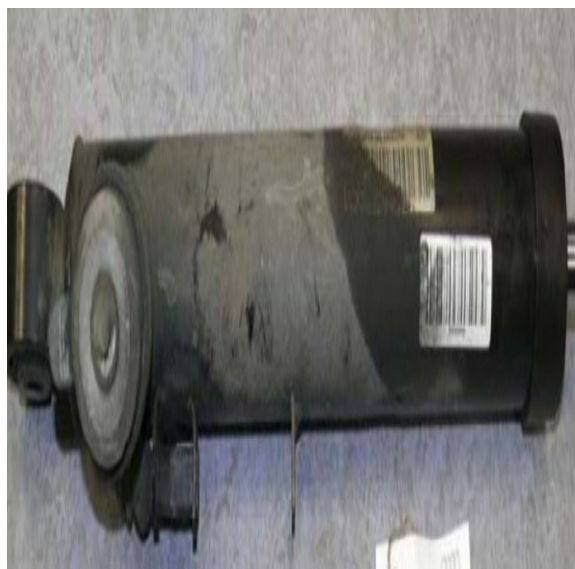
Figure 4. A shock absorber that is not leaking.
