Technical Service Bulletin

57 Corrosion traces on door hinges

57 22 90 2066621/1 March 23, 2022.

Model(s)	Year	VIN Range	Vehicle-Specific Equipment
e-tron GT, and RS e- tron GT	2022 – 2023	All	Not Applicable

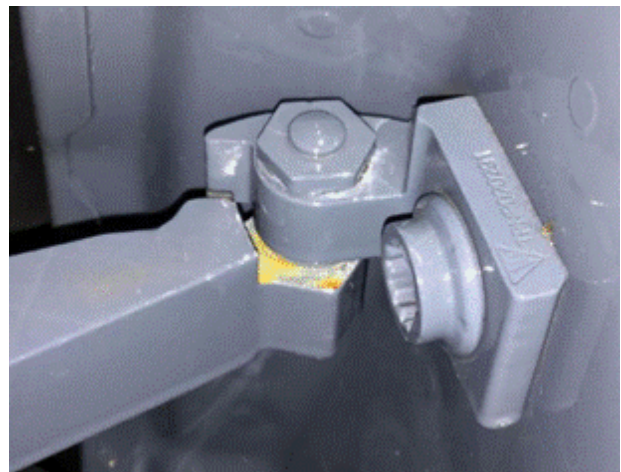
Visible traces of corrosion can be seen on the front and/or rear door hinge components.

An insufficient amount of corrosion protection may have been applied to the door hinge components in production.

Figure 1. Visible signs of corrosion on the door hinge.

The production process has been improved to ensure that adequate corrosion protection is applied during door assembly.

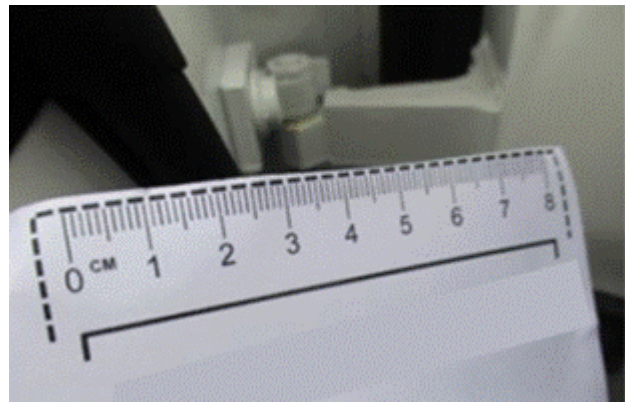
Figure 2. Photo documentation.

1. Should the vehicle present with visible corrosion traces on the door hinge components as described in this TSB, please take photos clearly depicting the condition. These photos should be taken at a distance suitable for determining the scale and location of the issue. Upload these to Doctl.

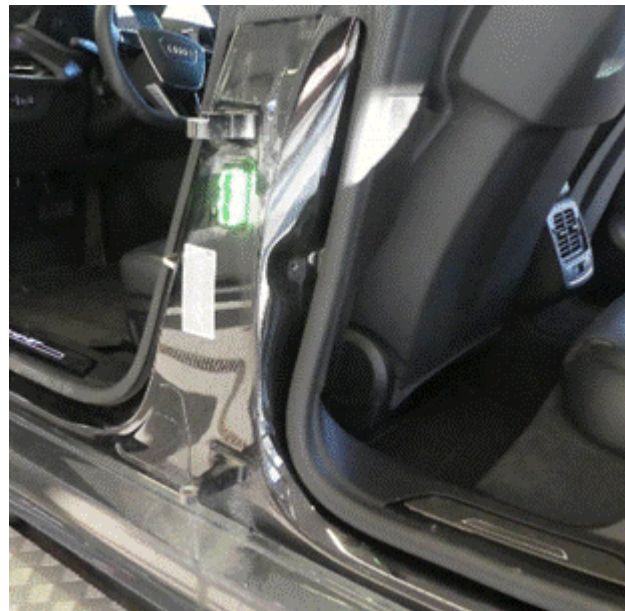
Figure 3. The rear door removed from the vehicle.

2. Remove the affected door using the procedure in the repair manual.

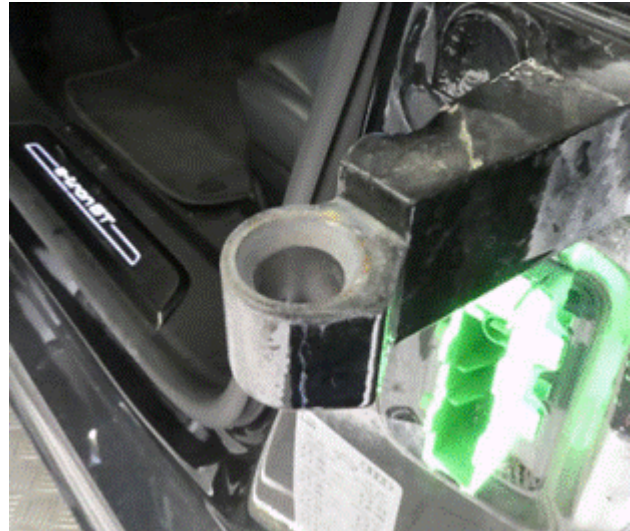
3. Figure 4 shows a close-up view of the door hinge body.

Figure 4. Upper door hinge body.

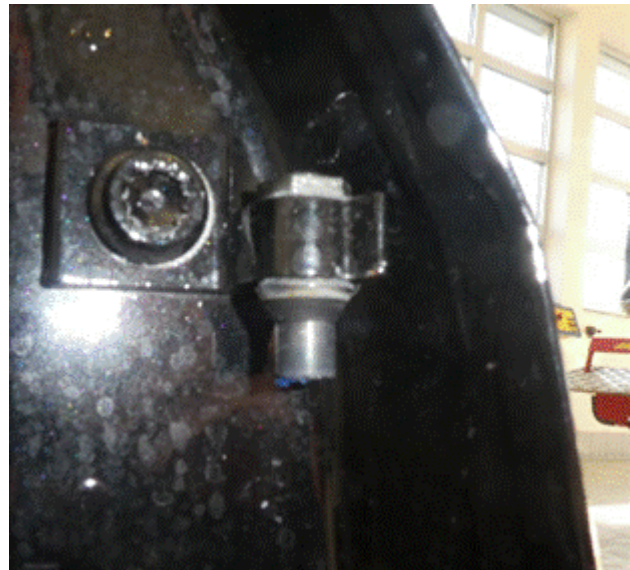
4. Figure 5 shows the door hinge pin on a removed door.

Figure 5. Door hinge pin on door.

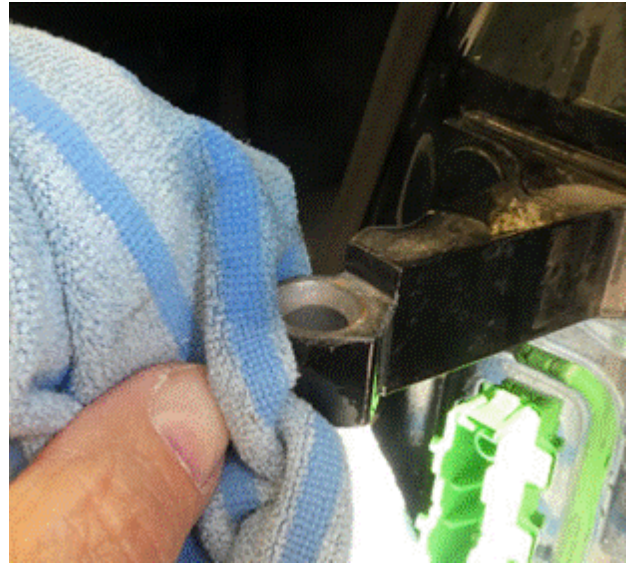
Figure 6. Cleaning the hinge body.

5. Clean the hinge body with all-purpose cleaner D 00940104 or equivalent cleaner that will not affect the painted surface such as isopropanol alcohol.

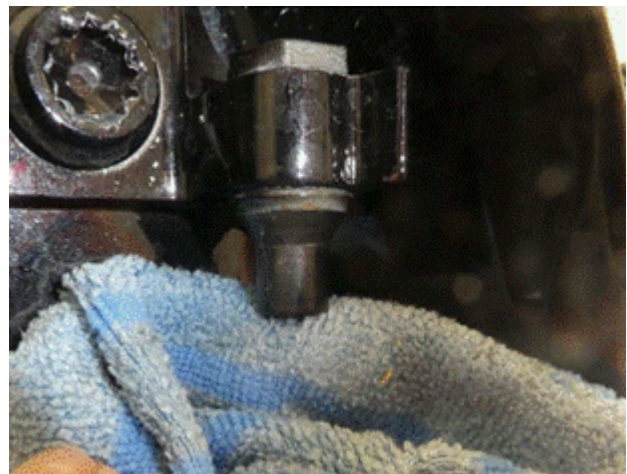
Figure 7. Cleaning the hinge pin.

6. Also, clean the hinge pin with all-purpose cleaner D 00940104 or equivalent cleaner that will not affect the painted surface such as isopropanol alcohol.

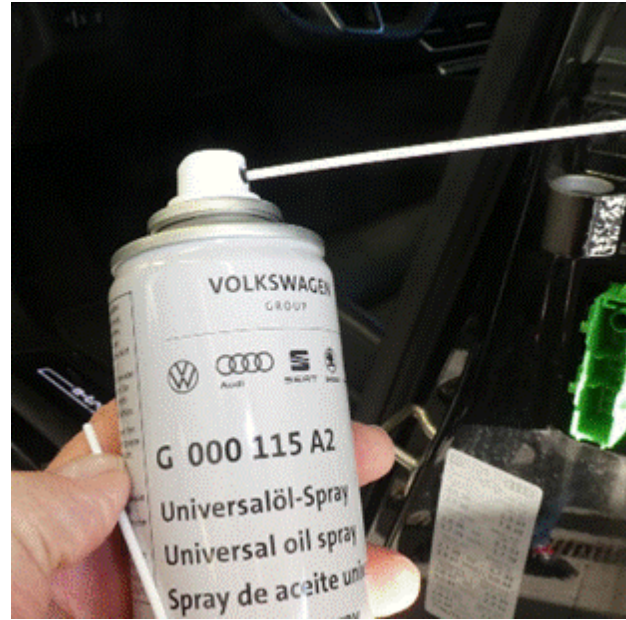
Figure 8. Universal oil G 000115A2.

7. Coat both hinge bodies and the hinge pins with universal oil G 000115A2.

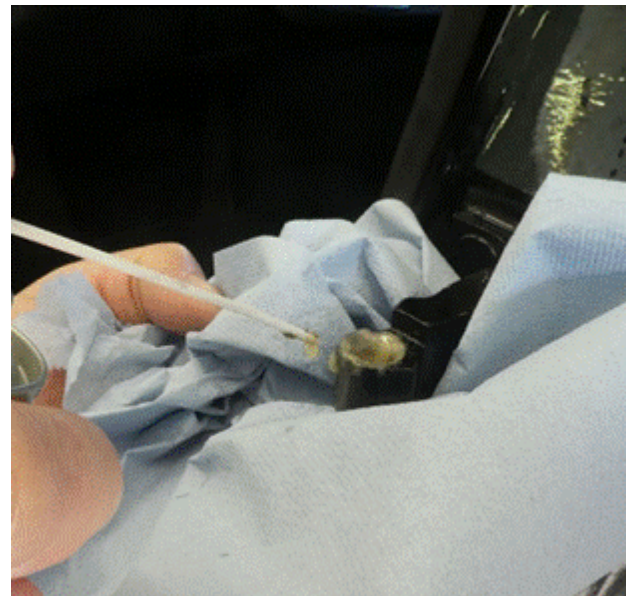
Figure 9. Applying universal oil to hinge body.

8. Figure 9 shows universal oil application to the hinge body. Protect the surrounding area from overspray using a cloth towel.

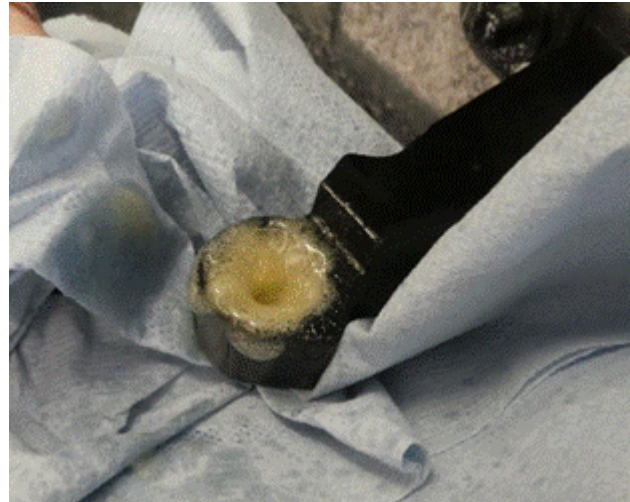
Figure 10. Hinge body with universal oil applied.

9. Ensure a thorough coating into the barrel of the hinge bodies as shown in figure 10.

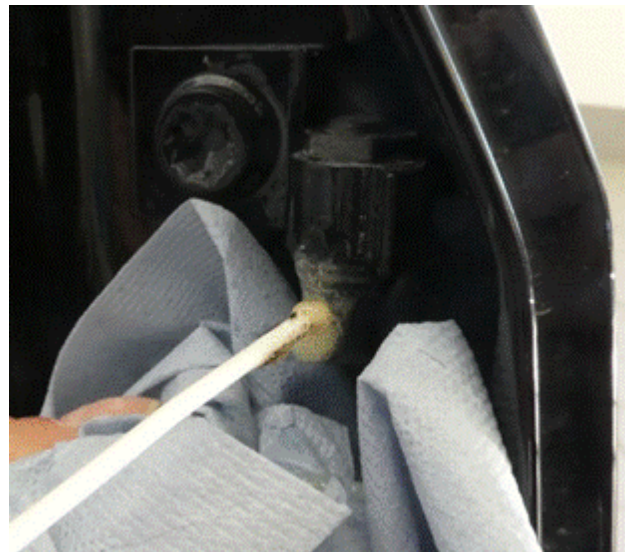
Figure 11. Hinge pin with universal oil applied.

10. Also coat both hinge pins on the door as shown in figure 11. Again, protect the surrounding area from overspray using a cloth towel.

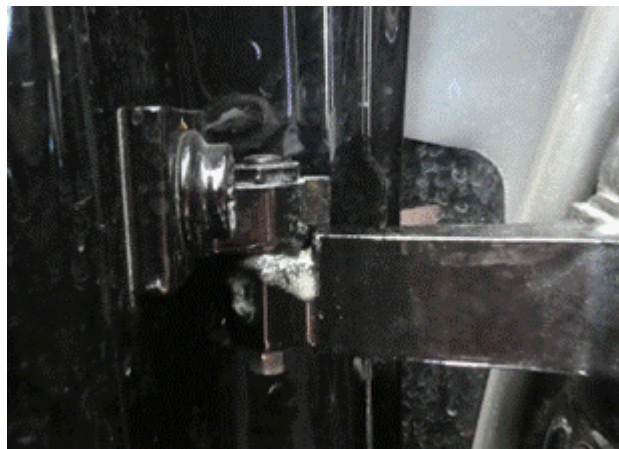
Figure 12. Universal oil on the assembled hinge.

11. Reinstall the door being serviced. The universal oil must remain on the hinge when assembled. A small amount will be visible.
