# TECHNICAL SERVICE BULLETIN

Technical Service Bulletin: 504-1470

Forest River is alerting you to an issue involving certain 2021 and 2022 Entrada Class C Motorhome recreational vehicles. Please see the information below which describes the issue and provides you with details on the steps you should take to have your vehicle repaired.

## TECHNICAL SERVICE BULLETIN 504-1470 REMEDY INSTRUCTIONS

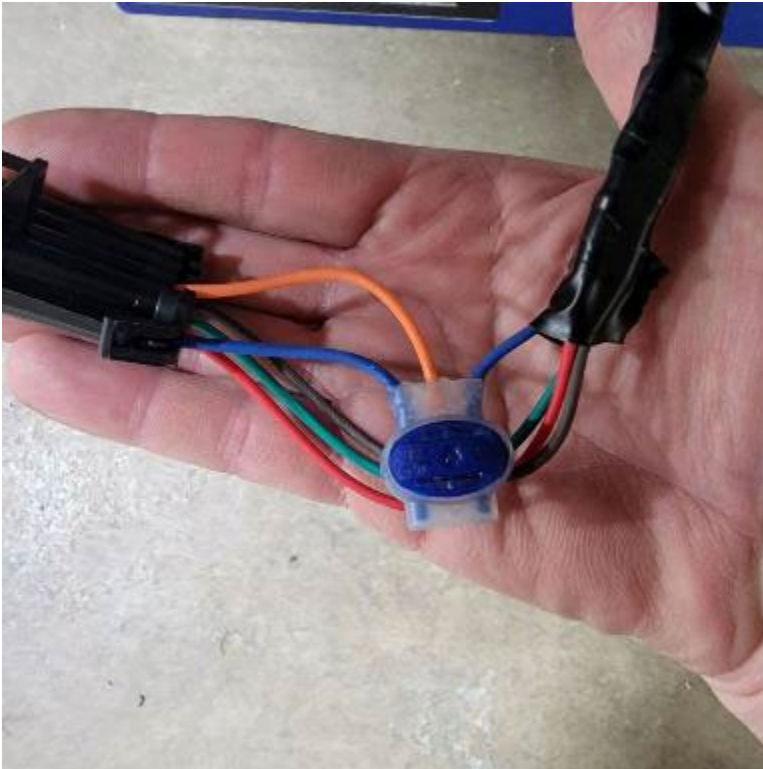
FIGURE 1

STEP 3: SPLICE THE ORANGE WIRE INTO THE BLUE WIRE AND SHOWN IN FIGURE 1. ENSURE TO USE A WATER PROOF CONNECTOR;

STEP 1: OPEN AND ACCESS THE WIRING HARDNESS INSIDE THE GENERATOR COMPARTMENT;

STEP 2: LOCATE THE ORANGE WIRE THIS ORANGE WIRE IS LIKELY CAPPED;
