Thor Motor Coach Technical Service Bulletin

TSB #	TSB 22-03		
Description/Title:	Axis & Vegas emergency starting issue.		
Affected Product Line(s):	Certain model year 2022 Axis & Vegas motorhomes		
Service Campaign # :	RC000260	Released Date:	3/28/2022
Codes:	Inspect Only: TMCTS80274Y Inspect with Repair: TMCTS80274W	Document Date:	3/28/2022
Time Allowed:	Inspect Only: 0.1 Inspect with Repair: 0.2	Document Revision:	A

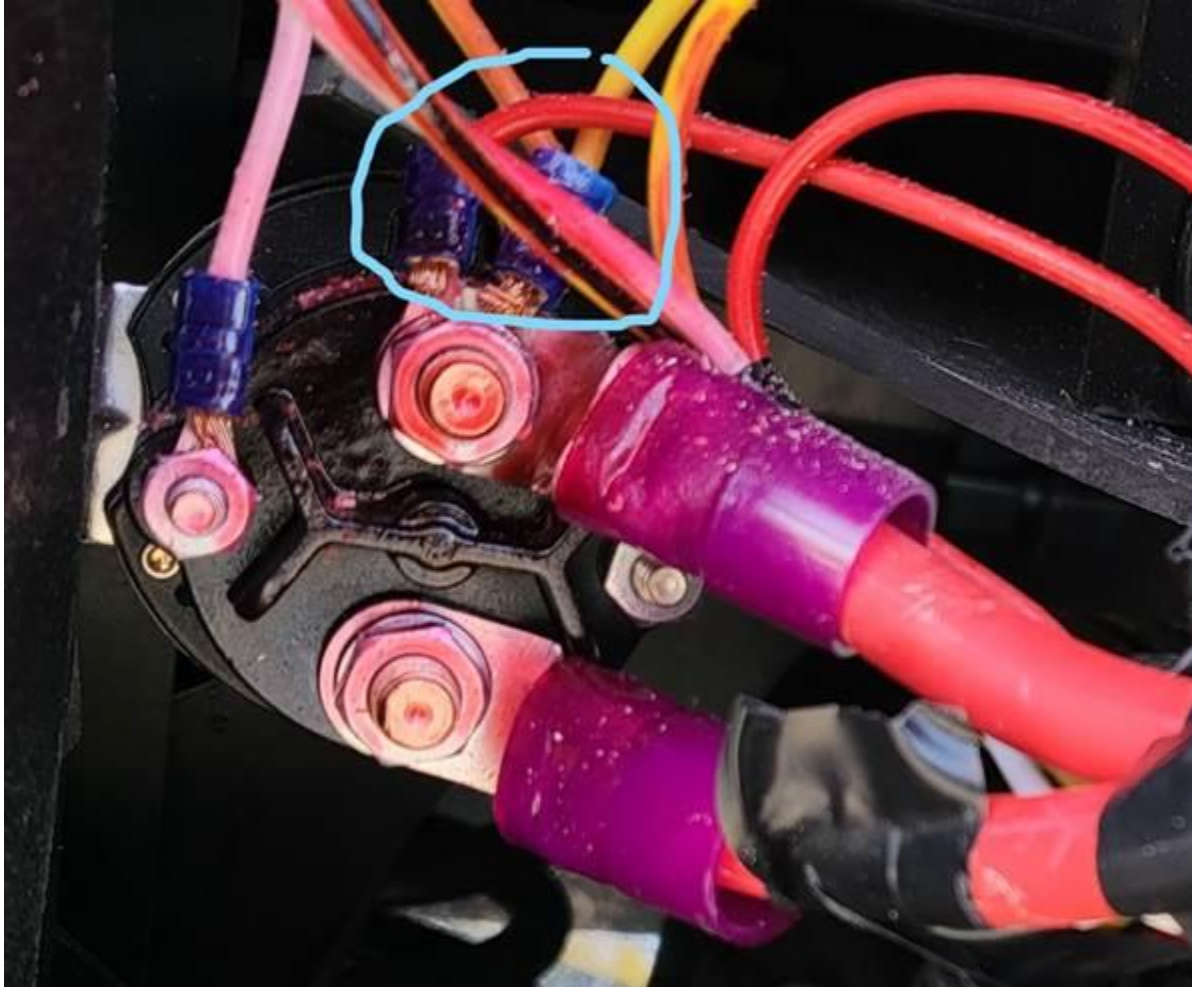
Axis & Vegas emergency start harness issue. The two inline fuses are on the post with the chassis battery cable and they should be with the coach battery cable.

2. In the picture below, you can see the two 2 gauge cables, one going to the coach battery and one going to the chassis battery. The two inline holders should be connected to the post with the coach battery cable. The easiest way to check is to disconnect the coach battery cable at the battery itself and then use a test light to see which of these two posts is dead. The dead post is the

coach post, and the fuses should be connected there. An alternative would be to see if the dash radio still turns on when the coach battery is disconnected. If it does they're on the wrong post.
