Service Bulletin

Bulletin No.: 21-NA-264

Subject: Liftgate Actuator Showing a Leaking Residue on Strut

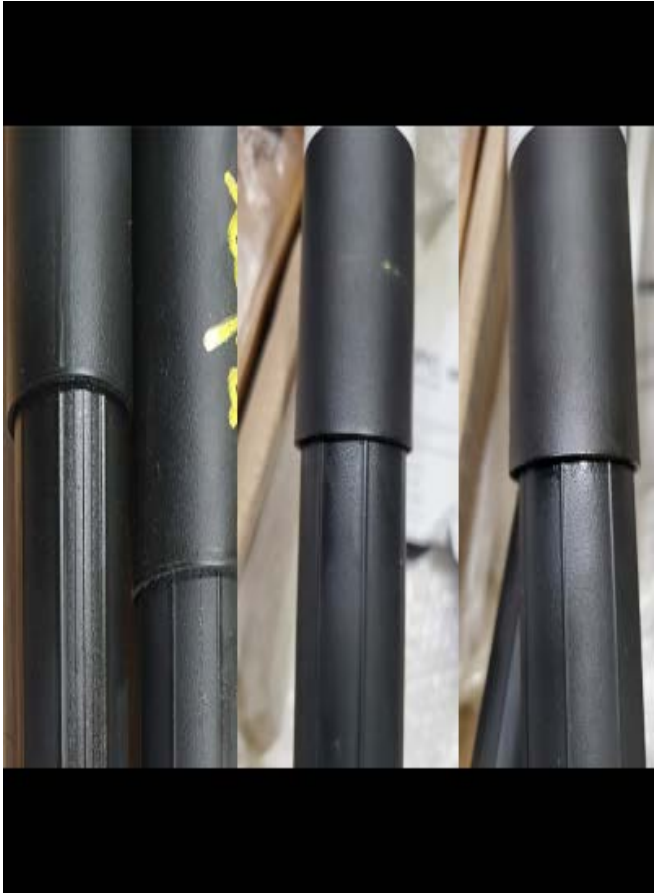
| | 5924501 |

| | Some customers may comment on seeing a leak, or residue on the rear liftgate strut. |

| <p>Cause</p> | <p>The cause of the condition may be a specific issue in which typically extra padded grease is used for the boot, to reduce noise from movement. This in some cases can be confused with a leak from a type of hydraulic fluid that assists with the pressure of the actuator. This is not the case. The struts do not contain any fluid for its mechanical functionality. There are no concerns with the part functionality from this residue of grease. This is extra grease that has found its way out from added pressure on the boot.</p> |
