## Odometer Flashing – B-Pillar Wiring

| <b>Bulletin #(s):</b> | 22-049 | <b>Make(s):</b> | Jayco & Entegra Coach |

| <b>Incident:</b> | Radio Harness Issue causing the Odometer to flash |

## INSTRUCTIONS FOR REPAIRING B-PILLAR WIRING

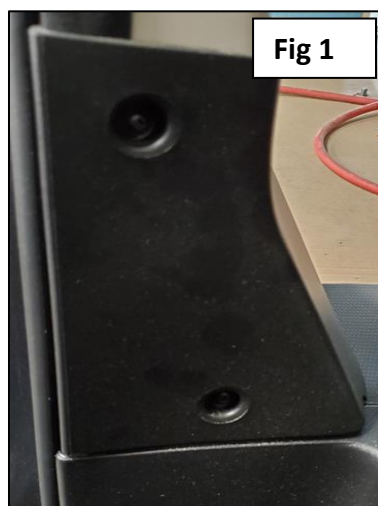
1. Remove fasteners with the Philips bit from the front door side of passenger B-Pillar Lower left Shroud (Fig. 1).
2. Pull the wiring out to verify (Fig. 2 – **Incorrect Wiring**). Wiring **Should Be:**
  - A. Green (LP/CO Detector) to Green
  - B. Purple (Chassis Ignition) to Red
  - C. Red-White (House Fuse Panel) to Red

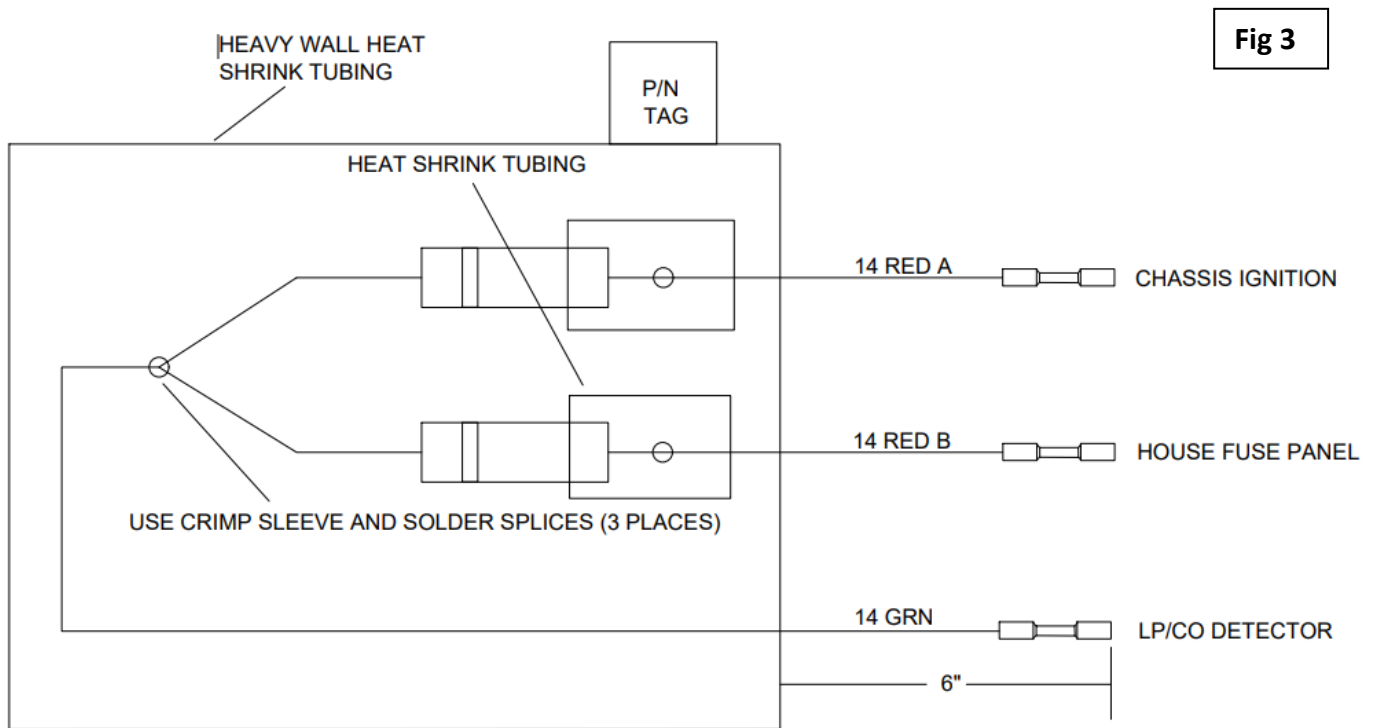
3. Please refer to Figure 3 for how the diode dual harness should be connected.
