CR 226 – Multistrada V4 Updates

Multistrada V4 S/STD MY 2021-2022
(all versions, excluding Pikes Peak)
Technical Service Bulletin SRV-TSB-22-002

Technical Service Bulletin SRV-TSB-22-002

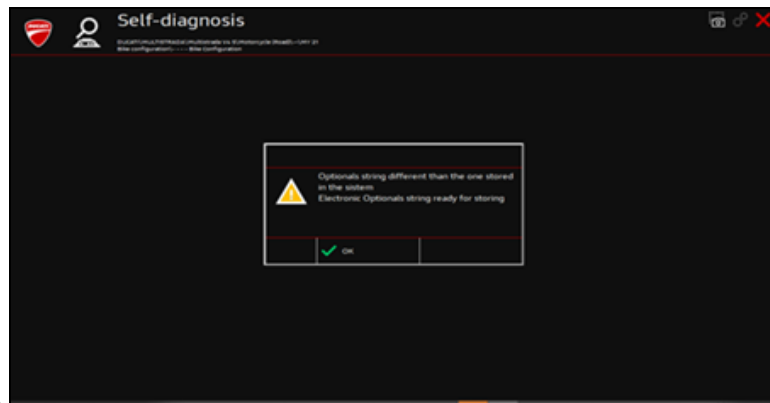
Image A

If the warning (**Image A**) pops up, check whether the accessories shown (**Image B**) are present and activated on the motorcycle being inspected.

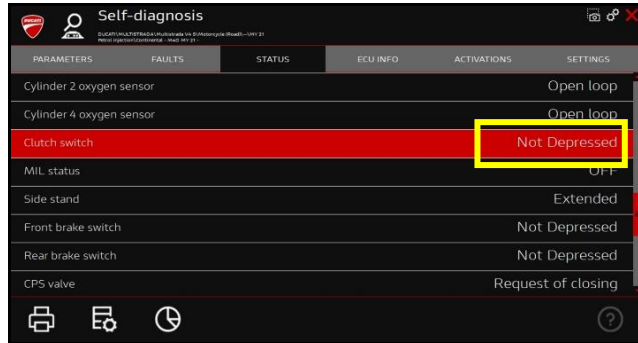
2. Select the **Status** section then select **Clutch Switch** parameter
3. Make sure that the status at rest is **Not pressed**

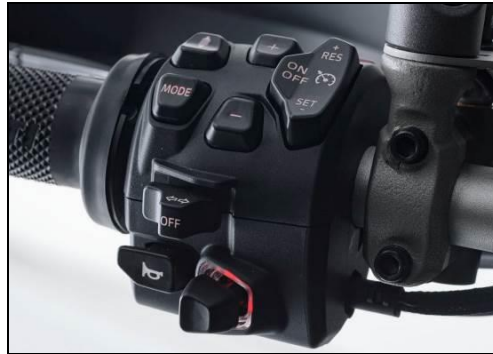
1. Visually check the backlighting of the left-hand switch

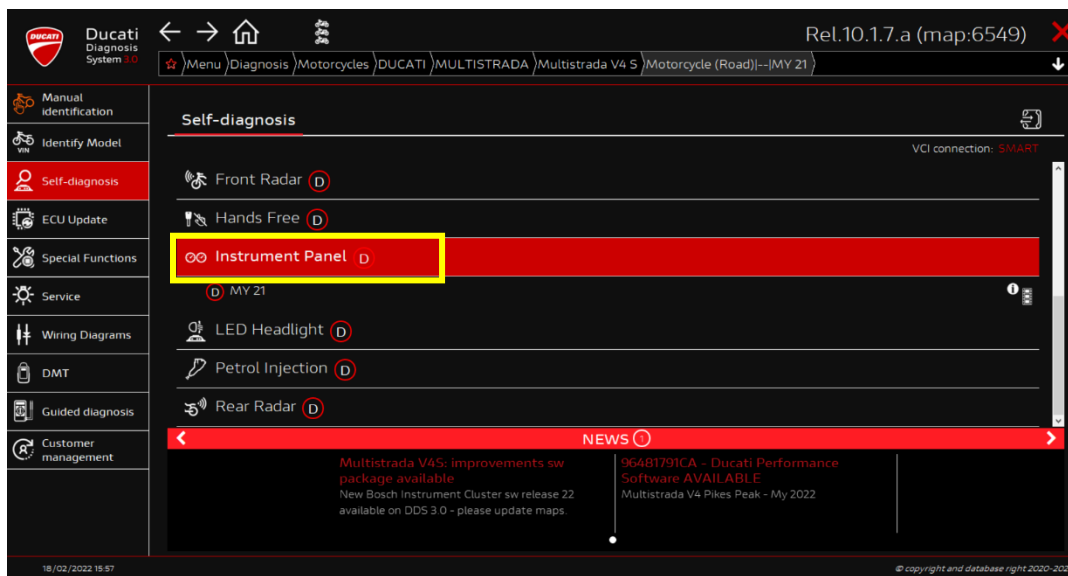
2. With DDS 3.0, open **Self-diagnosis** and select the **Instrument panel** control unit

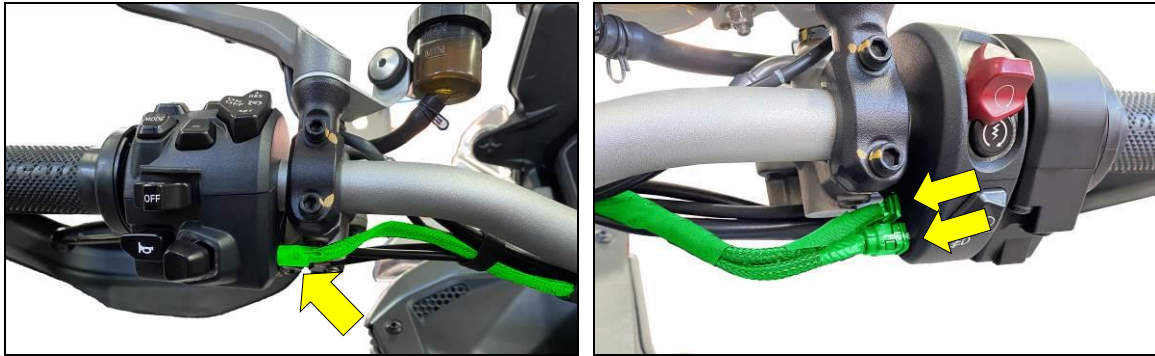
1. Check that the connectors are correctly connected and fully inserted

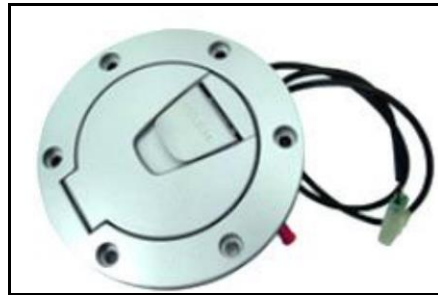
1. If present, check that the electric cap works correctly, remembering that to open the cap it is necessary to lift the appropriate lever within 50 seconds of turning the motorcycle off (key-off) a maximum of 5 times.

The opening flap must be operated gently. Excessively fast movements may impair the cap opening, even though the attempt will still be counted among the 5 available

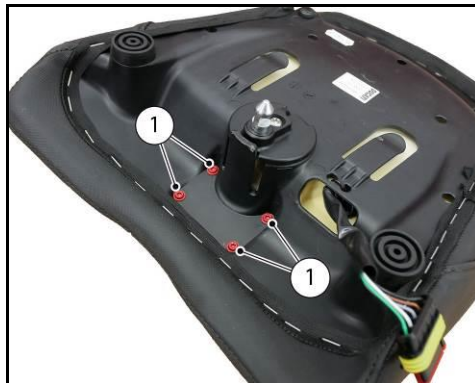
1. Remove the passenger seat (see Sec.5: "Fairing installation – Seat" of the Workshop Manual).
2. Remove the **4 self-tapping screws M3.5x10 (1)** located at the bottom of the passenger seat and slide out the **cover-switch-push-button assembly (2)** from the passenger seat

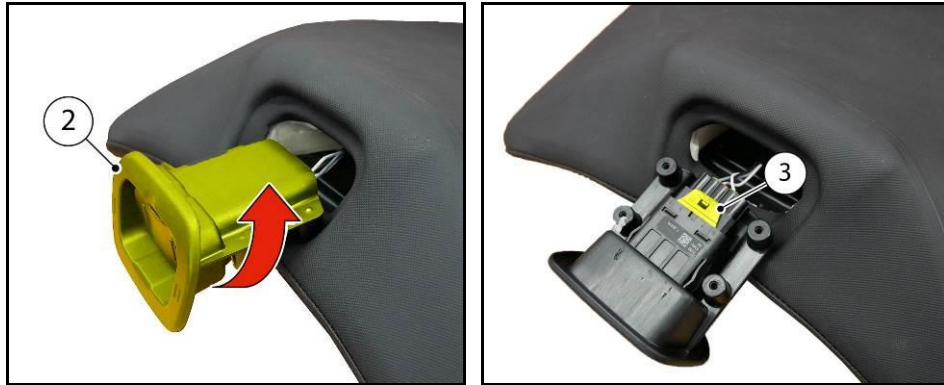
3. Turn the **cover-switch-push-button assembly (2)** over and check the connection between connector and switch, then ensure that **tab (3)** is properly engage

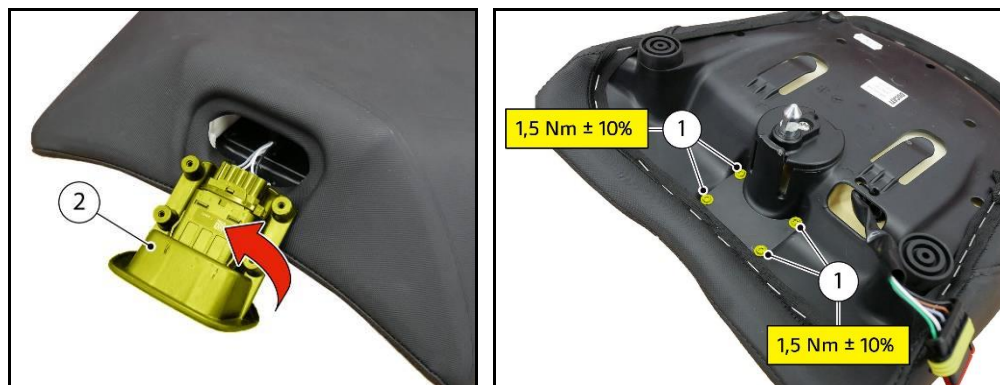
5. Turn the **button-switch-cover assembly (2)** back over, insert it into the passenger seat and tighten the 4 **M3.5x10 self-tapping screws (1)** to **1.5 Nm ± 10%**.

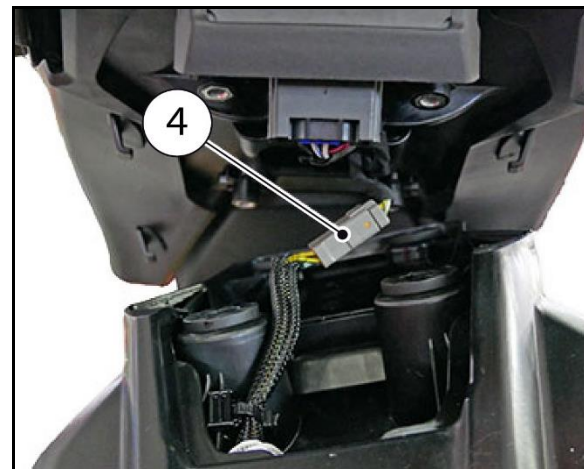
3. Pull the number plate holder wiring (6) out of lower support tabs (5) and disconnect the connector (4) of the number plate holder wiring

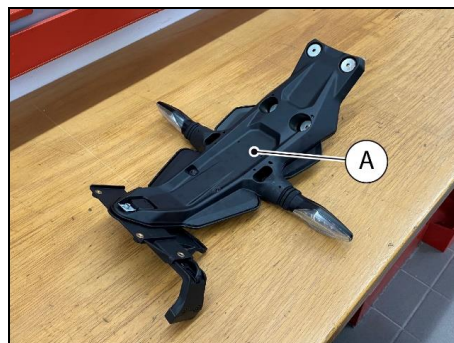
4. Place number plate holder (A) on a workbench to facilitate the operations to carry out

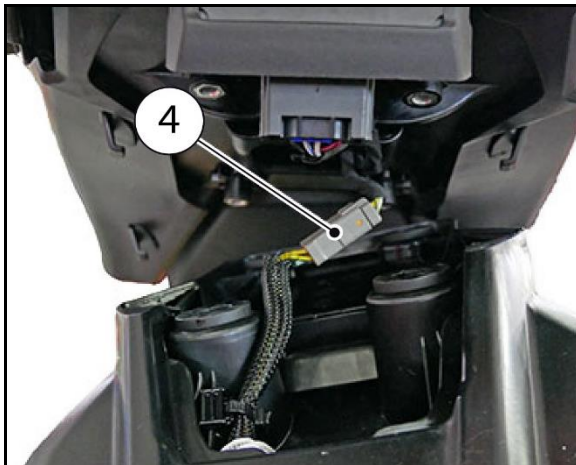
13. Connect the **connector (4)** of number plate holder wiring and position the wiring between the **tabs (5)** of lower number plate holder
