## Volvo Chassis - Technical Service Bulletin V-284 - 068, Exhaust Particulate Sensor, Repair ( 2016 Vehicles )

# Exhaust Particulate Sensor, Repair

V-284-068

Volvo with a 2 Box exhaust after-treatment system (EATS) and built between January 1st, 2016 and February 3rd, 2020.

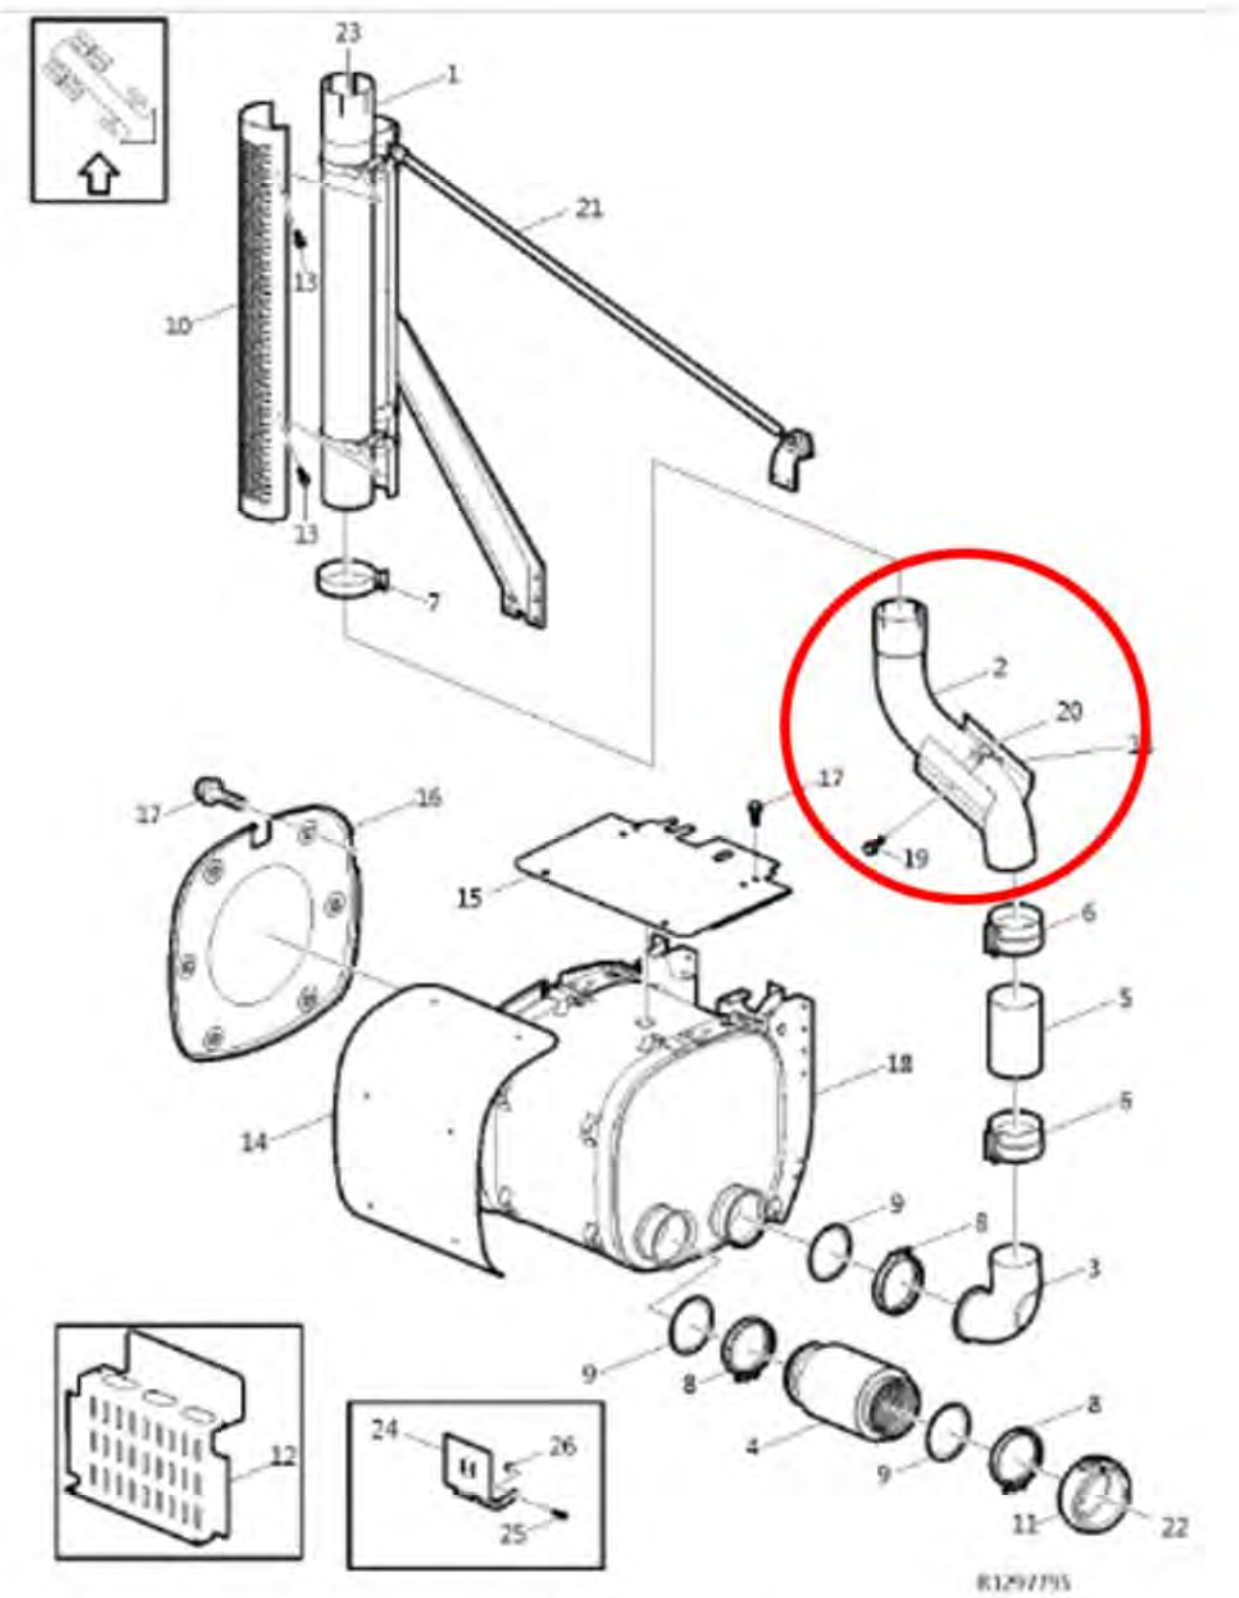
Repair 2

| Model | Cab Type | Exhaust Configuration | Pipe 1 |
|---|---|---|---|
| VNM/VHD | Day Cab | Single Outlet Right Side Inboard | 23630037 |

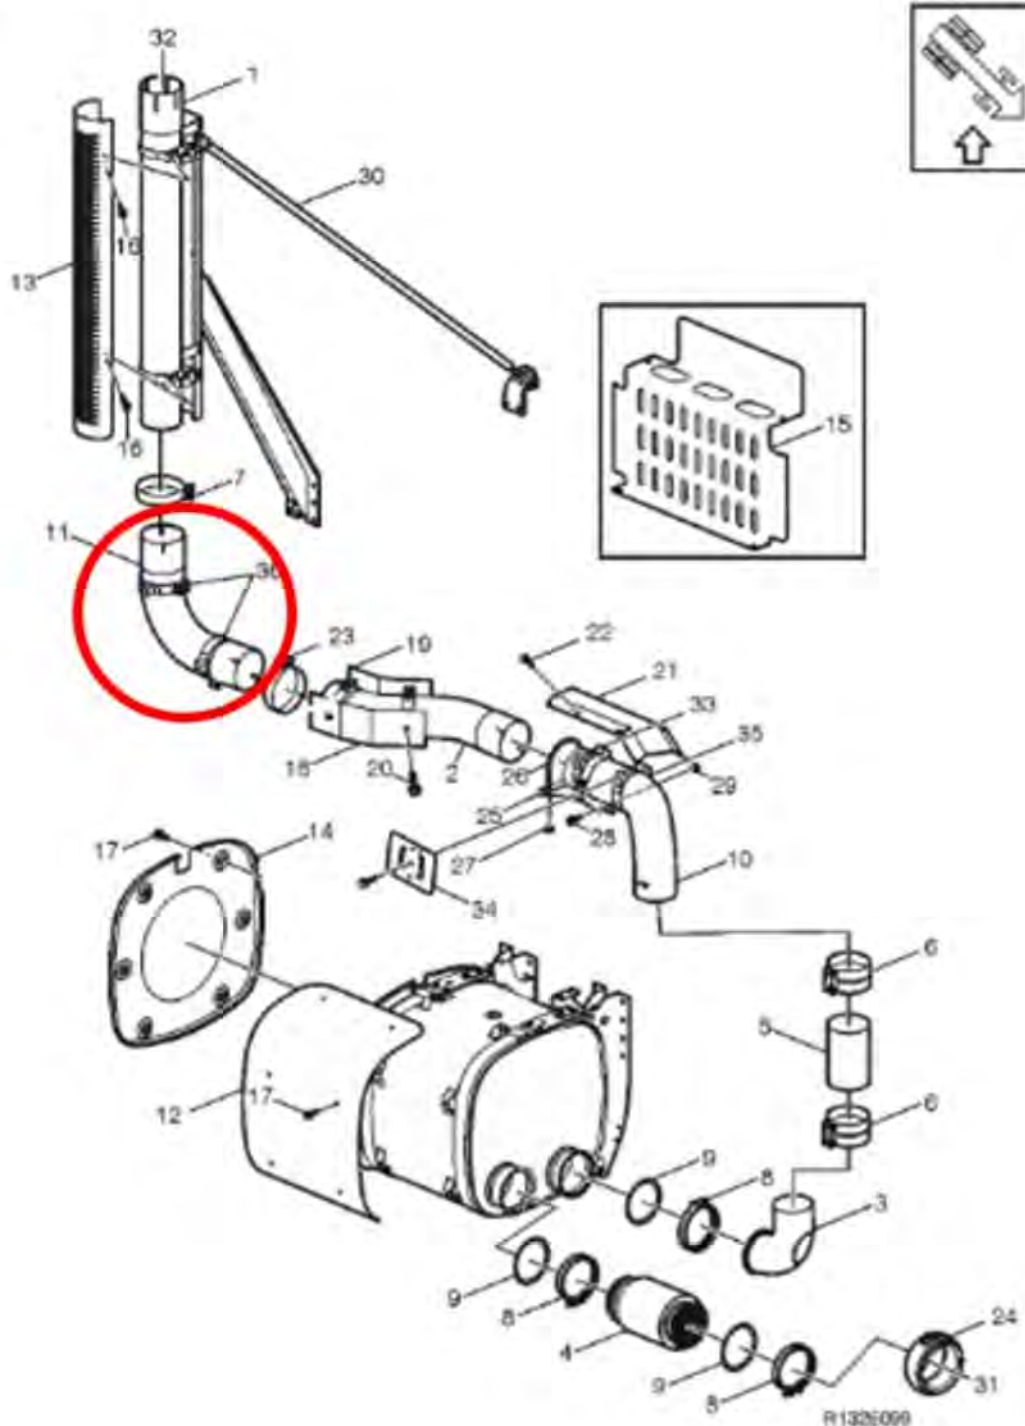
### Repair 3

| Model | Cab Type | Exhaust Configuration | Pipe 1 |
|---|---|---|---|
| VNL/VHD | 430/630 Sleeper | Single Outlet Right Side Inboard | (Not Bright)<br>23154798 |

Note: If the original flex pipe has previously been replaced, you will need a new elbow in addition to the new flex pipe.

| Model | Cab Type | Exhaust Configuration | Elbow |
|---|---|---|---|
| VNL/VHD | 430/630 Sleeper | Single Outlet<br>Right Side<br>Inboard | 21687278 |

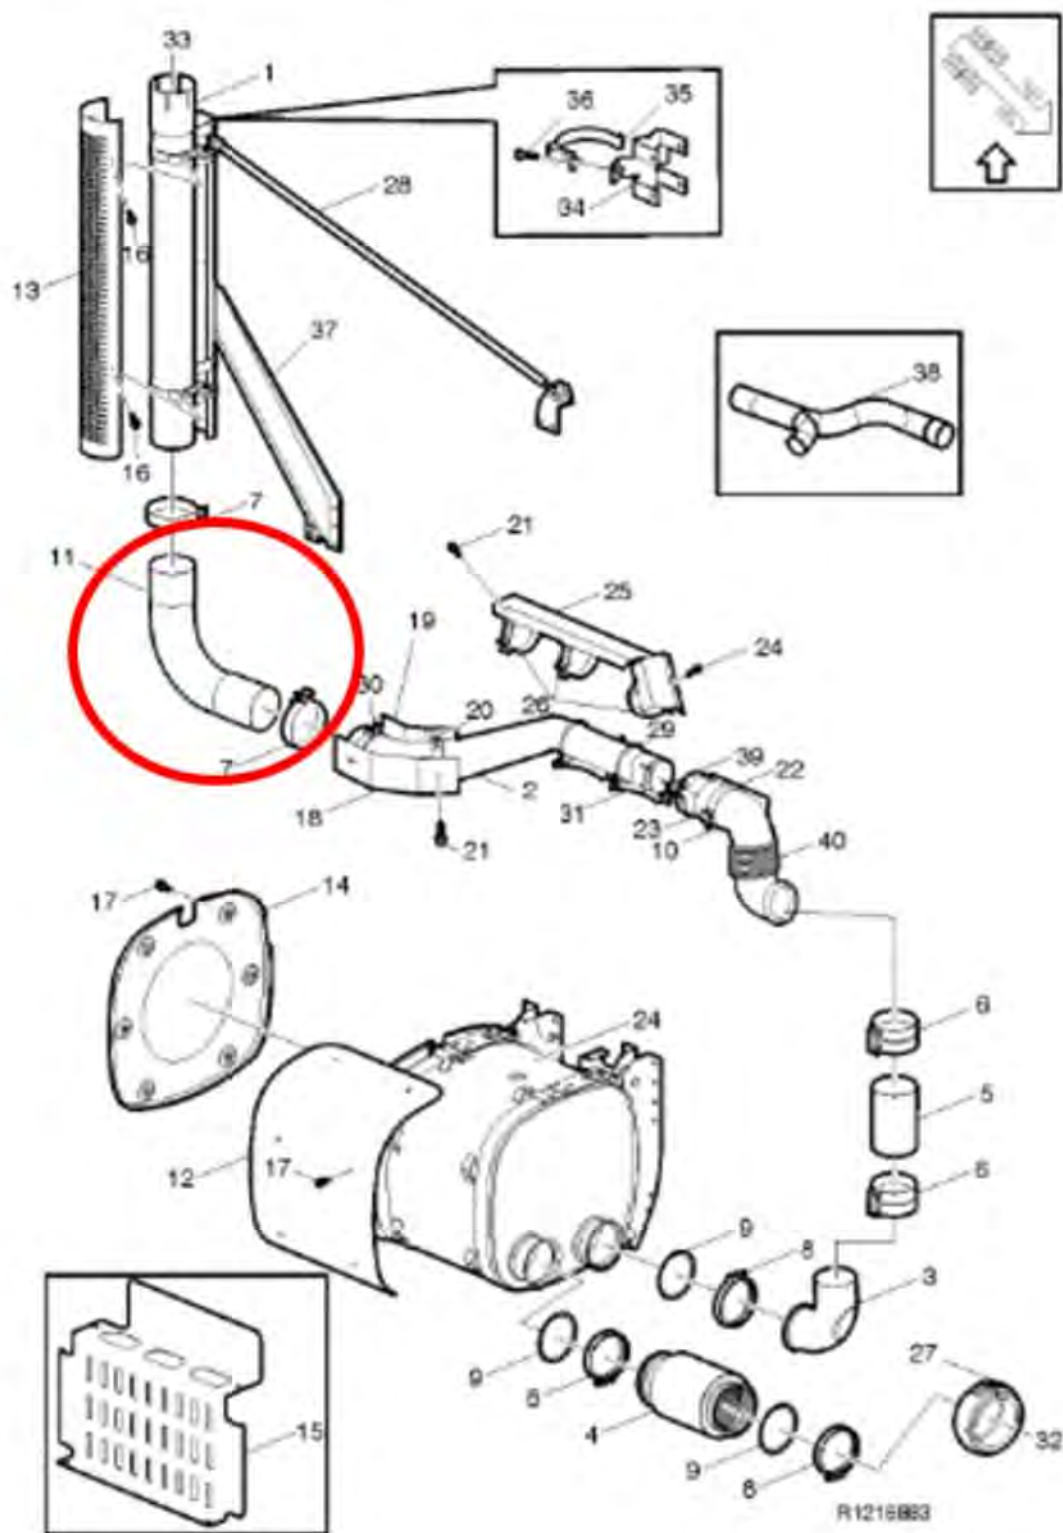
#### Repair 4

| Model | Cab Type | Exhaust Configuration | Pipe 1 |
|---|---|---|---|
| VNL | 430/670/780 Sleeper | Single Outlet<br>Right Side<br>Inboard | (Not Bright)<br>23154798<br>(Bright)<br>23154799 |

Note: If the original flex pipe has previously been replaced, you will need a new elbow in addition to the new flex pipe

| Model | Cab Type | Exhaust Configuration | Elbow |
|---|---|---|---|
| VNL | 430 Sleeper | Single Outlet Right Side Inboard | 21625282 |

| Model | Cab Type | Exhaust Configuration | Elbow |
|---|---|---|---|
| VNL | 670/780 Sleeper | Single Outlet Right Side Inboard | 21625281 |

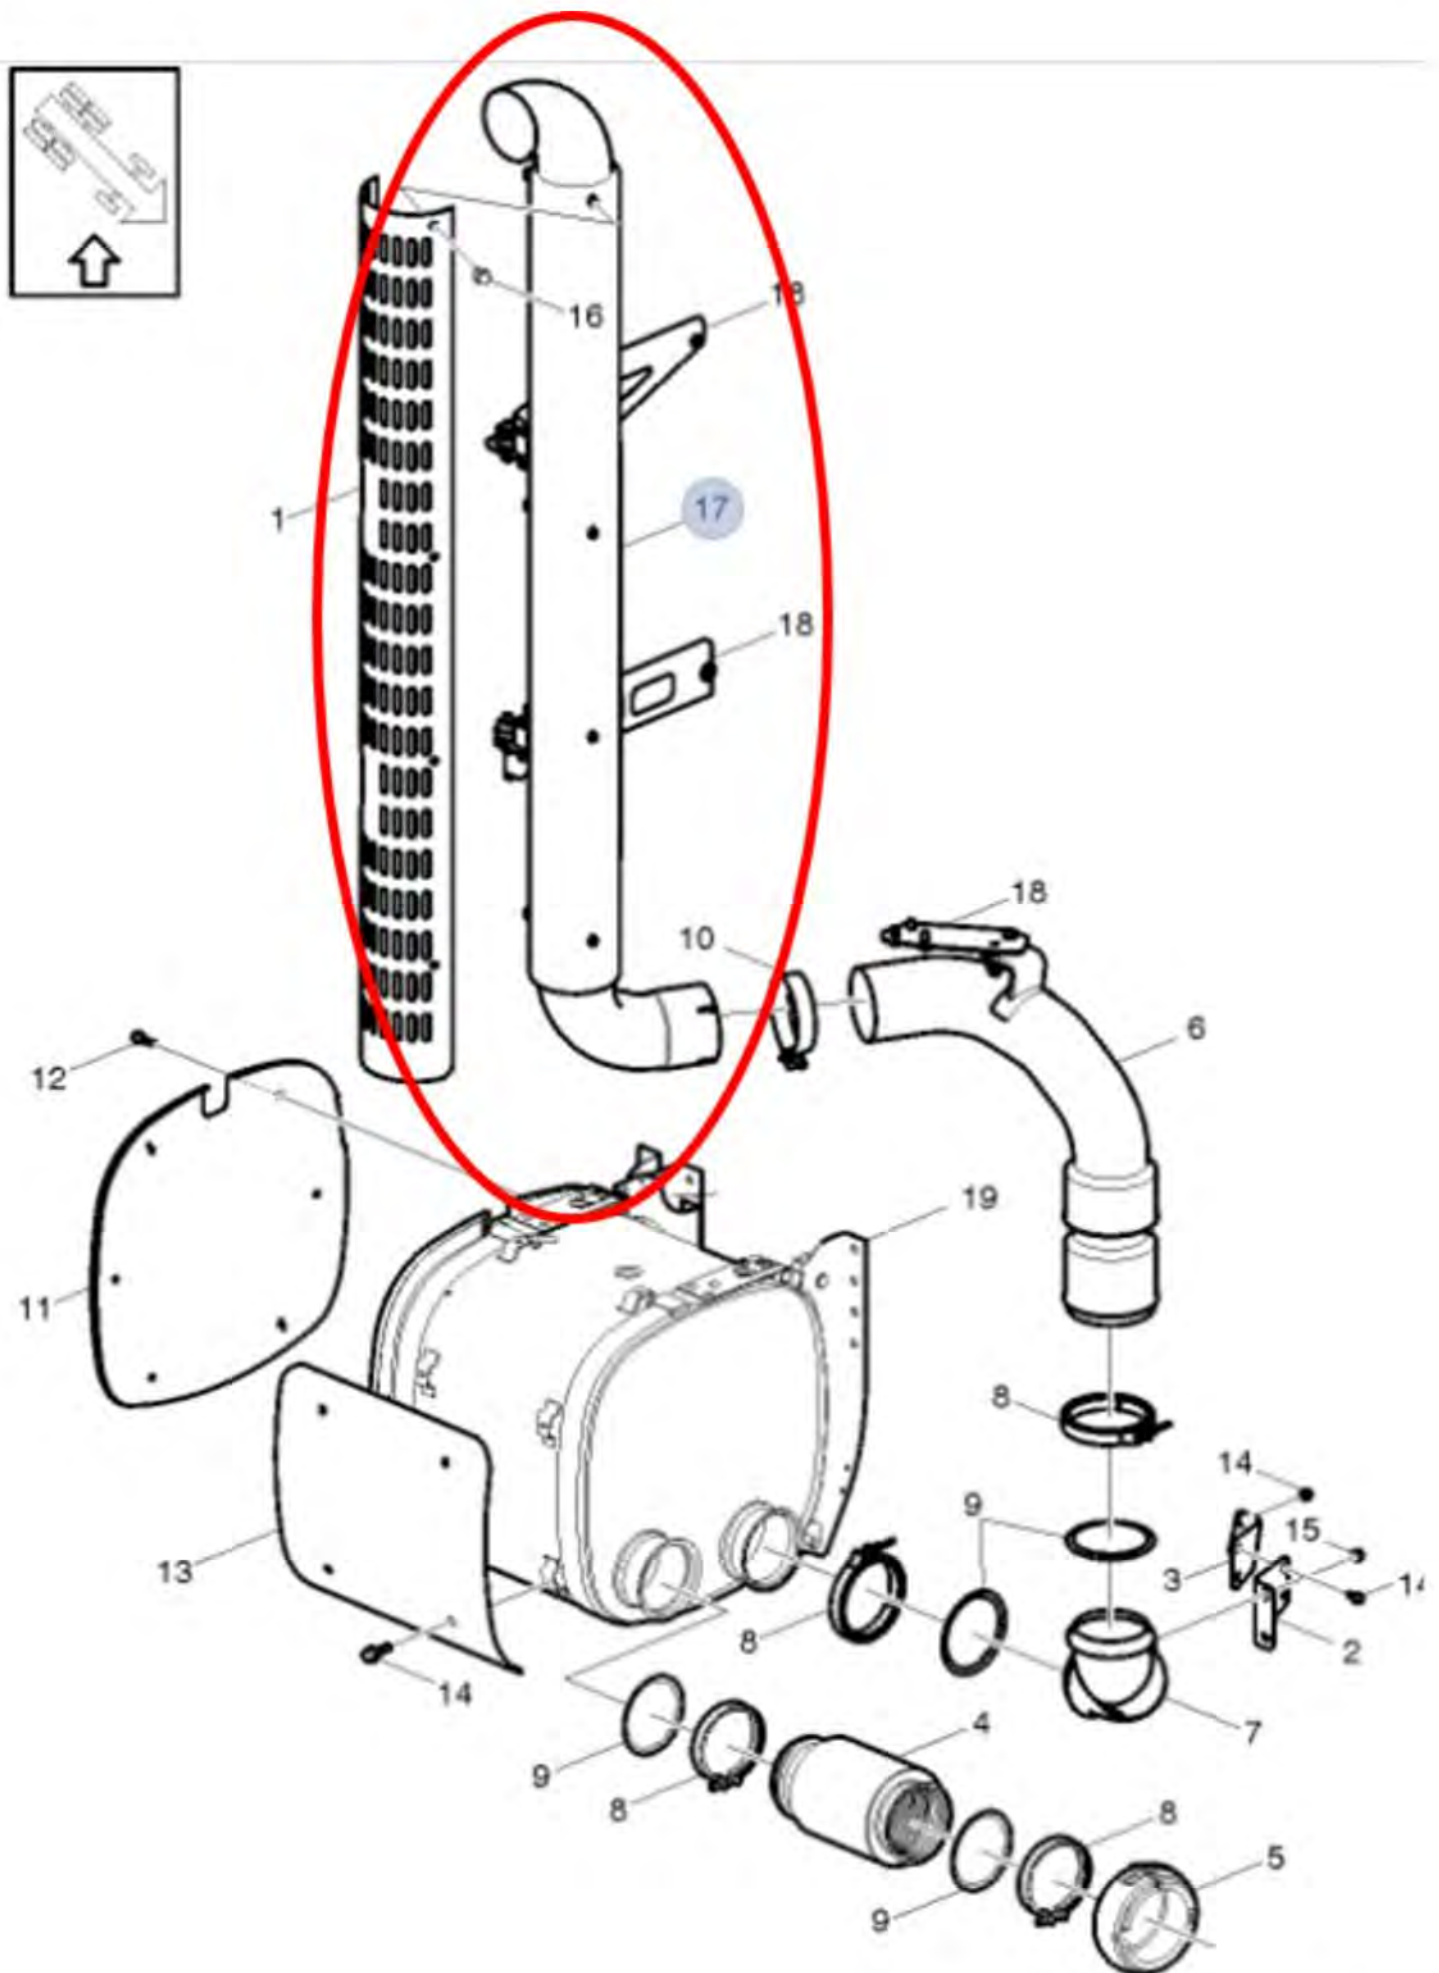
## Repair 6

| Model | Cab Type | Exhaust Configuration | Pipe 1 | Clamp (Qty will vary) |
|---|---|---|---|---|
| VHD/VNM | Cab Mounted | SCR RH Horizontal Forward Mount | 23154823 | 20961913 |
| VHD/VNM | Cab Mounted | SCR Horizontal | 23154825 | 20961913 |
| VNL 11/13 | Cab Mounted | SCR Horizontal | 23154827 | 20961913 |

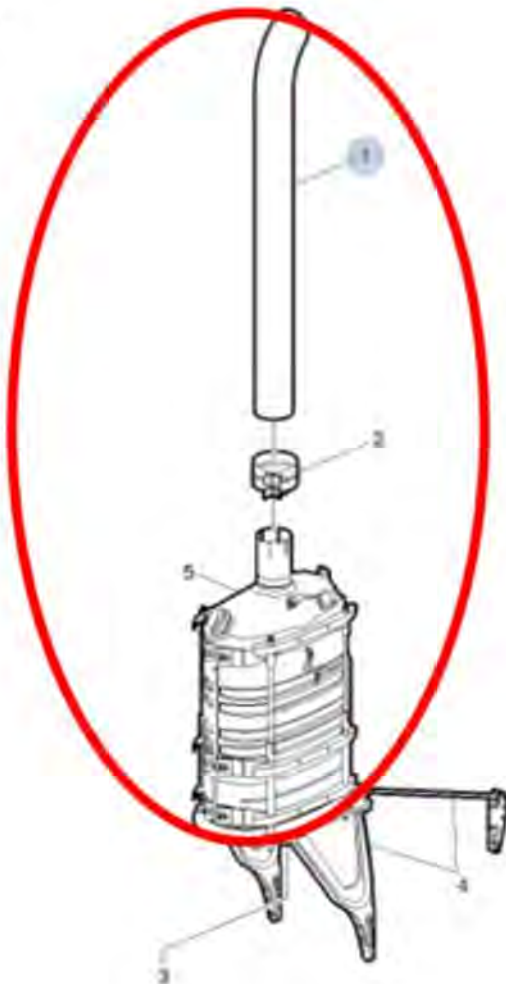
## Repair 7

| | | | | | vary) |
|---|---|---|---|---|---|
| All | 16L | 12.5 ft<br>Exhaust<br>Stack Right<br>Side | 23208705 | 23296273 | 23189982 |
| All | 11L /<br>13L | 11 ft 8 in<br>Exhaust<br>Stack Right<br>Side | (Not<br>Bright)<br>23208698<br>(Bright)<br>23208699 | 23176623 | 23189982 |
| All | 11L /<br>13L | 12 ft 6 in<br>Exhaust<br>Stack Right<br>Side | (Not<br>Bright)<br>23208700<br>(Bright)<br>23208701 | 23176623 | 23189982 |
| All | 11L /<br>13L | 13 ft 5 in<br>Exhaust<br>Stack Right<br>Side | (Not<br>Bright)<br>23208702<br>(Bright)<br>23208703 | 23176623 | 23189982 |
