B-pillar trim seal on rear doors peeling

Topic number	LI72.12-P-074542
Version	1
Function group	72.12 - Rear door
Date	3/10/22
Validity	MODEL 177 up to and including production date: November 2021.
Reason for change

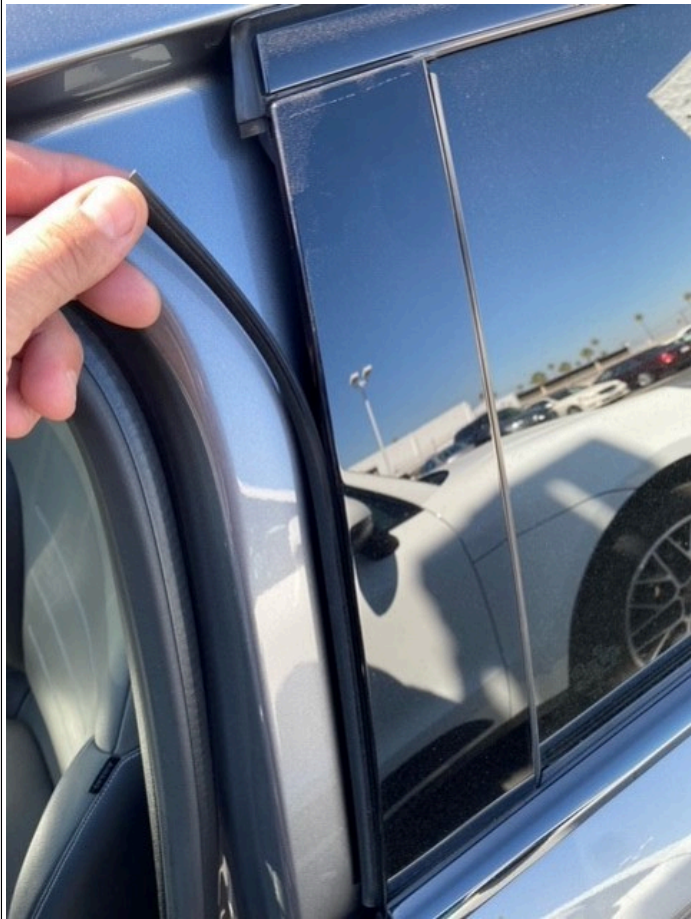
File	Description
Bild 1.jpg

The seal on the B-pillar trim of the rear doors may be peeling on upper area, see picture 1.

The part may exhibit this behavior under normal use.

Replace B-pillar trim through optimized parts.

WIS-References		
Document number	Title	Note
AR72.12-P-0001MFA	Remove/install sealing for side window at rear door	Step 7
