BULLETIN NUMBER:
SB18-C-001E

DOOR WIND NOISE/WATER INTRUSION – IMPROVED DOOR SEAL AND ADJUSTMENT PROCEDURE

- 2011MY – 2021MY Isuzu N-Diesel
- 2011MY – 2020MY Isuzu N-Gas
- 2018MY – 2021MY Isuzu FTR

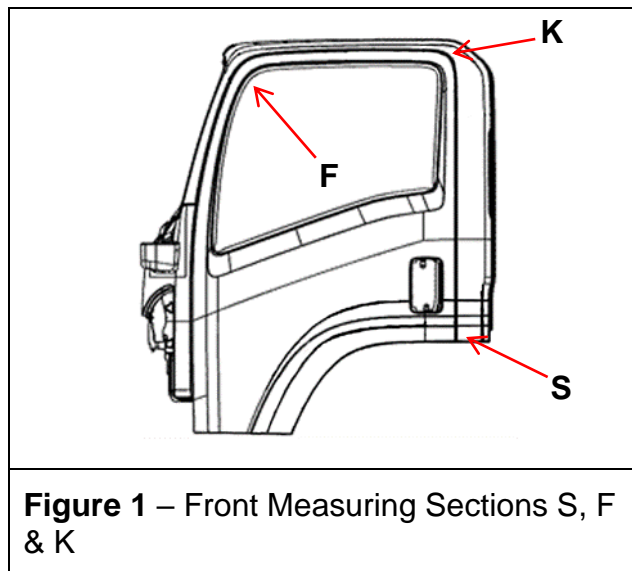
1. Measure the offset and gap of the doors at the locations shown in Figure 1. Specifications are shown in Table 3. Measurements are made using two metric rulers as shown in Figures 2, 3 & 4.

TABLE 3				
Door Surface Offset & Gap Specifications				
Location	Offset		Gap	
F	- 3.3mm	+/- 1.5mm	5.1mm	+/- 1.5mm
K	0.0mm	+/- 1.5mm	5.1mm	+/- 1.5mm
S	0.0mm	+/- 1.5mm	5.2mm	+/- 1.5mm

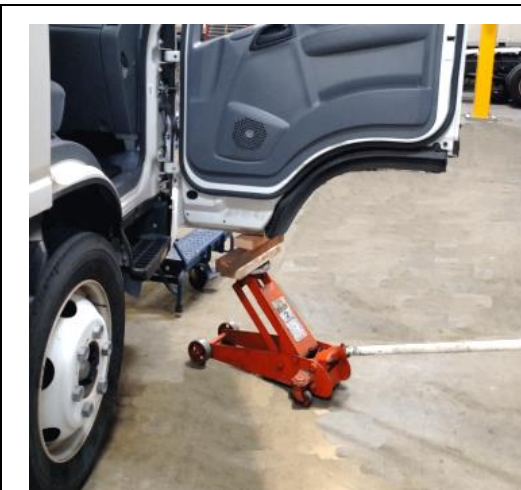
Figure 5

3. Open and support the door with a piece of wood using a floor jack. (See Figure 5.)
4. Using a grease pencil make an alignment mark for reference on the door hinge and front door panel. (See Figure 6.)

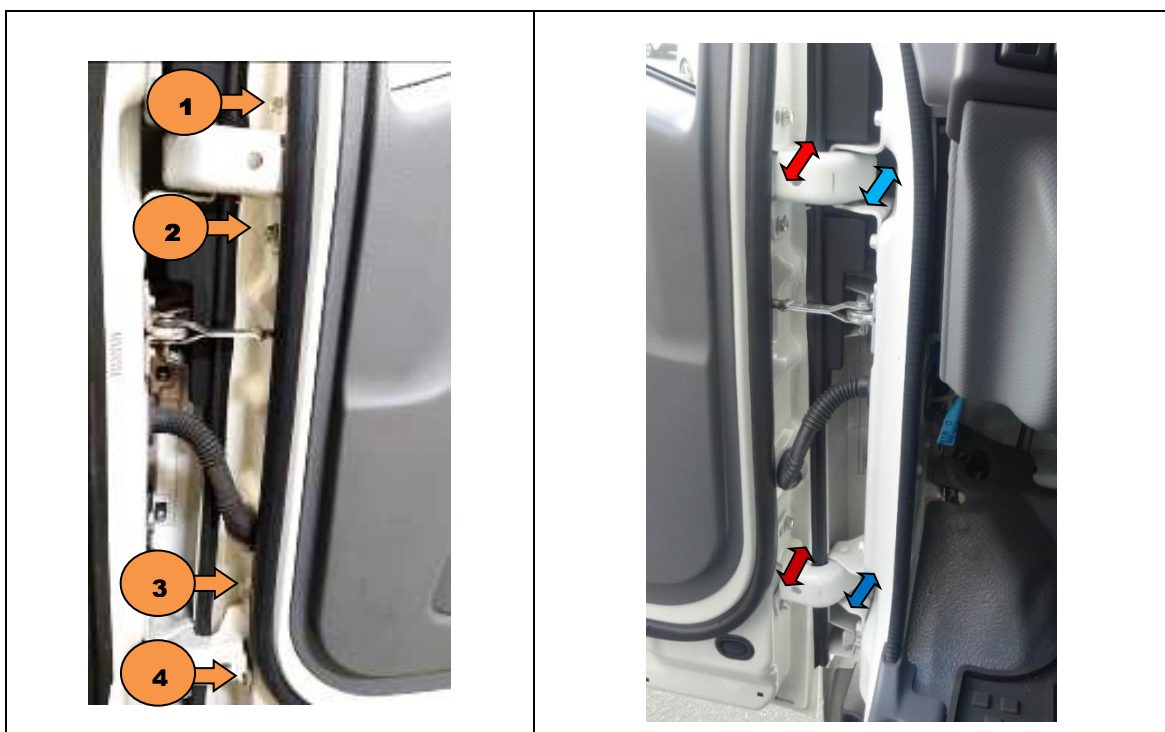
- Loosen bolt Number 1 shown in Figure 7 using a 3/8" drive ratchet, a 1" long-3/8" drive extension, and a 12mm crow's foot. After the bolt is loose, remove the bolt using a 12mm wrench. Replace bolt Number 1 with a new bolt, the part number for which is provided on the last page of this bulletin.

- Repeat Steps 5 and 6 for bolts 2, 3, and 4. (See Figure 7.)

- Adjust the doors.
 - If the door protrudes from the body or is recessed into the bodylines, adjust the door where the door hinge bolts to the door, as marked and shown by the red arrows in Figure 8.
 - Red arrows – moving the door away from the interior will raise the door from the cab when the door is closed.
 - If the door is not centered in the doorframe, adjust the door where the door hinge bolts to the cab, as marked and shown by the blue arrows in Figure 8.
 - Blue arrows – move the door in the direction needed to center the door in the doorframe.
- When the doors have been adjusted correctly, torque all the new door bolts to the specified torque using a 3/8" drive torque wrench, a 1" long-3/8" drive extension, and a 12mm crow's foot. Tightening Torque - 21.6 N•m (15.9 lb•ft)

Figure 8 - View from inside driver's door.

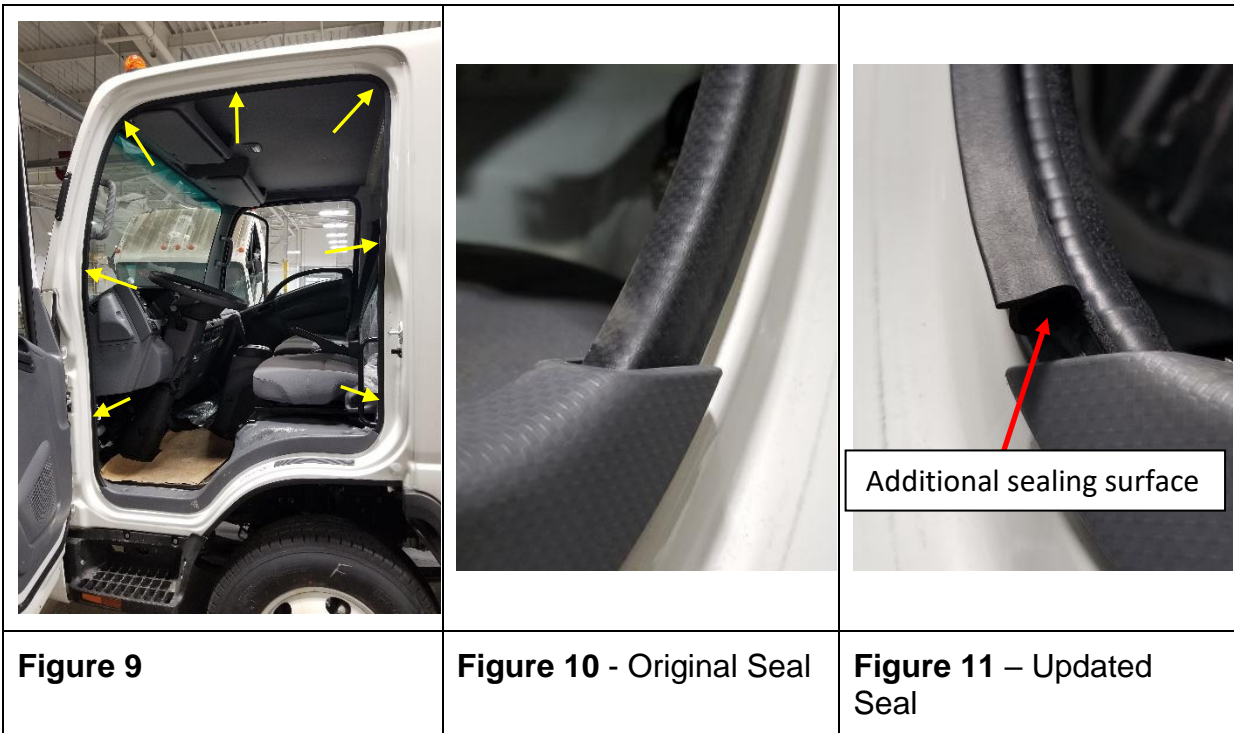
10. On single cab, N-Series vehicles check the seal on the **cab-side** of the door opening (See Figure 9) to determine if it is an original seal design or a previously offered revision. (See Figures 10 & 11.)
 - a. If the original seals are present as shown in Figure 10, replace them with the redesigned **cab seal** and continue to Step 11.
 - b. If the seals on the vehicle's **cab** are as those shown in Figure 11, skip to Step 24.
 - c. If vehicle is an FTR, continue to Step 11.

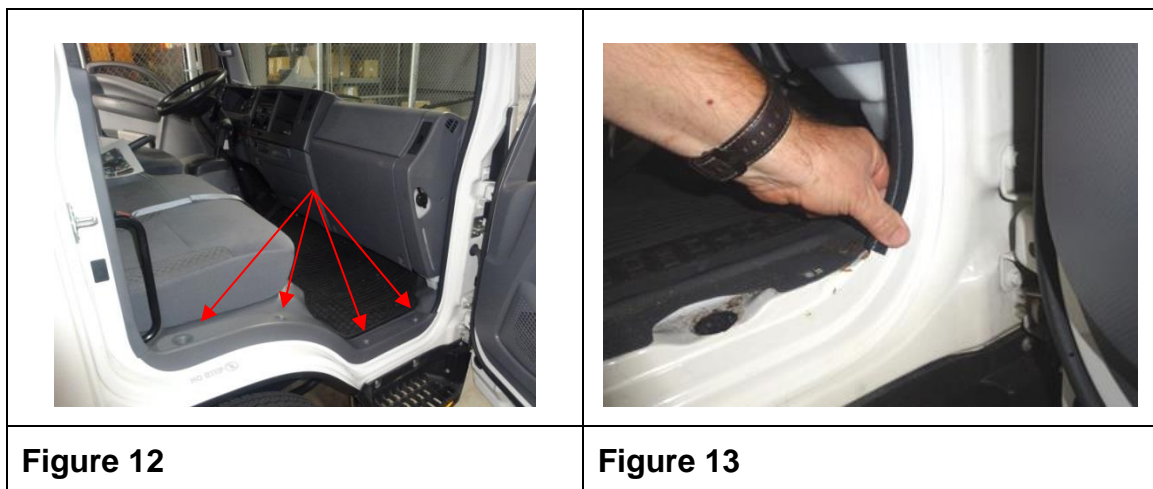
11. Remove the passenger door sill protector by removing four (4) screws. (See Figure 12.)
12. Remove the old weather strip by pulling weather strip away from the cabin pinch weld surface. (See Figure 13.)

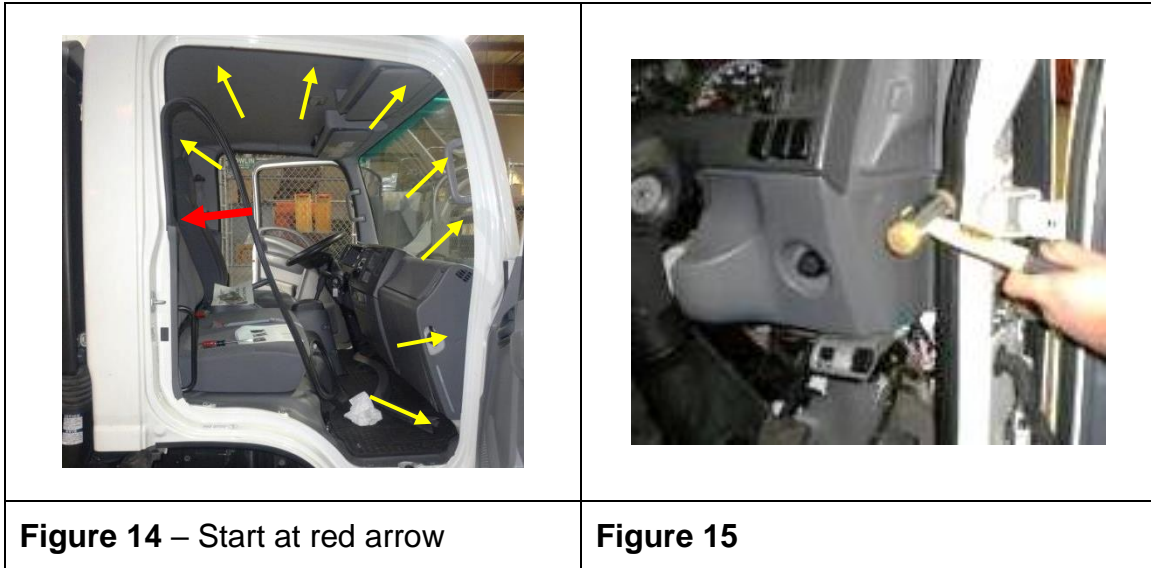
13. Wipe down the pinch weld surface using a clean cloth. (See yellow arrows in Figure 14.)

14. Attach the new weather strip to the pinch welding surface, starting at the rear quarter side, marked by the red arrow in Figure 14, and work towards the front.

15. Using a rubber mallet, ensure the weather strip is fully seated. (See Figure 15.)

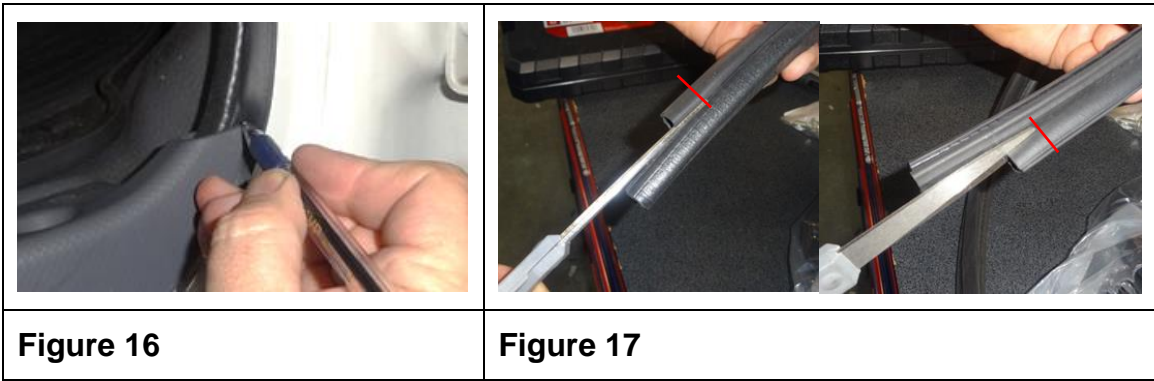
- If the new seal interferes with and sits below the door side sill protector, as shown in Figure 16 below, proceed to Step 17.
- If there is no interference, repeat on other side.
- If both doors have been completed, skip to Step 24.

17. Using a pen, mark the seal using the top of the door side sill protector as a guide to where the weather strip needs to be cut. (See Figure 16.)

NOTE: Weather strip is removed from vehicle in the photo below for illustrative purposes only. Procedure can be done with weather strip remaining on the vehicle. (See Figure 17.)

19. Using sharp scissors, cut both sides of the weather strip at the attachment points up to where the pen mark is shown in Figure 17.

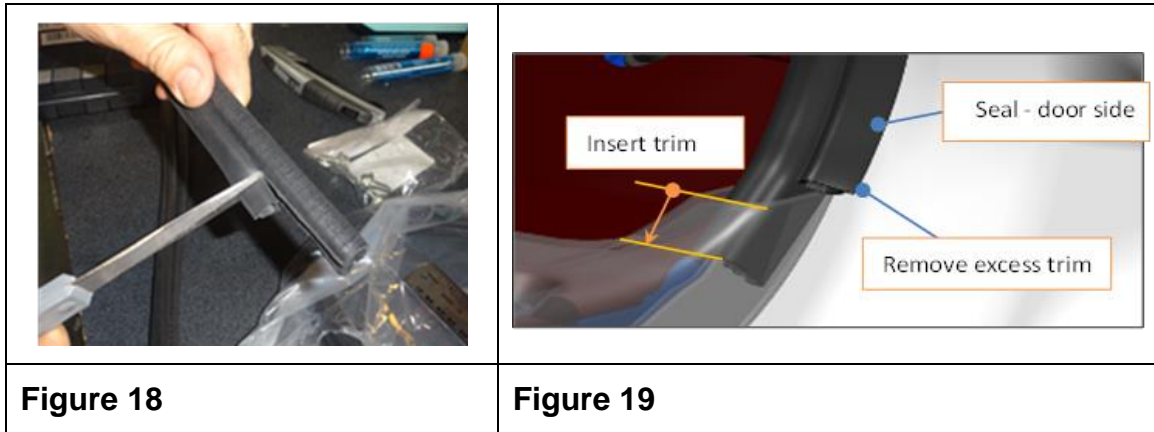
20. Cut off the piece of the seal that is interfering with the door sill protector. (See Figure 18.)

NOTE: Weather strip should fit into the door sill protector without interference. (See Figure 19.)

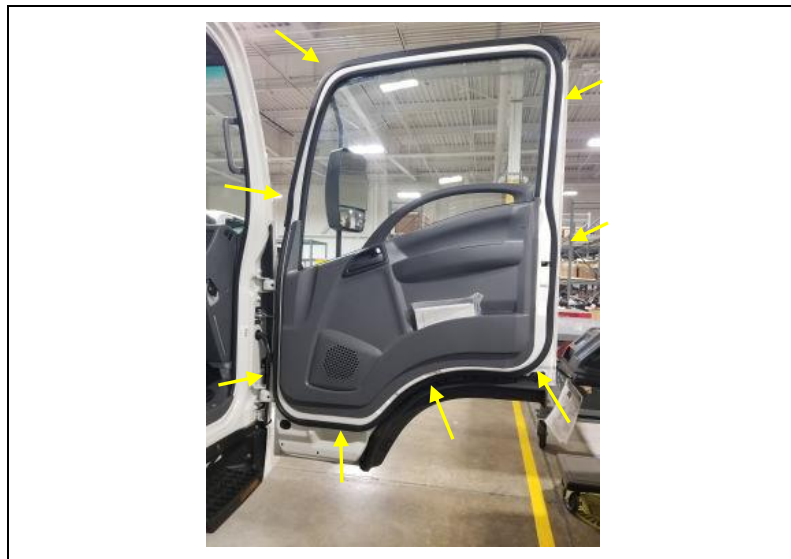
Figure 20

24. On single cab, N-Series vehicles check the seal on the **door side** of the door opening (See Figure 20) to determine if it is an original seal design or a previously offered revision.

- a. If the original seals are present as shown in Figure 20, continue to Step 25.
- b. If the seals on the vehicle's **door** are as those shown in Figures 21 & 22, skip to Step 29.
- c. If vehicle is an FTR, skip to Step 26.

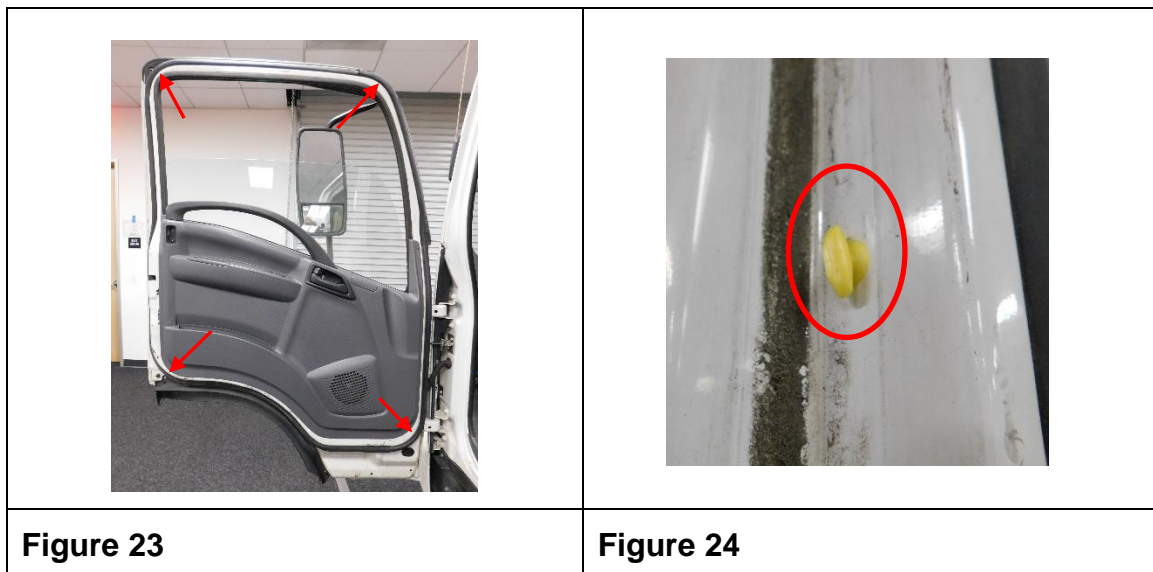
25. Remove the side **door seal** shown in Figure 23 by pulling door seal from the door.
 - Using a trim panel tool or wire cutters remove mounting fasteners from door. (See Figure 24.)
