Model Series 230: Airscarf Nonfunctional.

Topic number	LI91.29-P-059366
Version	3
Function group	91.29 - Seats - electrical system
Date	1/6/22
Validity	Model series 230 with SA code 403 (AIRSCARF system)
Reason for change	Change to part number of cable tie (project Focus)

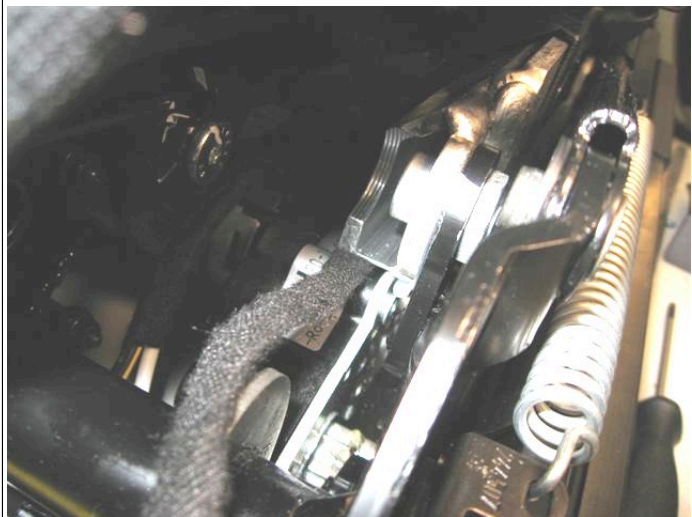
Attachments	
File	Description
Sitz 004 _Small_.jpg	Damage profile

The electrical wiring harness is trapped between the height adjustment gearing and the cushion frame.

Check the electrical wiring harness for damage (see Seat 004 _Small_.jpg) and repair if necessary.

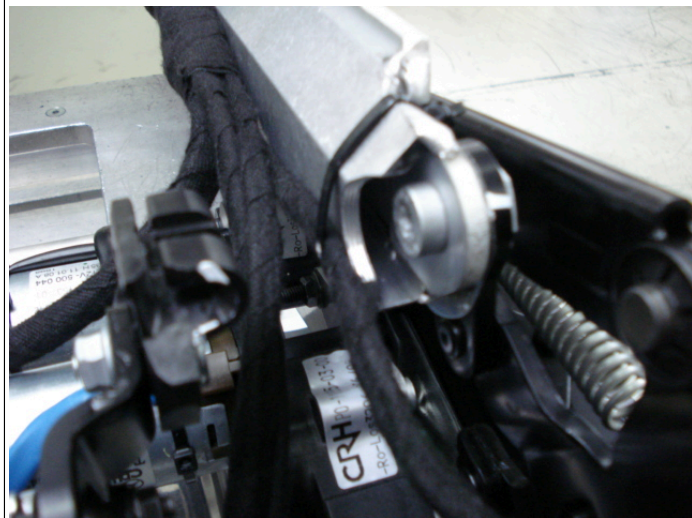
[Abhilfe.jpg](#)

Remedy for attachment of wiring harness using cable ties

Then secure the electrical wiring harness using additional cable ties (see Remedy.jpg).
