Service Bulletin

Bulletin No.: 22-NA-061

Subject: Fluid Leak In the Center of Vehicle on Drivers Side, Tapping/Knocking Noise on Turns

Brand:	Model:	Model Year:		VIN:		Engine:	Transmission:
		from	to	from	to		
Chevrolet	Express	2018	2019				
GMC	Savana

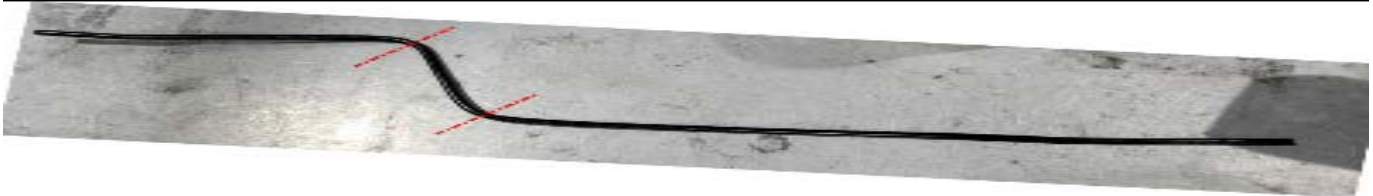
6014761

4. Using a pipe bender or equivalent, bend the tubing so that it matches the old tubing.

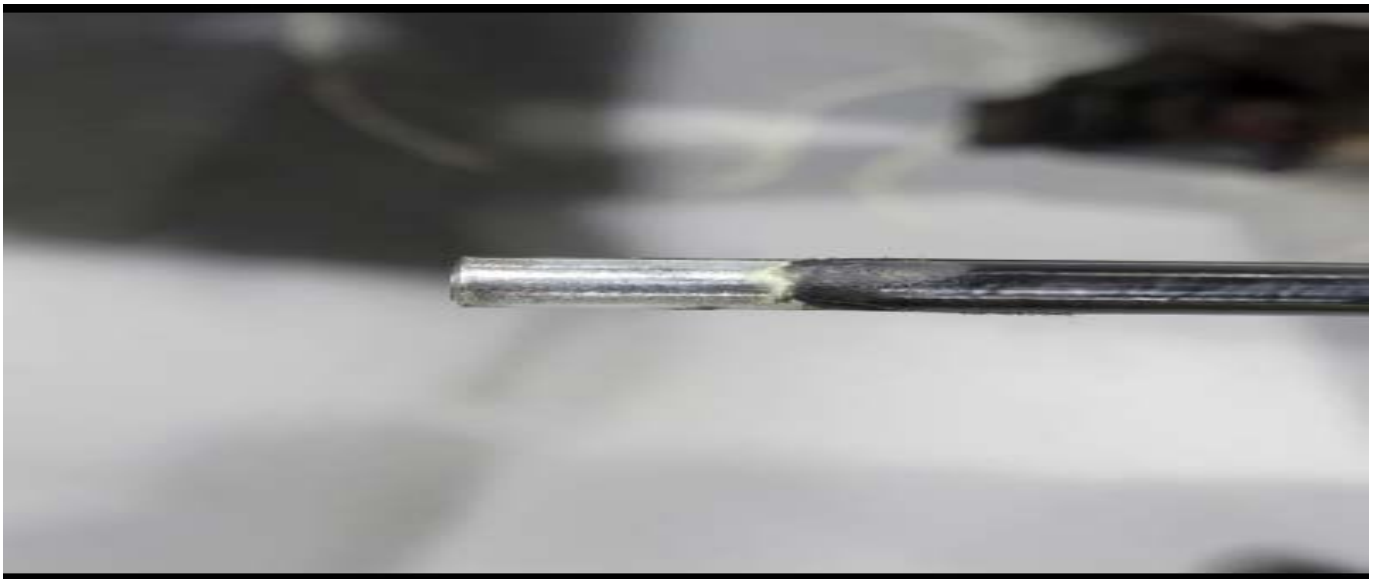
6014708

- If necessary, remove some of the protective coating before installing the pipe nut.
