**Communication #:** I-22-03-02

**Model Year(s):** 2015 - 2022

## SUBJECT: BATTERY INSTALL / SERVICE GUIDANCE

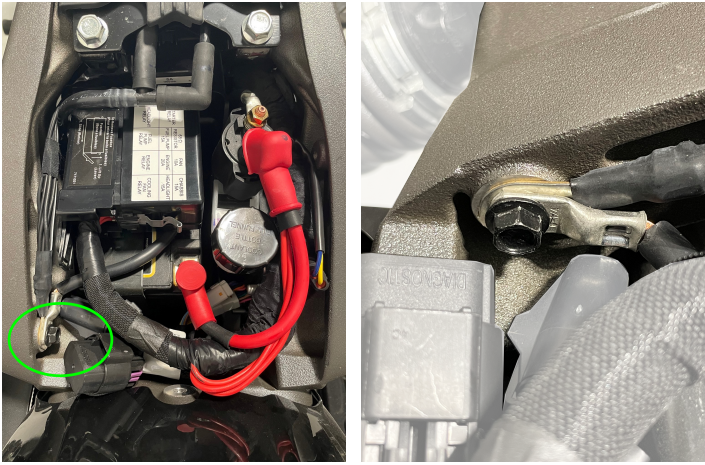
| IMPORTANT |
|---|
| Review the frame mount location for the chassis ground for the vehicle being serviced. Make sure when the joint is assembled and torqued that the terminals are clocked as shown below. For older vehicles with the chassis ground located on the side of mid-cast (pictured left), make sure the terminals are stacked so the wires are not overlaid. For newer models (pictured right) make sure the terminals are clocked 90 degrees apart as shown such that after tightening the battery can be removed without disassembly of the chassis joint. |

| SIDE MOUNT GROUND<br>2015 - 2021 MODELS | BOTTOM MOUNT GROUND<br>2021 - 2022 MODELS |

- 1. Inspect the frame ground pad and the chassis harness ground, make sure there is exposed aluminum on the ground surface where the chassis harness ground makes contact. Both the frame ground pad and chassis harness ground should be free of debris, corrosion, non-metallic coating, fluids, etc.
- 2. Assemble the connections in the correct order. The chassis harness ground is placed down with the serrations against the frame surface, then install the flat side of the negative battery cable on top. Make sure the bolt is free of debris before installation.
- 3. Clock the harness and negative battery cable apart as specified. Before torquing the fastener, make sure the negative battery cable is placed to allow battery installation and removal.
- 4. Torque the fastener to specification.

| TORQUE | |
|---|--|
| Chassis Ground Fastener:<br>84 in-lbs (9.5 N·m) | |
