TECHNICAL TOPICS

BODY/CHASSIS

2 nd Row Seat Deployable Heel Rest Lower Level Assembly	17MY-Onwards Range Rover
<p><u>Customer Voice:</u></p> <ul style="list-style-type: none">A customer may report that the heel rest for the 2nd row executive seats is not operating properly. <p><u>Technical Description:</u></p> <ul style="list-style-type: none">This may be caused by a heel rest motor malfunction or damage to the heel rest frame. <p><u>Status:</u></p> <ul style="list-style-type: none">The heel rest motor and frame have now been released as a lower level service part, preventing the need to replace the front seat back frame assembly to service the heel rest motor or frame.Please refer to the lower level assembly service parts to conduct repairs wherever possible upon diagnosis of a heel rest motor or frame failure.The service procedure has been added to the Workshop Manual, section 501-10: Seating > Removal and Installation > Front Row Passenger Seat Heel Rest Motor And Mechanism.

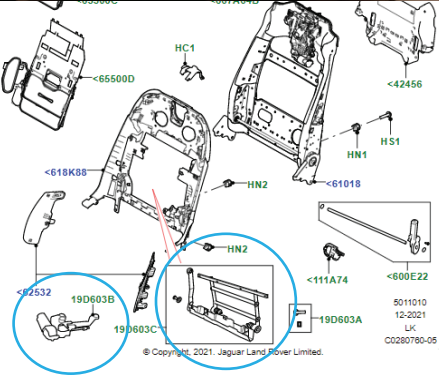
<p>Exploded view diagram of the heel rest lower level assembly. Key components and part numbers shown include: HC1, <65500D, <42456, HS1, HN1, <618K88, HN2, <61018, <111A74, <600E22, 5011010, 12-2021, LAK, C0280790-05, <2532, 19D603B, 19D603C, and 19D603A. A blue circle highlights the motor and frame assembly.</p> <p>© Copyright 2021, Jaguar Land Rover Limited.</p>
